Public remotely sensed data raise concerns about history of failed Jagersfontein dam

Luis Alberto Torres-Cruz[✉] & Christopher O'Donovan

A mine waste deposit known as a tailings dam recently failed in the town of Jagersfontein, South Africa. The failure occurred amidst global concern about the safety record of these structures. Herein we use public remotely sensed data to gain insights into the construction history of the dam. The data suggest a construction sequence that is inconsistent with sound tailings management practices: asymmetric deposition, erosion gullies, large ponds and absence of beaches. These observations highlight the criticality of adhering to good construction practices and the potential of public data to monitor such adherence. Additionally, we present commercially available very high resolution satellite images to illustrate some of the immediate consequences of the failure.

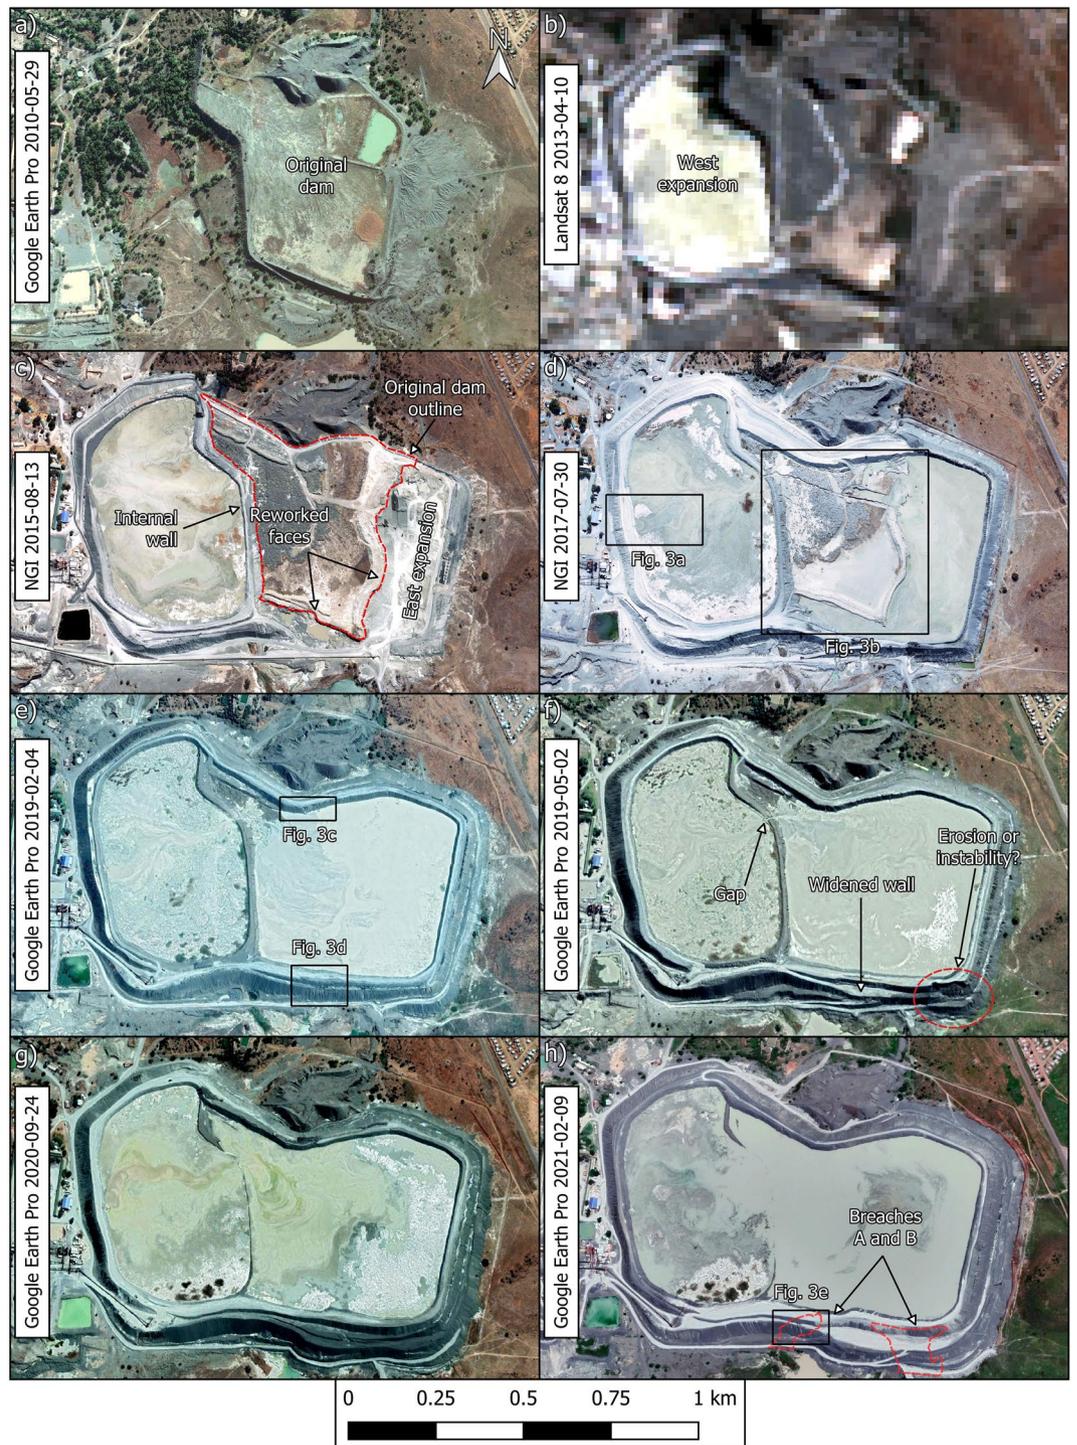
Construction and operation history of the Jagersfontein dam after 2010. Aerial and satellite images suggest that the Jagersfontein tailings dam and nearby mine waste stockpiles did not undergo significant changes between mine closure in 1971 and the onset of surface mine waste reprocessing in 2010 (Fig. S1). Accordingly, the focus herein is on the post-2010 development of the dam (Fig. 2). Hereafter we use the phrase 'original dam' to refer to the 2010 configuration of the dam prior to the deposition of tailings resulting from waste reprocessing (Fig. 2a). The images show that by April 2013, the original dam had almost doubled its footprint due to an expansion built on its west side (Fig. 2b). By August 2015, all tailings were being deposited in the west expansion while parts of the original dam were being reworked and activity in the area that would become an east expansion was also underway (Fig. 2c). By July 2017, tailings were being initially deposited into the west expansion and subsequently transported to the original dam and east expansion via two furrows connected to a gap in the internal wall (Figs. 2d, 3a,b). By February 2019, erosion gullies 4 to 5 m wide had developed on the internal face of the northern wall and on the external face of the portion of the southeastern wall that eventually failed (Figs. 2e, 3c,d). By May 2019, the furrows were almost entirely buried but eastward migration of tailings deposited in the west expansion continued through the gap in the internal wall (Fig. 2f). The increased width of the southeastern wall, which eventually failed, may indicate that buttressing efforts were underway. The southeastern corner of the dam exhibited an irregular geometry which may have been due to erosion or slope instability¹⁶. Eastward migration of tailings continued during 2020 (Fig. 2g) and by February 2021, the internal wall had been almost entirely covered and the southeastern wall remained significantly wider (potentially buttressed) than the remainder of the perimeter wall (Fig. 2h). A segment of the perimeter wall appeared wet and the slope directly underneath it exhibited erosion gullies (Figs. 2h and 3e). A preliminary stereoscopic analysis of satellite images indicates that the dam grew by ~ 18 million m³ to accommodate the tailings that resulted from the post-2010 reprocessing of legacy mine waste¹⁷.

Figure 2. Historical imagery of the Jagersfontein dam. (a) Configuration prior to reprocessing of legacy mine waste. (b) West expansion is visible by April 2013. (c) Deposition in the west expansion concurrent with reworking of the original dam and activity in the east expansion. (d) Furrows are visible by July 2017. (e–g) Eastward migration of tailings from the west expansion through a gap in the internal wall in 2019 and 2020. (h) Internal wall is almost entirely buried. NB: Part (h) shows location of breaches A and B which developed during failure (Fig. 5). Created using QGIS software version 3.26 (<http://www.QGIS.org>).

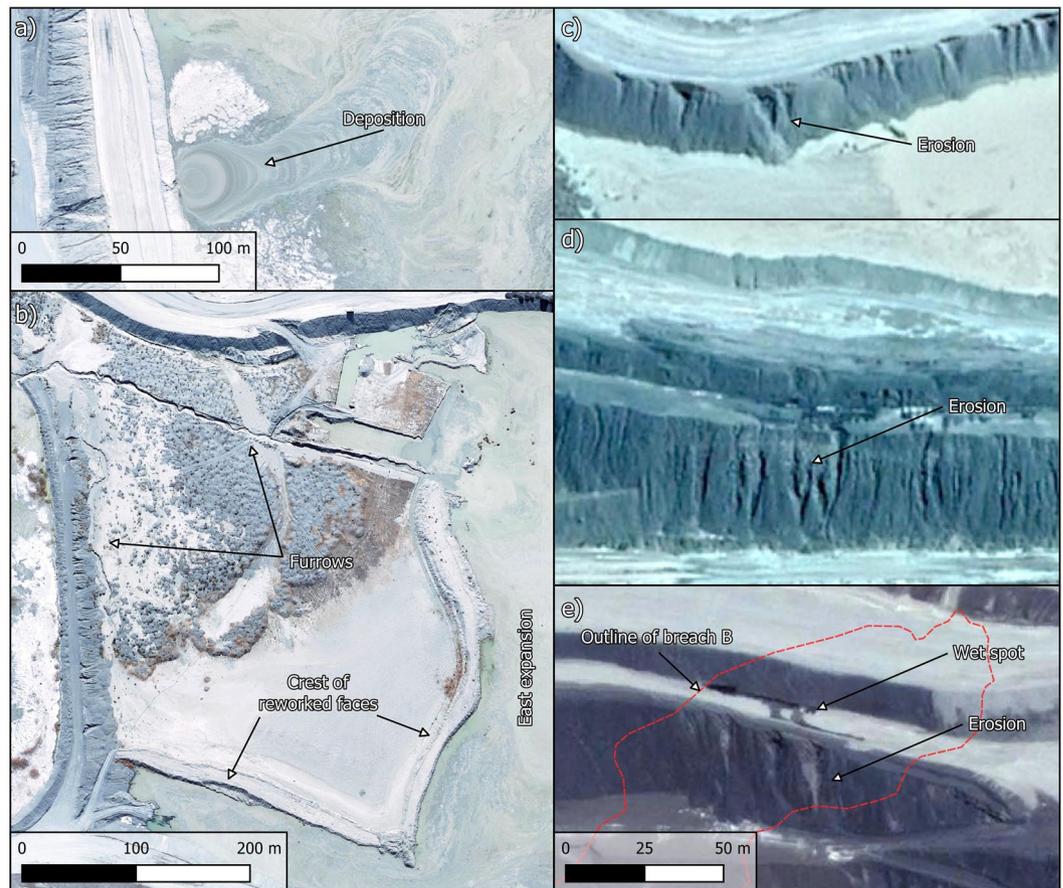
Figure 3. Details of the dam's history. (a) Deposition into west expansion enlarged from Fig. 2d. (b) Furrows in original dam enlarged from Fig. 2d. (c and d) Erosion gullies enlarged from Fig. 2e. (e) Wet spot and erosion gullies enlarged from Fig. 2h with outline of breach B which developed during failure (Fig. 5). NB: Parts (c), (d) and (e) share the same scale. Created using QGIS software version 3.26 (<http://www.QGIS.org>).

The discerned construction and operation history of the dam raises several concerns. For instance, Fig. 3e showed a wet spot on the portion of the outer wall on which breach B eventually developed. This image was captured on 9 February 2021 yet weather records do not show any significant rainfall events during the five preceding days (Fig. S3a). This suggests that the wet spot in Fig. 3e was caused by impounded water seeping through the perimeter wall and then cascading down the slope creating the erosion gullies. This is consistent with the large decant pond present in the dam on the same day and the day before the wet spot was observed (Figs. 2h and 4f). Large amounts of water in a tailings dam (Fig. 4) can initiate failure mechanisms, exacerbate the consequences of failure by enhancing tailings mobility, or both^{9,10,21}. Furthermore, the supernatant pond was on occasions located against the perimeter wall (Fig. 4), whereas recommended practice in dams built progressively is to keep a relatively small pond near the centre of the impoundment. This promotes safety by enabling the development of long beaches between the pond and the perimeter wall⁹ which is particularly important when dams do not have distinct core and filter zones. However, even in zoned dams, the absence of beaches can contribute to exacerbate failure consequences²¹. Lastly, tailings deposition predominantly from the west end of the dam (Figs. 2, 3 and 4) contravenes best practice which calls for deposition to proceed sequentially from different points on the

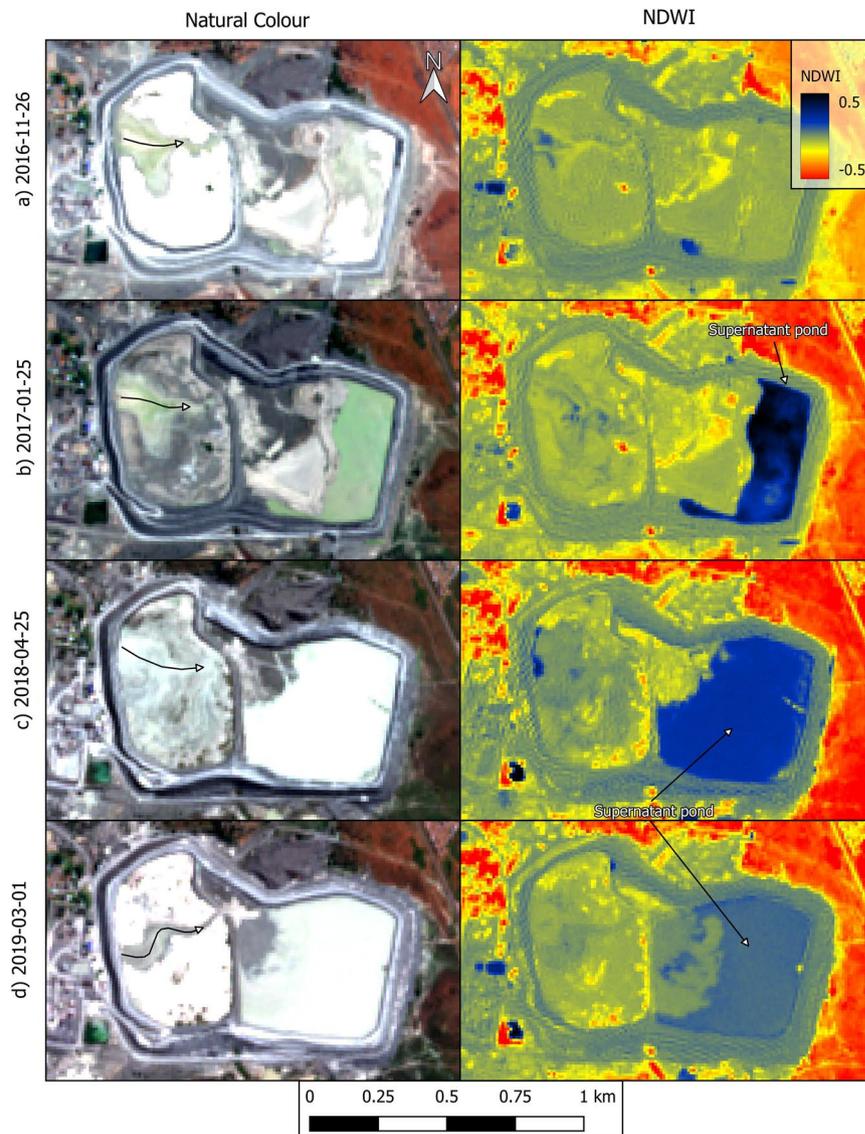
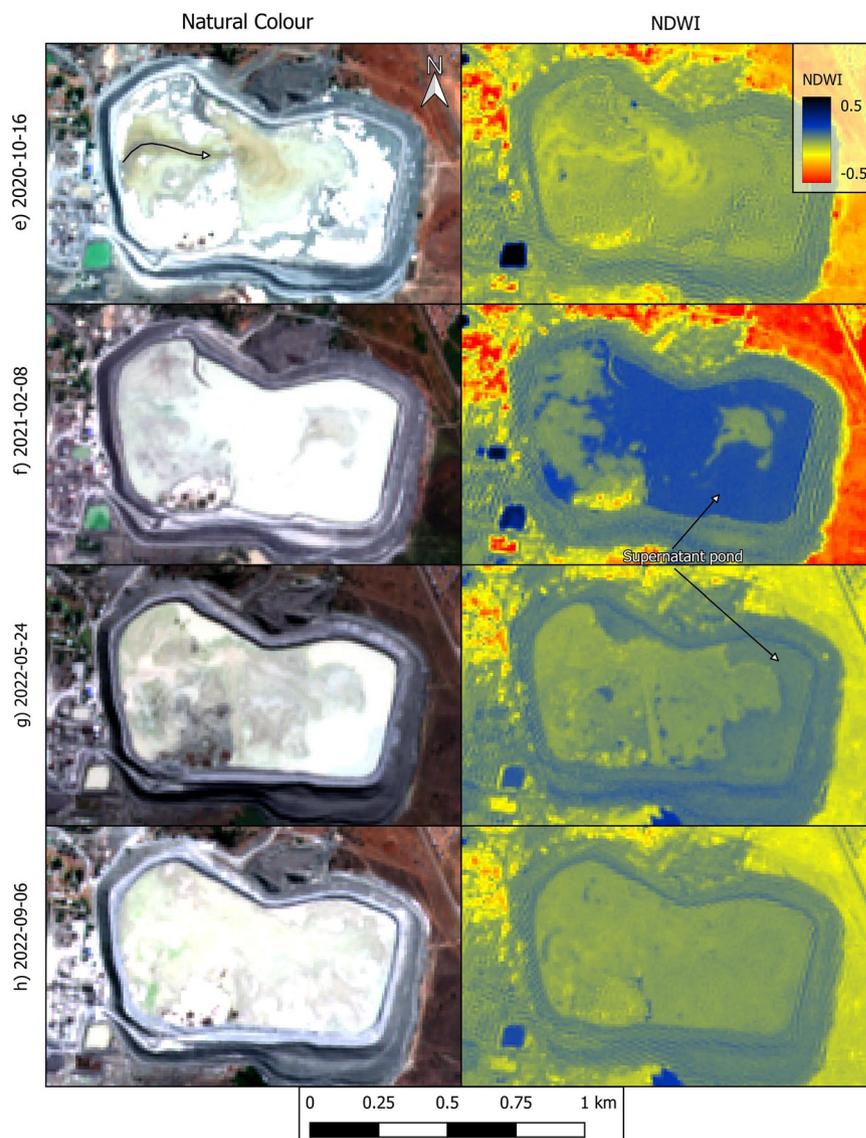
The natural colour and normalised difference water index (NDWI)¹⁸ images in Fig. 4 indicate several instances in which significant amounts of supernatant water accumulated atop the dam, especially over the east expansion and original dam (see details in figure caption). Interestingly, Fig. 4h, captured only 5 days before the failure, suggests that there was no significant pond of supernatant water atop the dam. In fact, although Sentinel-2 images are captured every five days²³ and clouds did not often compromise the images, one has to go as far back as 24 May 2022 (more than three months before failure) to find an image in which an extensive pond can be identified (Fig. 4g). This suggests that while large decant ponds were present in the historical development of the dam, they were not present in the months immediately prior to the failure. Several images in Fig. 4 (see details in figure caption) also indicate that tailings deposition was taking place predominantly, perhaps exclusively, from the west wall of the dam. This is consistent with the pattern of deposition observed in the higher resolution images (Figs. 2d–g and 3a).

Figure 4. Natural colour and NDWI renderings of Sentinel-2 images captured from 2016 to 2022. Natural colour renditions of parts (a) to (d) show eastward migration of tailings after initial deposition in the west expansion. NDWI renditions of parts (b) to (d) show a large supernatant pond located against the perimeter wall. Natural colour rendition of part (e) shows eastward migration of tailings after initial deposition in the west expansion. NDWI renditions of parts (f) and (g) show a large supernatant pond located against the perimeter wall. There is no discernible supernatant pond in part (h), captured 5 days before failure. NB: curved arrows indicate the inferred eastward migration of tailings after deposition. Created using QGIS software version 3.26 (<http://www.QGIS.org>).

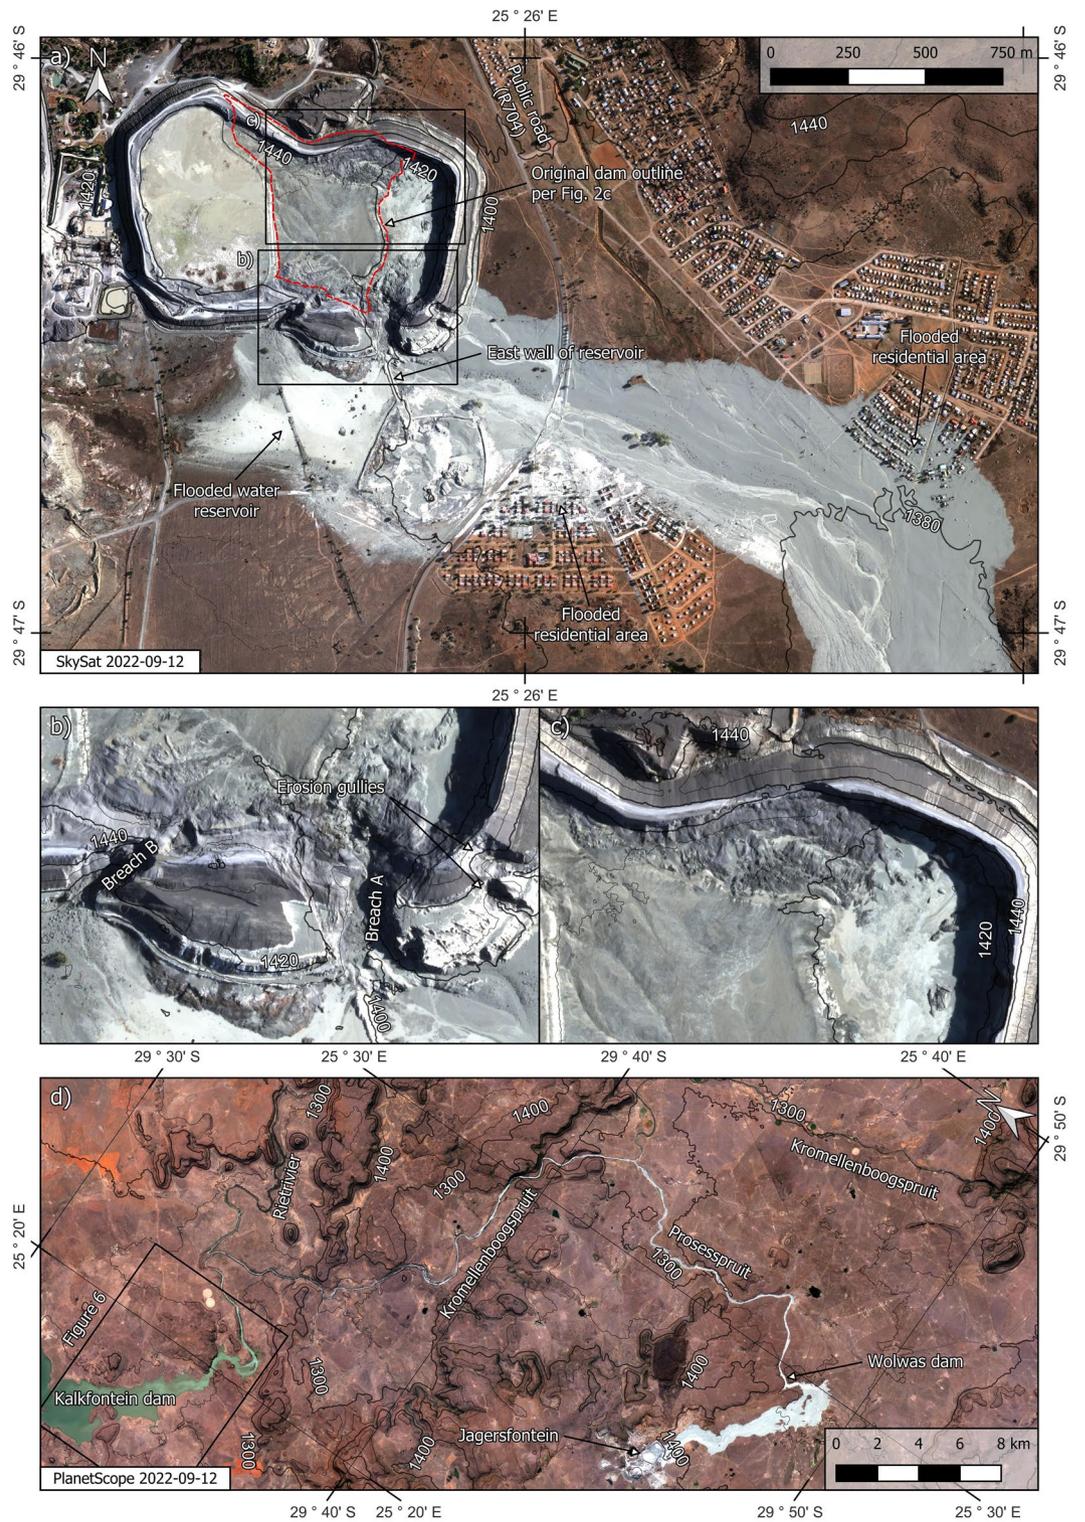
The immediate consequences of failure. The dam failed close to its southeastern corner and also experienced instability in its north perimeter wall (Figs. 5a–c and S2). The released tailings escaped primarily from the original dam and the east expansion. Tailings in the west expansion above the internal wall may have also escaped. Assuming that the level of tailings prior to failure was between 1435 and 1440 masl, we estimate the

Considering the geometry of the breached wall (Fig. 5b), our hypothesized general failure sequence is as follows. Breach B developed first, possibly due to a runaway erosion gully that began as shown in Fig. 3e. The fact that the wet spot in Fig. 3e coincides with the location of breach B supports this possibility. Furthermore, the absence of heavy rainfall events in the weeks prior to failure (Fig. S3b), coupled with the absence of a decant pond only five days before failure (Fig. 4h), suggests that it is unlikely that failure was triggered by an overtopping event. Similarly, there have been no reports of seismic events preceding the failure, suggesting that it was not triggered by an earthquake. From the images presented herein, the postulated runaway erosion mechanism (Fig. 3e) thus emerges as the most likely triggering event. The tailings released through breach B flooded the adjacent water reservoir causing the erosion of its east wall which lies at the toe of breach A (Fig. 5a). Loss of toe support then triggered further instability leading to breach A. Slurry flowing along the benches of the dam that are close to breach A subsequently led to the development of the large erosion gullies (Fig. 5b). This last observation is based on helicopter footage captured on the day of the failure²².

Figure 5. The post-failure scenario. (a) Impact on the immediate surroundings. (b) Enlargement of breached area. (c) Enlargement of collapsed northern wall. (d) Full extent of the tailings runoff. NB: see also Fig. S2 for expanded version of part (a). In part (d), words with the suffixes *-spruit* or *-rivier* refer to the names of rivers. NB: Contour lines indicate metres above sea level. Created using QGIS software version 3.26 (<http://www.QGIS.org>).

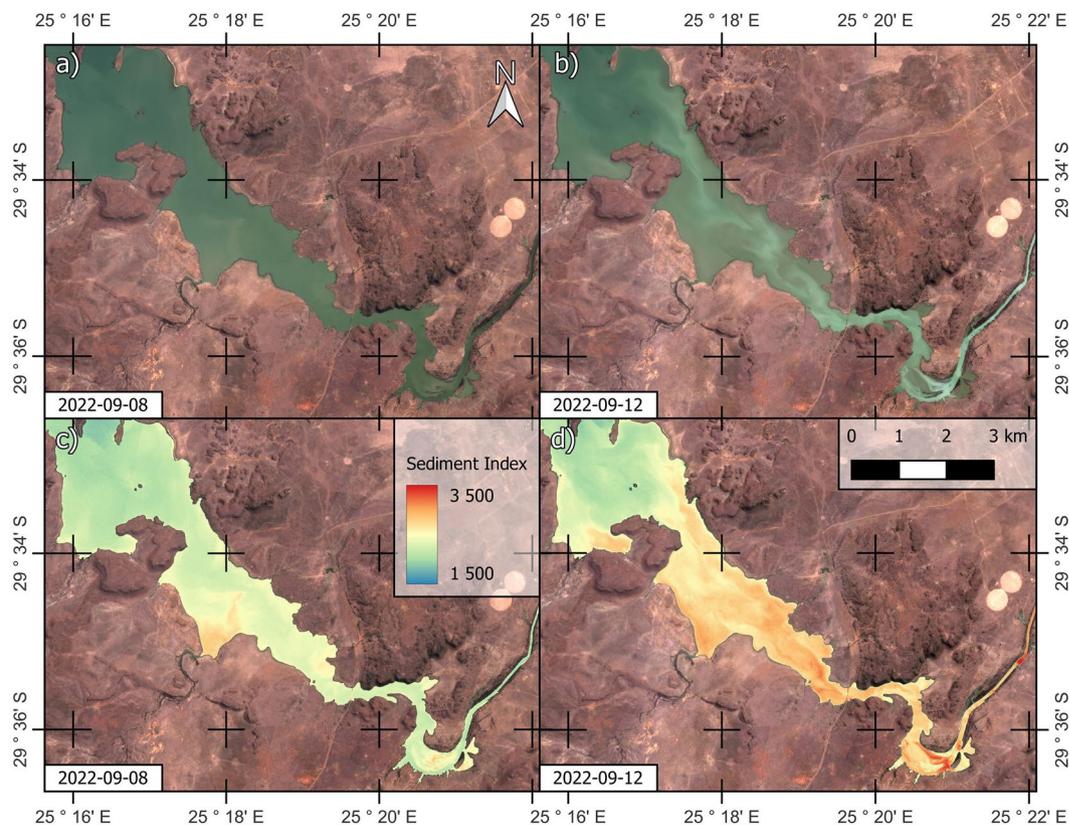
The mudflow travelled ~ 7 km over dry land before reaching the reservoir of the Wolwas dam (Fig. 5d). Tailings continued to flow along ~ 56 km of streams and rivers causing some of them to overflow and take on a pale colour. Pre and post-failure natural colour images and sediment index^{19,20} renderings strongly suggest that the tailings had reached the Kalkfontein dam reservoir by 12 September (Fig. 6).

Figure 6. Pre and post-failure PlanetScope images of the upper part of the Kalkfontein dam. (a) and (b) Natural colour renderings. (c) and (d) Sediment index rendering. NB: Parts (c) and (d) share the same Sediment Index colour ramp. See greater context in Fig. 5d. Created using QGIS software version 3.26 (<http://www.QGIS.org>).
