# OPEN Failure analysis of 3Cr oil pipe body fracture

The fractured tube is a Φ73.02 mm×5.51 mm 110-3Cr EU repaired tube, which was re-entered into the well in September 2020, and the fracture of the tubing column occurred from January 2024 onwards, as shown in Fig. 1.

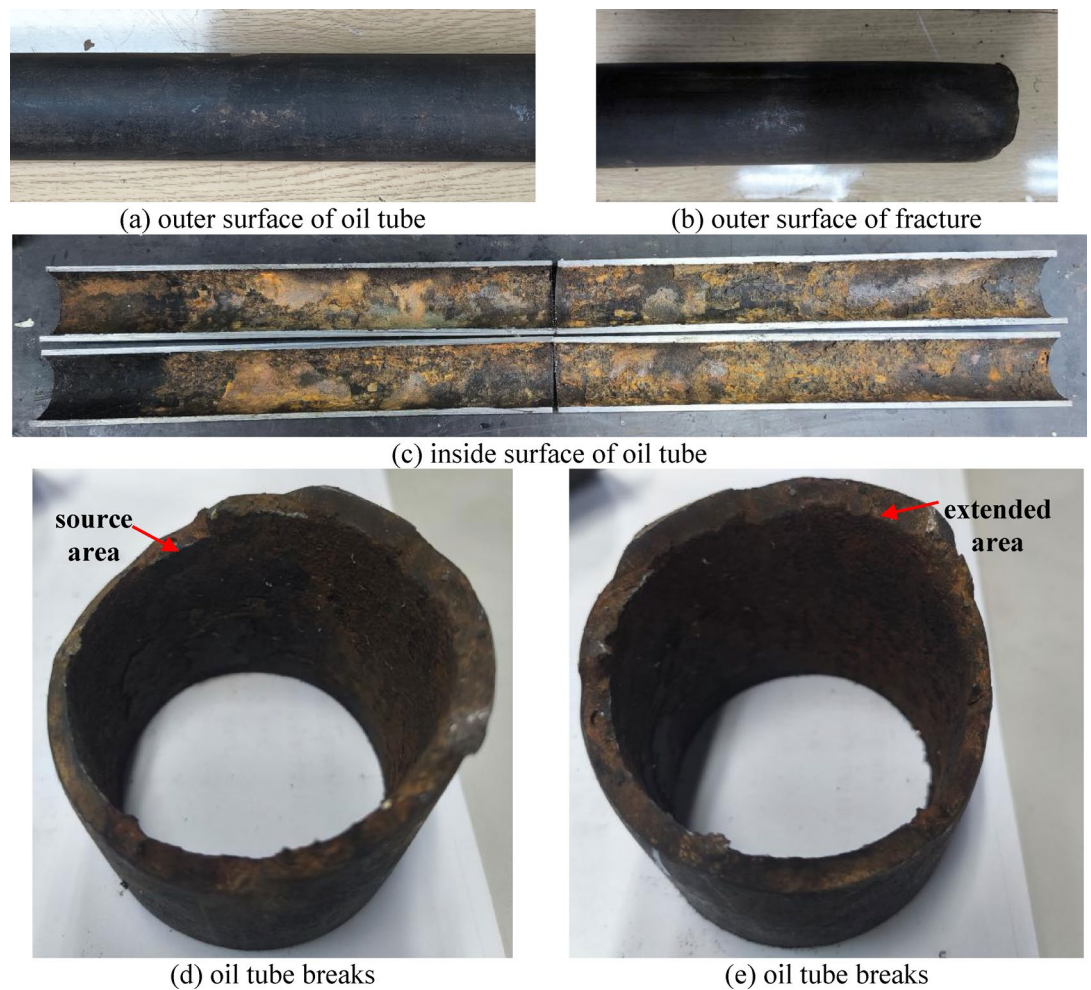
The macroscopic morphology of the fractured oil tube is shown in Fig. 2. The outer surface of the oil tube is black, with no obvious corrosion products, and there is a certain degree of necking at the fracture. The inner surface is rusty yellow, with a large number of corrosion products that can be easily dislodged. There are a large number of corrosion pits on the inner surface of the oil tube. The fracture is mainly divided into two districts, the source area and the extension area, and the extension area mainly consists of the shear lip, accounting for more than 80%. The corrosion pits mainly have a rounded blunt shape morphology, as shown in the 3D measurements of Fig. 3. The depth of the corrosion pits is about 0.287 ~ 0.785 mm, and the average annual corrosion rate is 0.086 ~ 0.236 mm/a, as shown in Table 2.

**Fig. 2.** Macroscopic shape of oil tube.

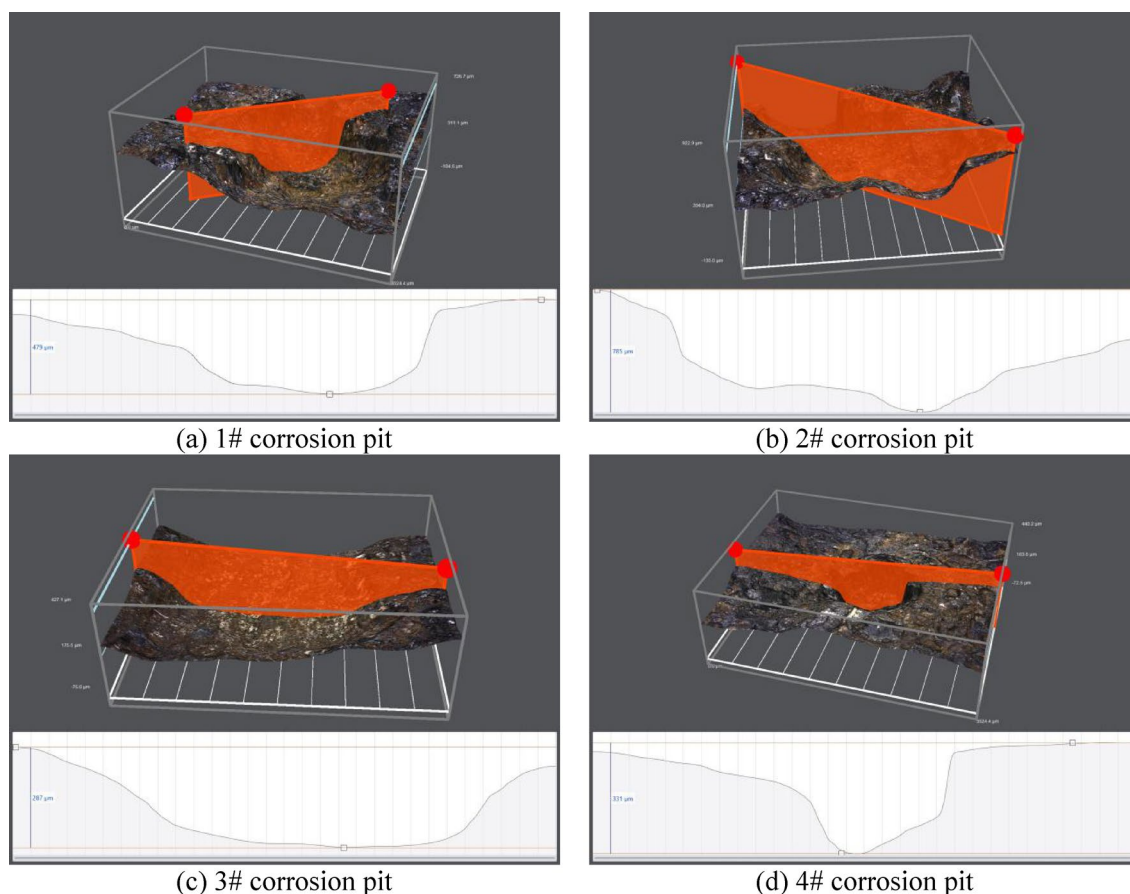
**Fig. 3.** 3D measurement results of corrosion pits on the inner surface.

Corrosion pit location	Corrosion pit depth (mm)	Pitting corrosion rate (mm/a)
1# corrosion pit	0.479	0.144
2# corrosion pit	0.785	0.236
3# corrosion pit	0.287	0.086
4# corrosion pit	0.331	0.099

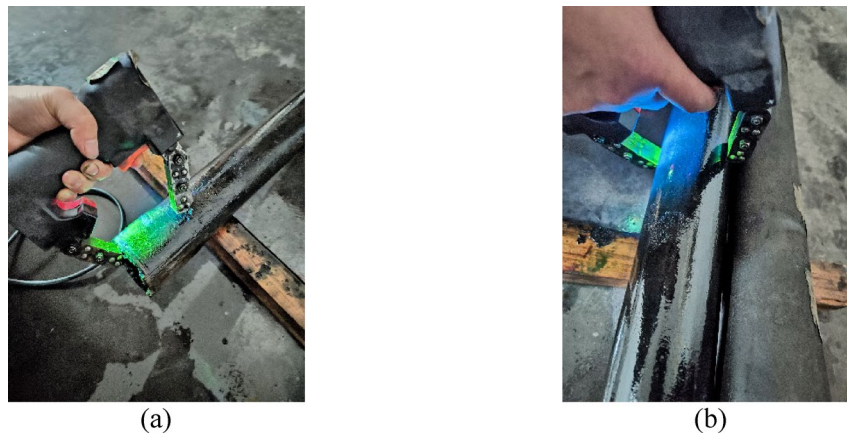
According to ASTM E 709 – 14 standard, magnetic particle inspection was carried out on the inner and outer surfaces of the fractured oil tube with the help of ZCM-DA1206A magnetic particle flaw detector, as shown in Fig. 5 ~ Figure 6. As can be seen from the test results, no crack characteristics were found on the outer surface of the fractured oil tube, and a total of 6 cracks were found on the inner surface.

**Fig. 5.** Oil tube outer surface inspection results.

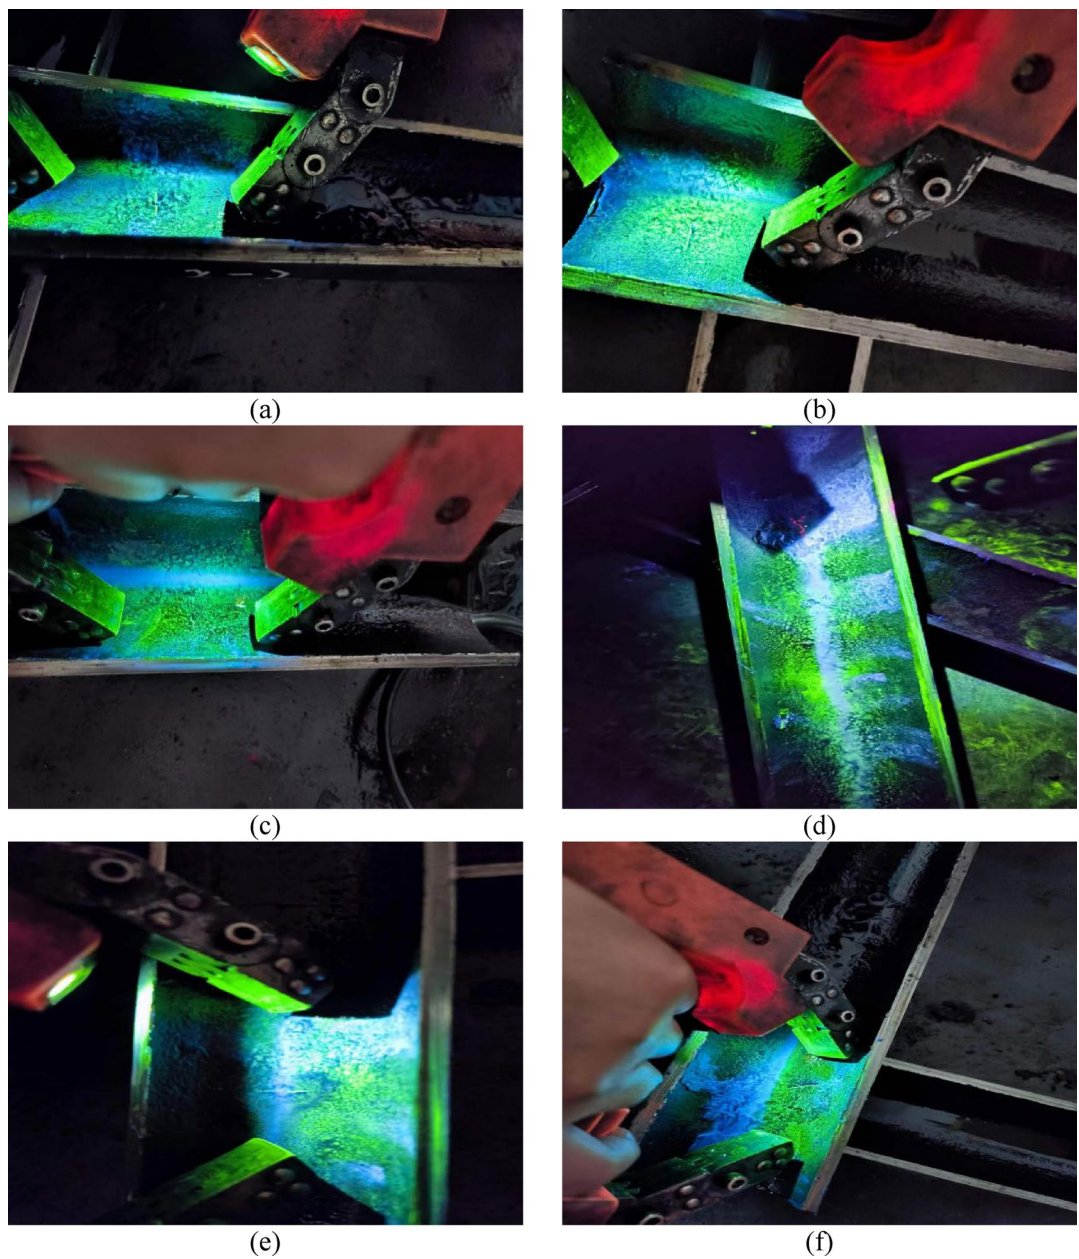
**Fig. 6.** Oil tube inner surface inspection results.

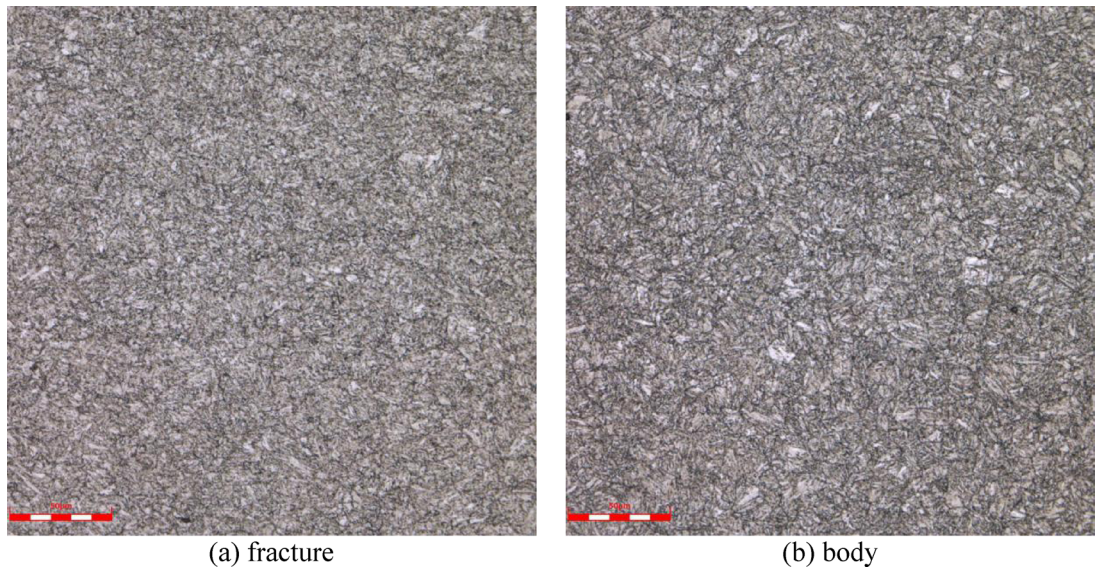
Specimen	Non-metallic inclusions								Microstructure	Grain size
	A		B		C		D			
	Thin	Thick	Thin	Thick	Thin	Thick	Thin	Thick		
Fracture	0.5	0	0	0	0	0	0.5	0	Tempered austenite (Fig. 7a)	9.0
Body	0.5	0	0	0	0	0	0.5	0	Tempered austenite (Fig. 7b)	9.0

**Fig. 7.** Microstructure photos of fractured tube.

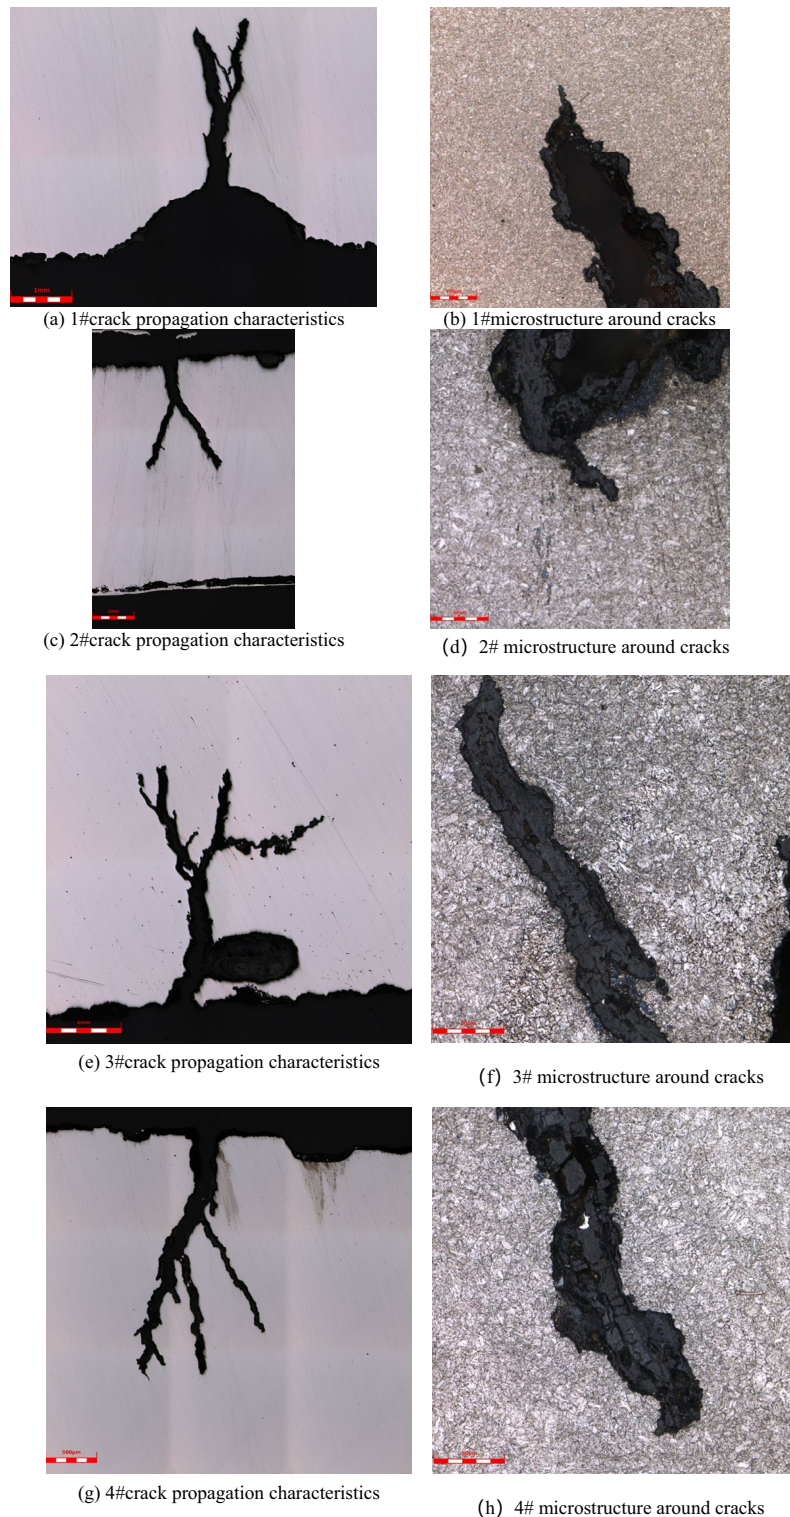
According to ASTM E45-18a, GB/T 13,298–2015 and GB/T 4335–2013 standards, the microstructure, grain size and non-metallic inclusions were analyzed by MEF4M metallographic microscope, OLS 4100 laser confocal microscope and image analysis system. The analysis results are shown in Table 7, and the microstructure photos are shown in Fig. 7. The grade of non-metallic inclusions at the fracture and body of the oil tube is A0.5 and D0.5, the microstructure is tempered austenite, the grain size is 9.0, and there is no obvious microstructure abnormality. Metallographic cross-section samples were taken from the typical crack area on the inner surface of the oil tube for analysis, and the results were shown in Fig. 8. It can be seen that the crack originated from the corrosion pit on the inner surface of the oil tube, and there was no abnormal surrounding tissue in the corrosion pit area. The overall bifurcation of the crack was less, and there was no abnormal surrounding tissue.

**Fig. 8.** Metallographic section characteristics of oil tube crack.

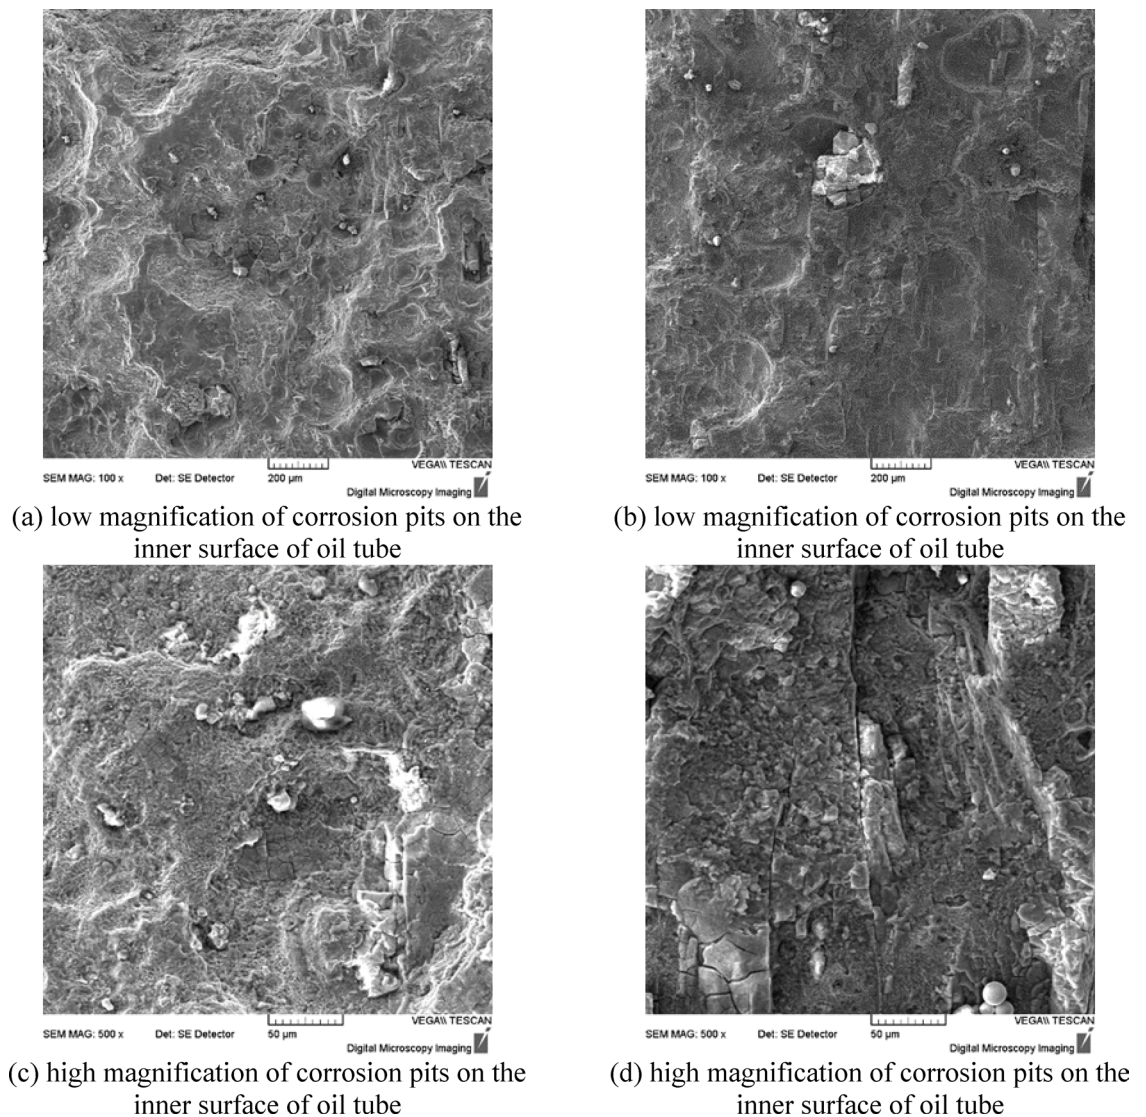
inner surface of the oil tube, and there are a large number of dense corrosion products in the corrosion pit area. The cracking characteristics of the substrate surface can be observed at high magnification. Figure 10 shows the energy spectrum analysis results of the selected partial corrosion zone. There are high contents of O, Fe, S, Cl, Cr and other elements on the inner surface of the fractured oil tube.

**Fig. 9.** Micro-morphology of corrosion pits on the inner surface of oil tube.

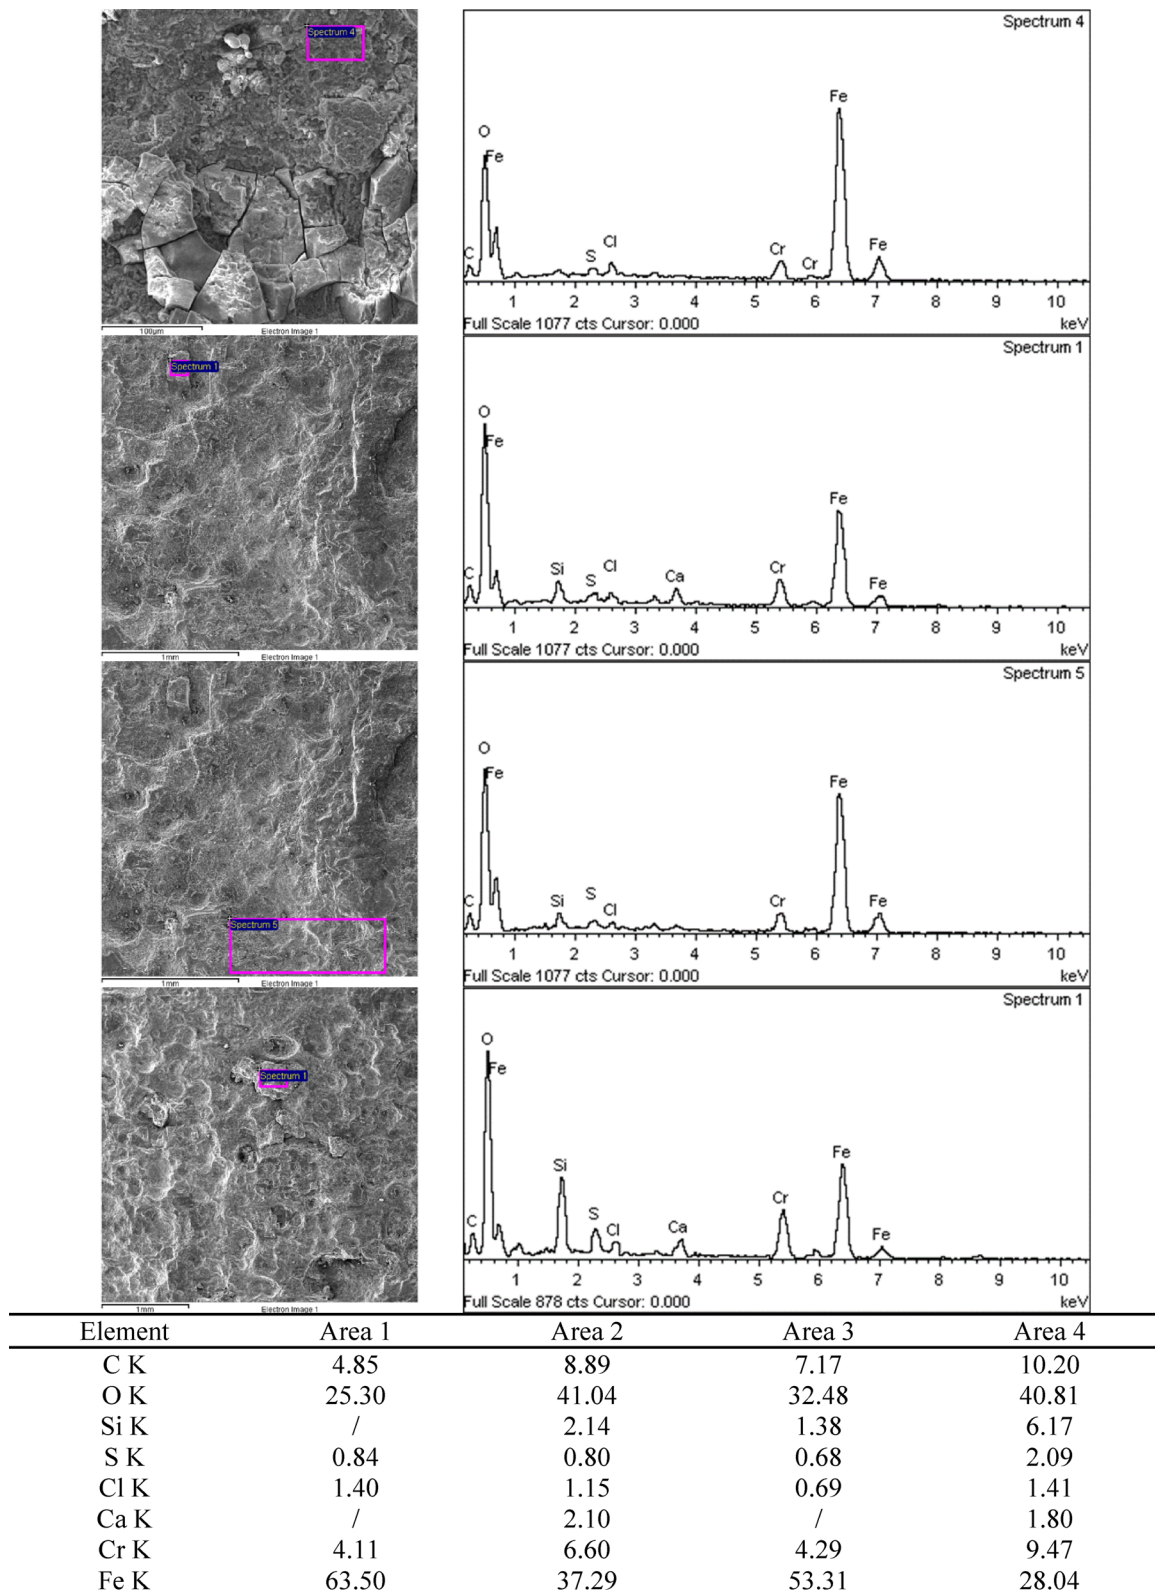
**Fig. 10.** The energy spectrum analysis results of corrosion pits on the inner surface of the oil tube.

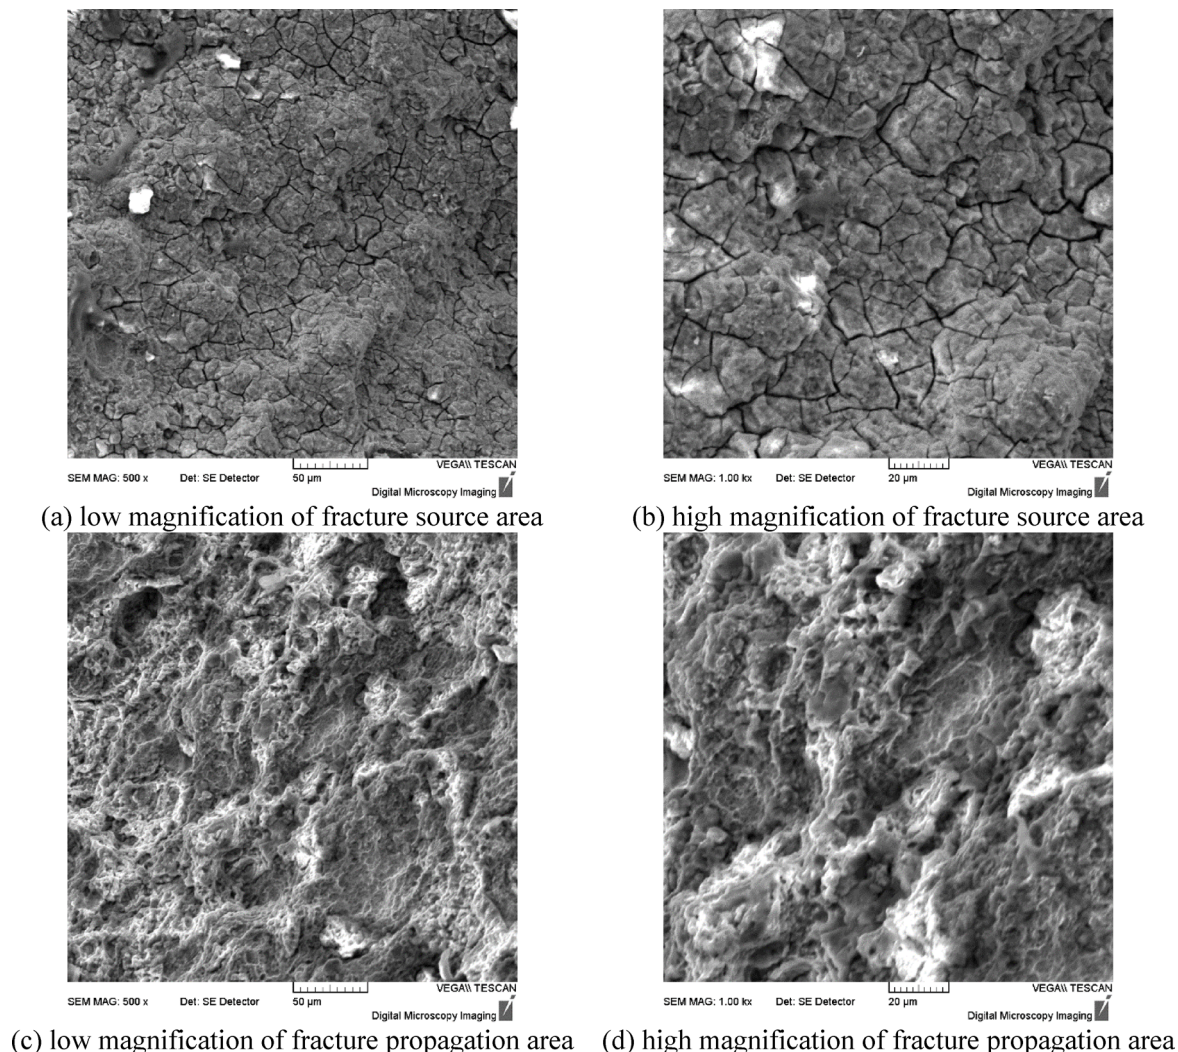
The results of the oil tube section morphology and energy spectrum analysis are shown in Figs. 11, 12 and 13. From Fig. 11, it can be seen that the micro-morphology of the source area of the cross-section is blocky, with obvious traces of cracking and the presence of a large number of corrosion products. The extended area of the section shows some tiny wineglass-shaped microporous pits, also called the tough nests. The tough nest is the trace left on the fracture surface after the material plastic deformation in the micro-area range of the microvoid produced by the nucleation, growth, aggregation, and finally interconnected and led to fracture. The results of the energy spectrum analysis show that the S and Cl contents in the fracture source area are higher than those in the fracture extension area, while in terms of the Cr content, the concentration in the source area is 10.45%, which is much higher than the 3% in the 3Cr steel matrix. This is mainly related to the corrosion resistance mechanism. In the initial stage of corrosion, Cr will dissolve rapidly and accelerate the material corrosion due to its higher activity than Fe. However, when the  $\text{Cr}^{3+}$  produced by dissolution precipitates to form  $\text{Cr}(\text{OH})_3$  and mixes with the corrosion products, a Cr-rich product film is formed, and this dense Cr-rich layer hinders further dissolution of the metal, thus reducing the corrosion rate of the material.

**Fig. 11.** Micromorphology of oil tube fracture.

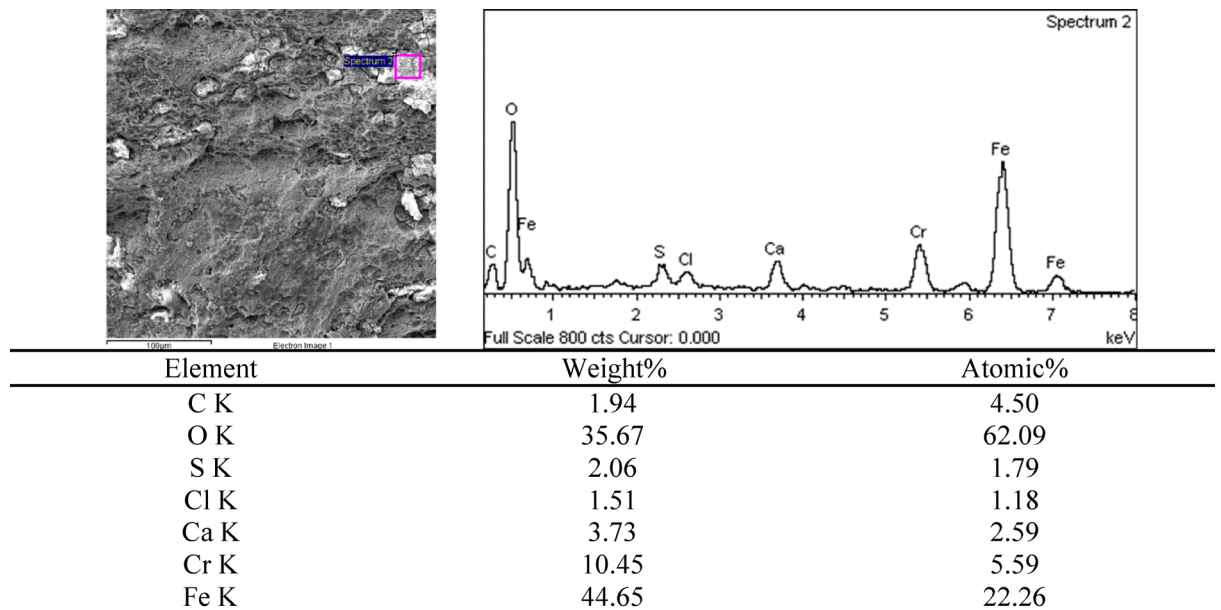
**Fig. 12.** Energy spectrum analysis results of fracture source region.

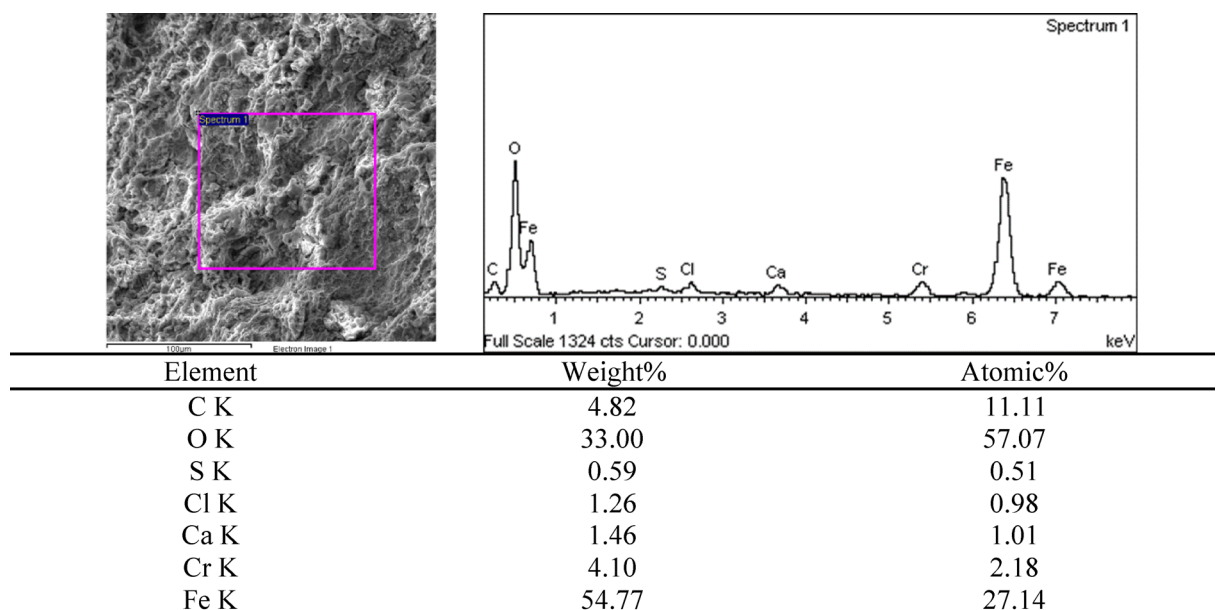
**Fig. 13.** Energy spectrum analysis results of fracture propagation zone.

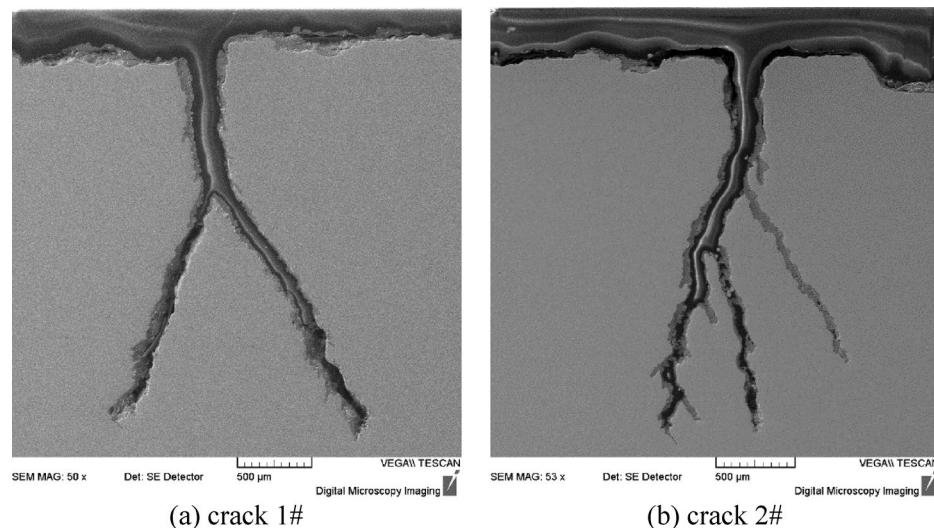
Two samples were selected from the cracks found in the magnetic particle testing of the inner surface of the fractured tubing, and the scanning electron microscope and its attached energy spectrum analyzer were used to observe the microstructure and analyze the energy spectrum of the samples. The crack mainly originated from the bottom of the corrosion pit on the inner surface of the oil pipe. As shown in Fig. 14, the crack propagated along the wall thickness direction, and there were a large number of corrosion products in the crack. The crack initiation position has obvious morphological characteristics, showing a round blunt shape, which is consistent with the shape of the corrosion pit, indicating that the crack is gradually developed on the basis of the corrosion pit. The results of energy spectrum analysis show that the distribution characteristics of crack elements are similar, mainly including Fe, O, Cr, Cl and other elements, as shown in Figs. 15 and 16 (the regions in the figure are root, middle and tip from top to bottom in turn).

Microscopic observation of the crack growth zone by scanning electron microscope (SEM) showed that the main crack showed typical transgranular growth characteristics, and the crack path was tortuous with obvious secondary crack branches. The internal morphology of the crack shows that the wall presents a typical “muddy crack” feature, and the surface is covered with a loose corrosion product layer, which is in sharp contrast to the smooth section of conventional mechanical fracture. Irregular serrated edges can be observed in the crack tip region, indicating that the crack growth process is accompanied by a continuous anodic dissolution process.

**Fig. 14.** Crack micro-morphology diagram.

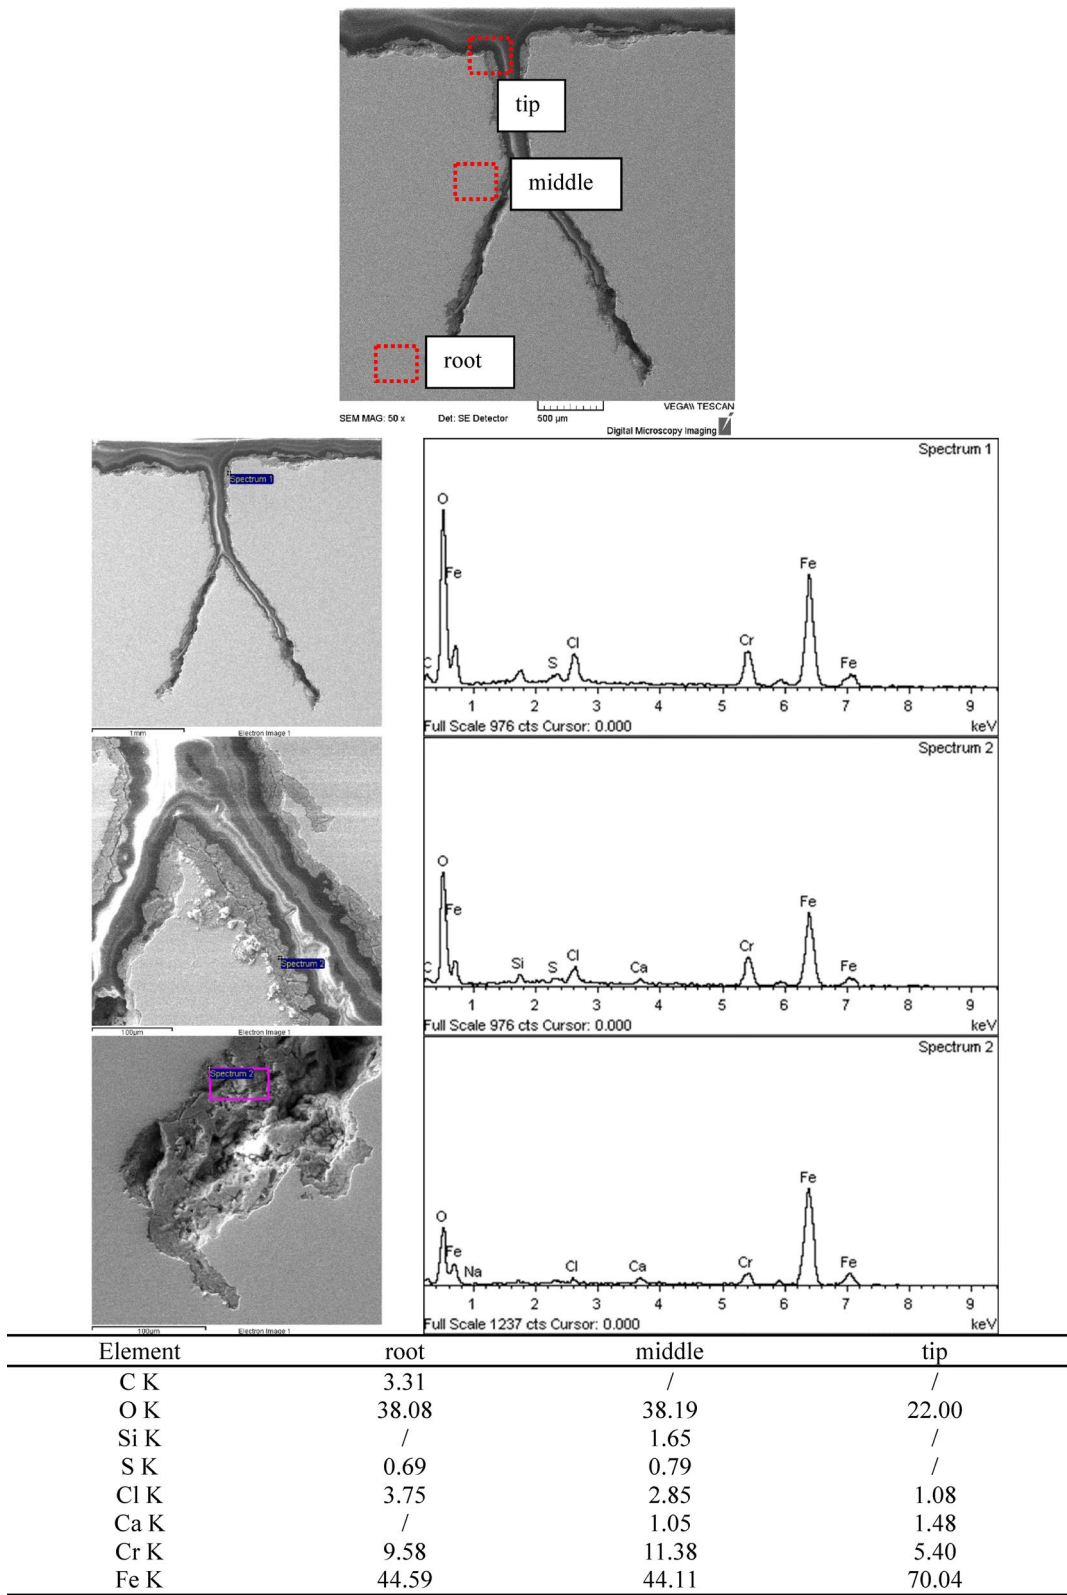
The energy spectrum analysis showed that the content of Cl in the crack was significantly higher than that in the matrix area, and an obvious Cl enrichment zone was formed at the crack tip, which confirmed the key role of  $\text{Cl}^-$  in the stress corrosion process. There is a corrosion affected zone on both sides of the crack, in which the abnormal Fe/O atomic ratio is detected by energy spectrum, indicating the selective dissolution of iron.

**Fig. 15.** Energy spectrum analysis results of crack 1#.

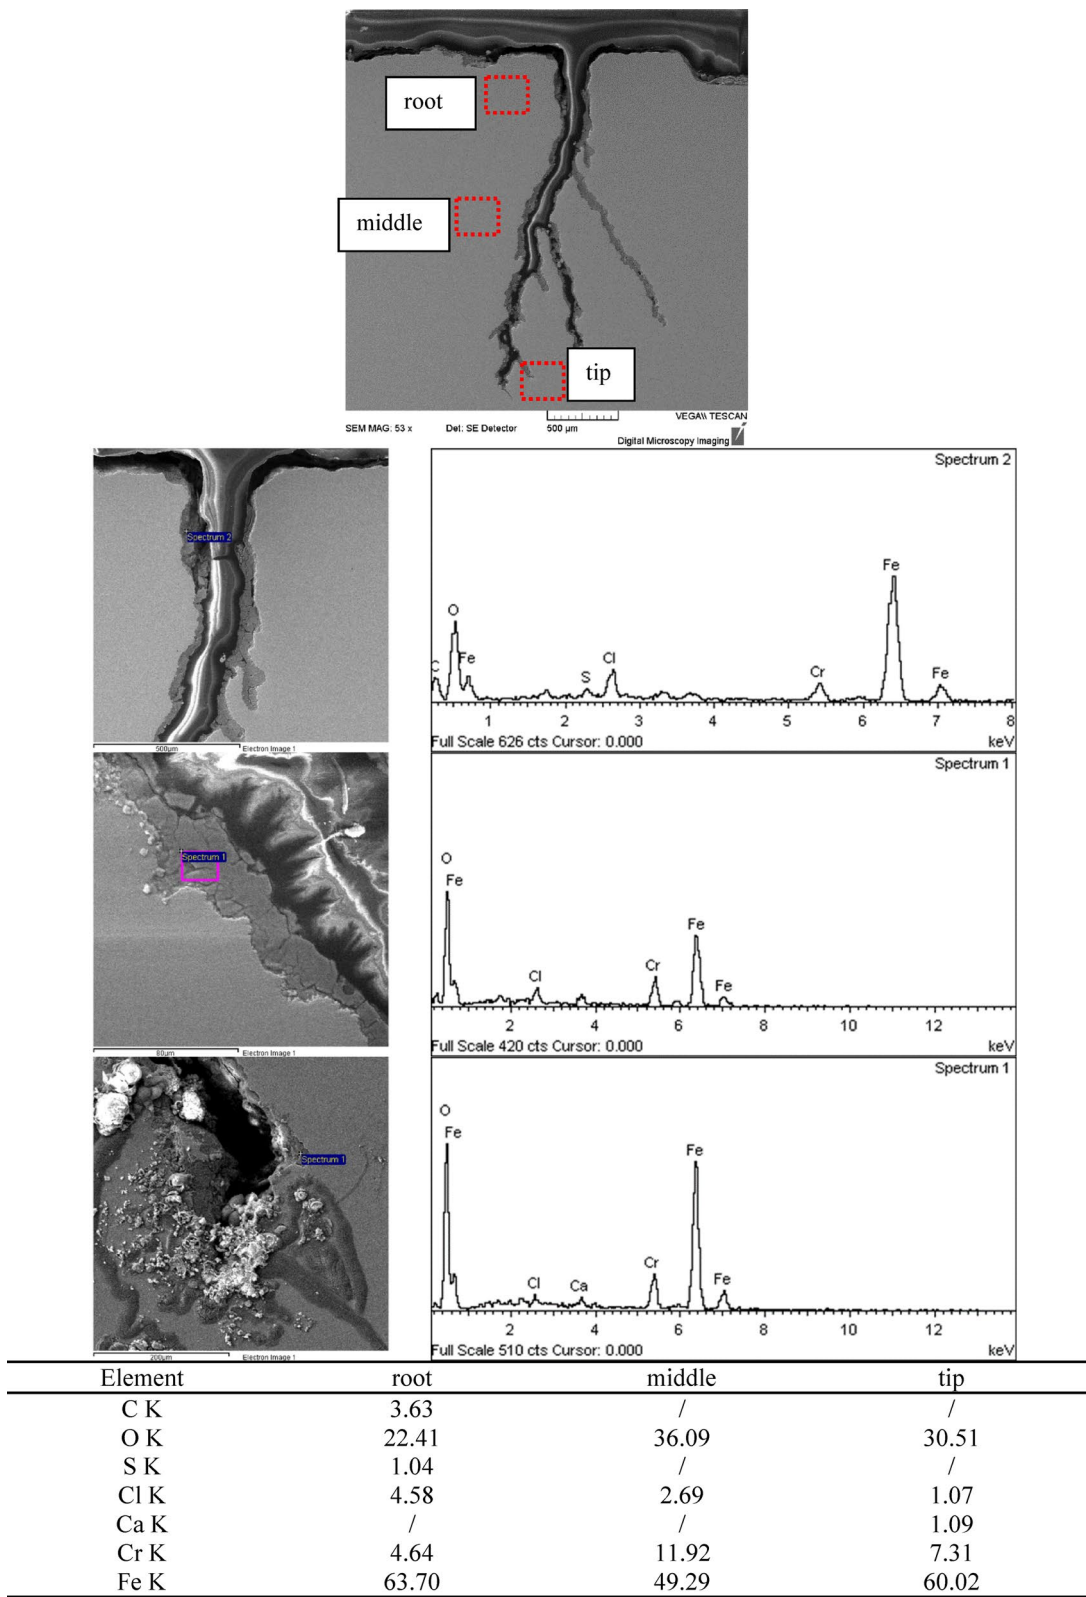
Fig. 16. Energy spectrum analysis results of crack 2#.

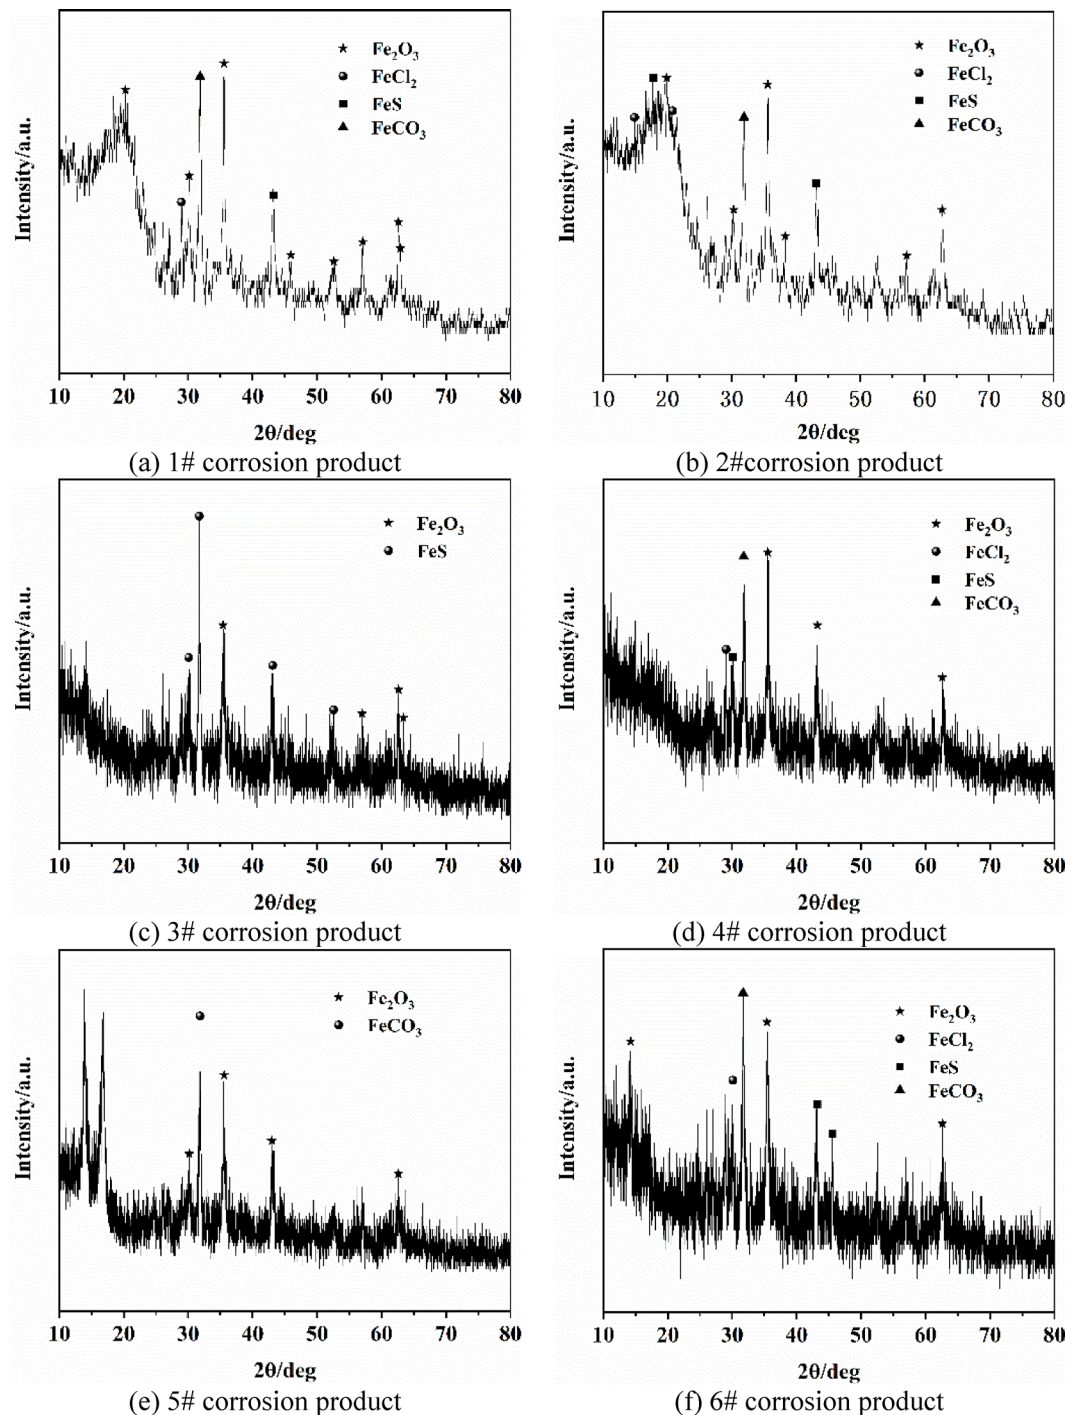
phase ferric oxide ( $\text{Fe}_2\text{O}_3$ ), followed by ferrous carbonate ( $\text{FeCO}_3$ ), ferrous chloride ( $\text{FeCl}_2$ ) and ferrous sulfide ( $\text{FeS}$ ).

**Fig. 17.** XRD Analysis results of corrosion products on the oil tube inner surface.
