## Study on the disaster mechanism and prevention technology of embankment slip-collapse after extreme rainfall in the loess area

This study investigates railway embankment slip-collapse disasters triggered by July 2021 extreme rainfall in Zhengzhou, China, through field investigations, in-situ tests, laboratory tests, field monitoring, and numerical simulations. The research results indicate that: (1) Zhengzhou loess experiences accelerated strength degradation when moisture content exceeds plastic limit, with shear modulus, cohesion, and internal friction angle decreasing rapidly beyond this threshold. (2) Embankment slip-collapse, a geohazard characterized by shallow failures in slope surfaces, is primarily triggered by hydro-mechanical coupling under extreme rainfall, with deformation severity controlled by infiltration intensity. (3) Three stages of slope stability division criteria are proposed, namely metastable zone, critical instability zone, and instability zone. The critical threshold of moisture content of 20.71% under these conditions provides a quantifiable benchmark for early warning systems targeting surface collapse prevention. (4) A steel grouting pipe reinforcem

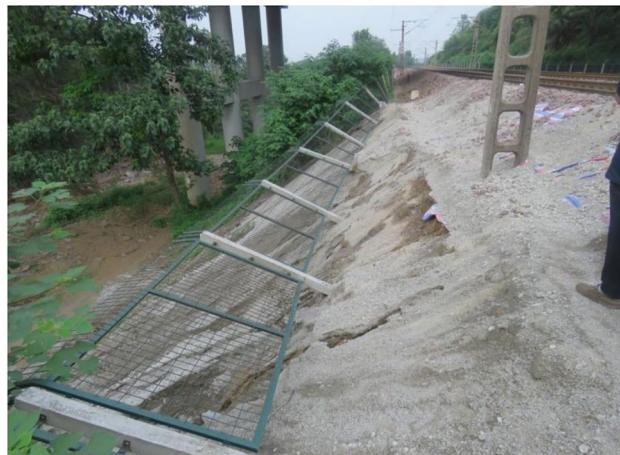
**Fig. 5.** Embankment slope slip-collapse.

An embankment experienced slope slip-collapse, as shown in Fig. 5. Field investigations revealed that the shallow layer of soil on the slope surface softened due to water seepage and flowed downstream along the slope

surface, leading to slope slip-collapse. The range of the slip-collapse extended from the toe of the embankment slope to the toe of the railway ballast. The shoulder protection net lost its foundation support, and eventually collapsed, causing severe damage to the vegetation on the slope.

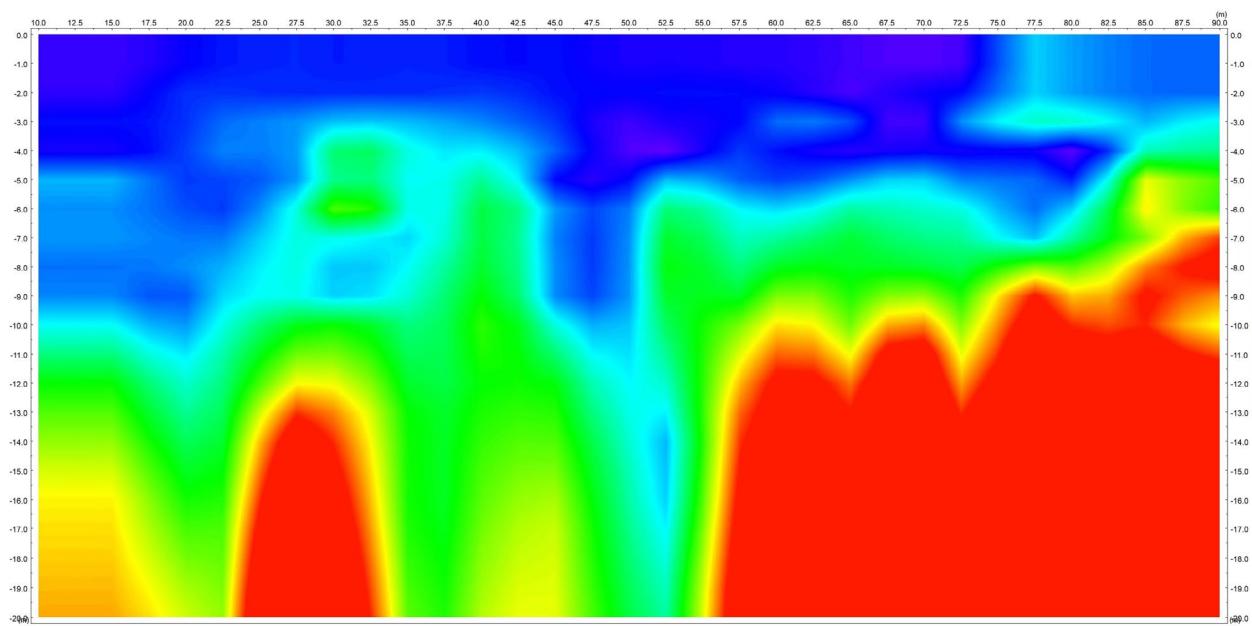
There were areas of low wave velocity in the depth range of 7–9 m at 28–35 m along the profile direction, and in the depth range of 13–17 m at 52–53 m along the profile direction. The wave speed in these areas ranged from 186 to 263 m/s. It was speculated that the loess desiccation cracks were well-developed in these regions, with local voids present.

**Fig. 23.** Wave velocity interpretation results before grouting.

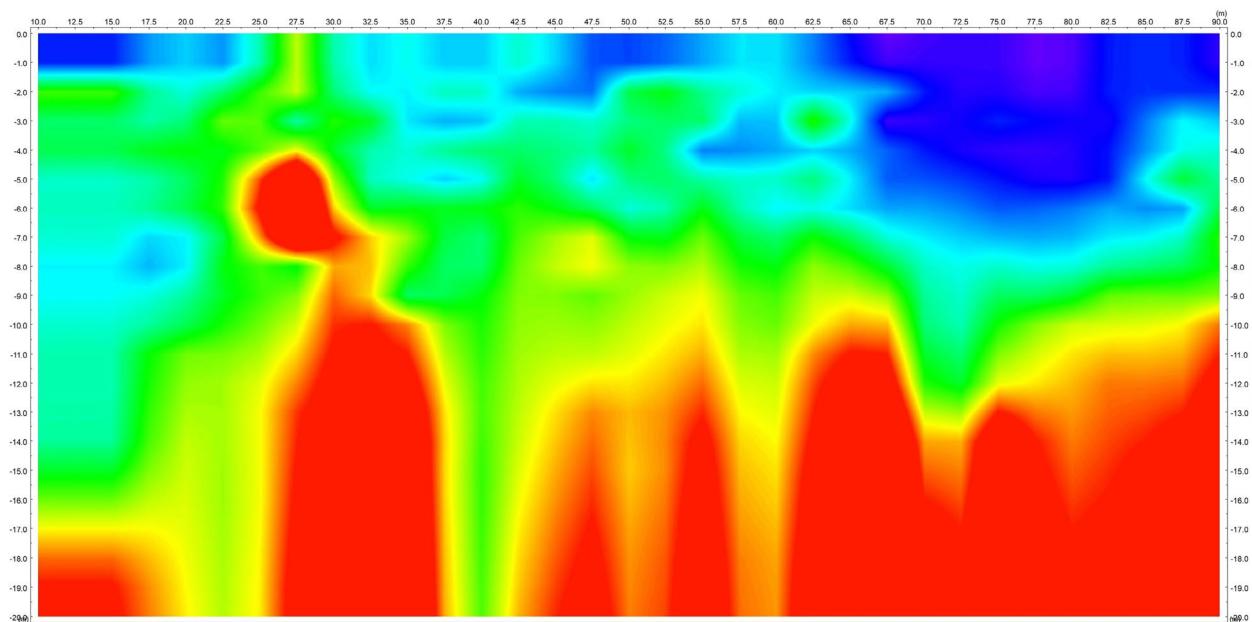
As shown in Fig. 24, two months after grouting, there was a zone of low wave velocity in the depth range of 0–1 m at 10–25 m along the profile direction. The wave velocity in this area ranged from 169 to 255 m/s, which represented an increase compared to that before grouting. Notably, the area of low-velocity zone at 10–25 m along the profile direction had decreased compared to that before grouting. Meanwhile, there was a significant increase in velocity in the depth range of 1–9 m, with a wave velocity ranging from 220 to 340 m/s. The wave velocity was about 100 m/s higher than that before grouting.

The area of low-velocity zone in the depth range of 0–3 m at 25–45 m along the profile direction had decreased significantly. The wave velocity within the region increased, with a velocity range of 237–417 m/s, representing an increase of 100 to 200 m/s compared to that before grouting.

**Fig. 24.** Wave velocity interpretation results 2 months after grouting.

There was a low wave velocity area in the depth range of 0-w m at 45–50 m along the profile direction. The wave velocity in this area ranged from 178 to 263 m/s, increasing a lot compared with that before grouting. It was worth noting that the area of low-velocity zone at 45–50 m along the profile direction had decreased compared to that before grouting. Besides, there was a significant increase in velocity in the depth range of 2–10 m, with a wave velocity ranging from 289 to 417 m/s. The wave velocity was about 150 m/s higher than that before grouting.

The area of low-velocity zone in the depth range of 0–5 m at 50–65 m along the profile direction had decreased significantly. The wave velocity within the region increased, with a velocity range of 178–314 m/s, representing an increase of about 50 m/s compared to that before grouting.

Two months after grouting, there were areas of high wave velocity in the depth range of 7–9 m at 28–35 m along the profile direction, and the depth range of 13–17 m at 52–53 m along the profile direction. The wave

velocity in these regions ranged from 426 to 486 m/s, representing an increase of over 200 m/s compared to before grouting. The results indicated that the cracks and the local voids had been improved after grouting.
