## OPEN Root cause analysis and evaluation of corrective actions for discharge boom suspension failure in bucket wheel excavator

The article analyzes the failure of a bucket wheel excavator's discharge boom suspension. The failure caused significant operational disruption and financial losses. The study includes metallographic tests and FEM analysis of the damaged axle, revealing a fatigue fracture due to inappropriate material microstructure and a structural notch. The fracture led to the boom falling, damaging the excavator and conveyor. Corrective actions involved redesigning the axle and using suitable materials, verified through extensive testing, to enhance durability and prevent future failures, ensuring safer operation.

**Keywords** Bucket wheel excavator, Discharge boom, Fracture, Redesign

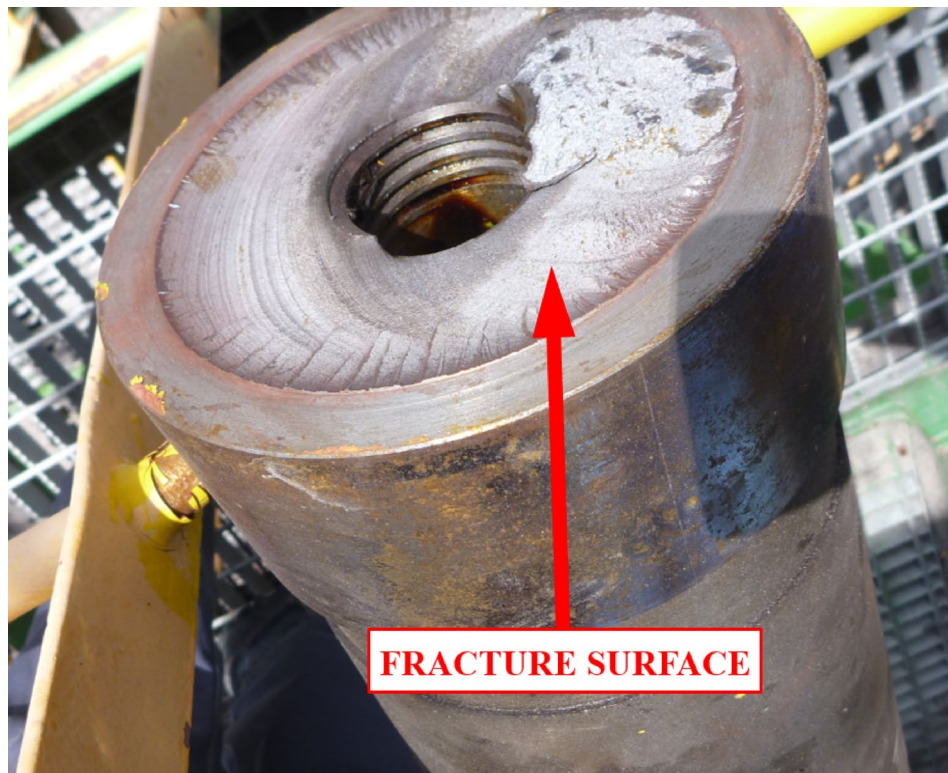
The axle failure shown in Fig. 5 caused an uncontrolled movement in the vertical direction of the entire discharge boom. The maximum height at which the end of the boom can be raised is 11.3 m. This means that there is a risk that the boom will fall from this height if the axle fails. Such a situation was a consequence of the failure discussed. As a result of axle breakage, the discharge boom fell on a self-propelled conveyor belt. This resulted in significant financial losses. The reasons for these losses were as follows. The first concerns material damage related to machine damage. The structure of the boom itself as well as the self-propelled belt conveyor was damaged. A view of the damaged structures after the failure is shown in Figs. 7 and 8. The second concern financial losses due to them being taken out of service for several months. According to data available in the literature<sup>24</sup>, one month of inability to use these machines brings losses of € 148 000 due to the lack of production.

Fig. 5. Post failure view of fatigue fracture of a vertical axle of a damaged discharge boom.

the fatigue fracture took place in the notch. It is shown in Fig. 13 as a cross section change with radius 0.84 mm, which is according to technical documentation of the axle<sup>25–29</sup>.

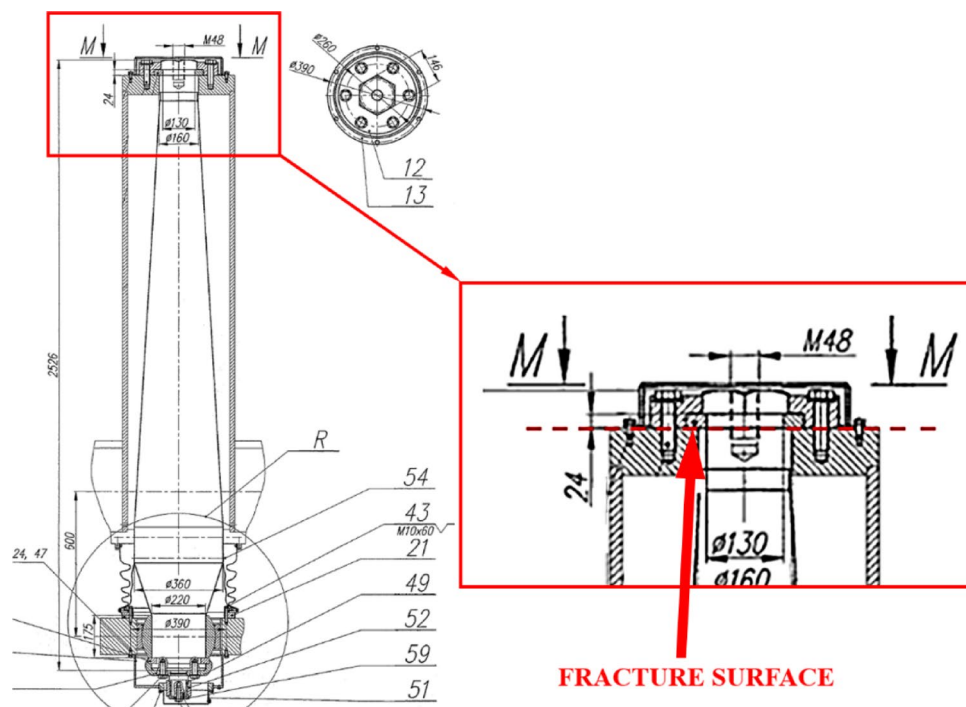
The boom suspension in the area of the axis connecting it with the rest of the machine's structure was damaged. It occurred in the form of a crack in the cross-section that prevented the axle from sliding out of the socket. Figure 5 shows a view of the axle immediately after a failure. Figure 6 presents a technical drawing of the axle with marked cross section that was cut during failure.

Fig. 6. Drawing showing whole damaged axle with cross section where axle was cut—marked with a red line (well visible on the magnified part of the drawing).

Presented article was focused on failure analysis of the discharge boom suspension of the bucket wheel excavator. Unexpected axle damage occurred during regular operation of the machine. As a result of the failure of this element, the discharge boom fell to the self-propelled conveyor boom causing catastrophic failure. Extensive root cause analysis was carried out. The causes of the failure have been found due to the fracture and material analysis. Fracture of the broken cross section proved that it was mainly due to fatigue, which was supported by well-visible slip bands. The rapture zone of fracture was measured and compared with fatigue fracture zone to calculate the static safety factor. The static fracture zone was 20% of the section, which gives the static safety factor was about 5. The fatigue fracture initiation point was located in the notch of the axle (change of cross section in the groove visible in Fig. 6).

3. The fatigue fracture initiation point was located in the notch of the axle (in Fig. 6).
4. Material microstructure verification showed an undesirable ferrite acicular structure with features of the Widmanstätten pattern observed in the axle material, not suitable for carrying structural elements subjected to high loads

The repair of the excavator was based on the change of its design and material. The final design of the axle is presented in Fig. 26. Compared to Fig. 6 it is well visible that sensitivity to fatigue crack in the notch was decreased thanks to replacement of the groove with two spherical bearings and additional axle in the most

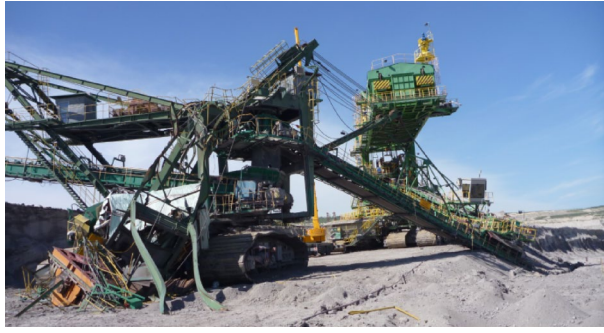
The event shown in Figs. 7 and 9 had a huge impact on the operations of the owning company. It caused significant damage to the discharge boom of the bucket wheel excavator. For this reason, it had to be put out of service for many weeks to assess its technical condition and repair any damage found. An example of damage found during the technical assessment is shown in Figs. 9 and 10. Furthermore, the self-propelled conveyor belt was so badly damaged. It was necessary to rebuild a significant part of its carrying structure, especially the superstructure. This was associated with large financial losses and many months of difficult operation at the mine. Taking into account the above facts, it is important to find the cause of this failure. Especially since only 9 years have passed since the excavator was put into operation.

**Fig. 7.** View of the self-propelled conveyor after failure.

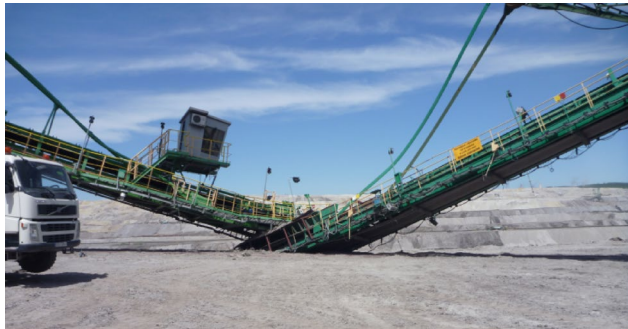
**Fig. 8.** Discharge boom of bucket wheel excavator (left side) and self-propelled conveyor (right side) after failure.

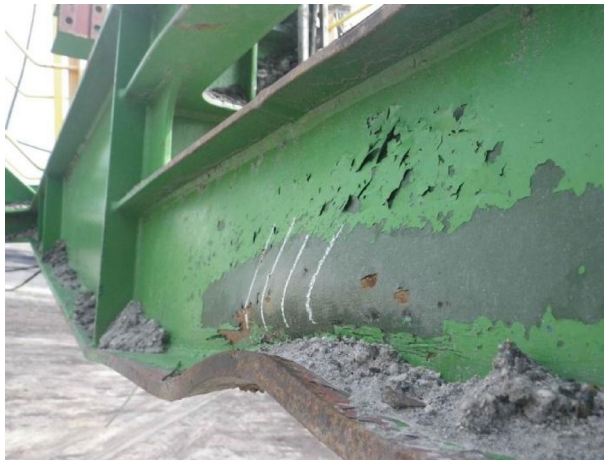
**Fig. 9.** Exemplary damage after a failure of the carrying structure of the discharge boom—plastic deformation.

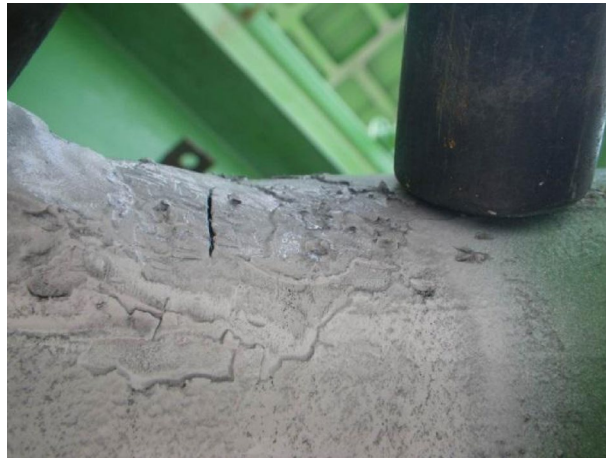
**Fig. 10.** Examples of damage after a failure of the carrying structure of discharge boom—cracks.

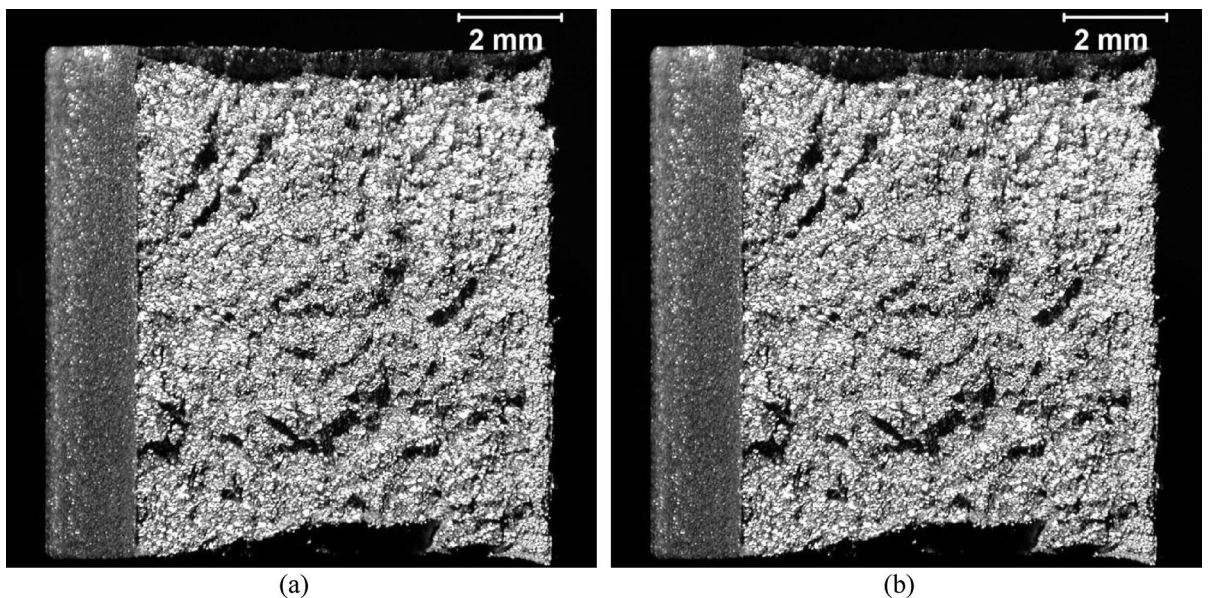
Firstly, macroscopic and fractography analysis was performed with use of stereoscope (SMT-800 type) and scanning electron microscope (Hitachi S-3400N). Fracture fractography was realized after impact resistance test for two different samples, taken both in longitudinal as well as in transverse direction to axle axis. In Fig. 11 brittle fracture is clearly visible in cases of both specimens. Further analysis proves that for broken axle, there is a fatigue fracture with slip bands and origin point next to the surface, what is well visible in Fig. 12. Final rupture zone has features of a ductile and brittle fracture. This zone is about 20% of the fracture, which indicates that the safety factor of axle was about 5. Such fracture mode was the result of a unidirectional bending. The initiation of

**Fig. 11.** Brittle fracture on the sample taken along longitudinal (a) and in transverse direction (b) to axle axis.

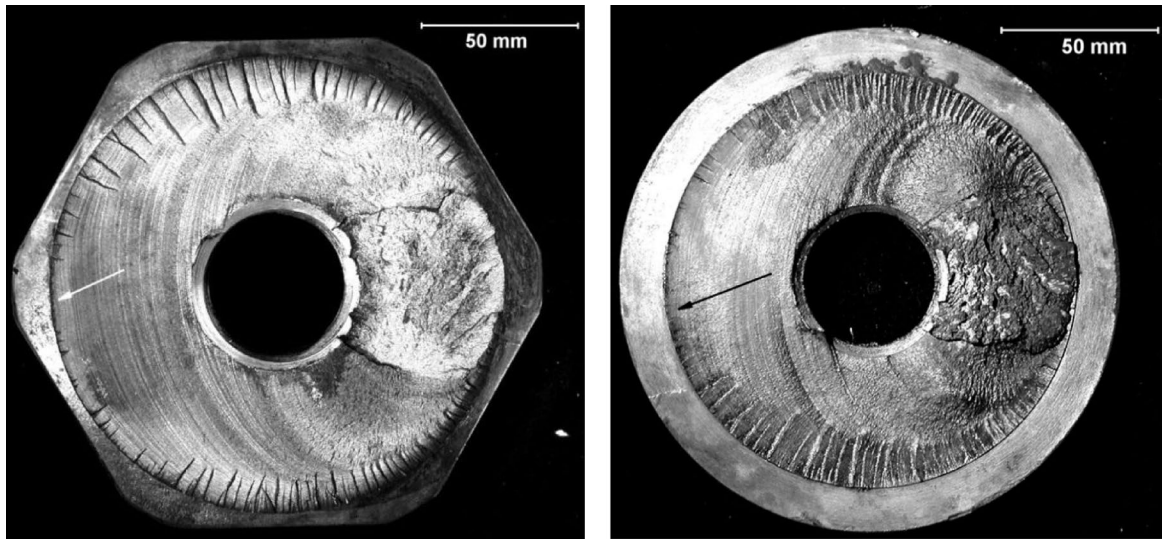
**Fig. 12.** Fatigue fracture with well visible slip lines in two different sections. The arrow indicates the fatigue origin point.

1. Fracture of the broken cross section showed the fatigue phenomena by well-visible slip bands.
2. The static safety factor was calculated as 5 based on the rupture zone fracture cross section.

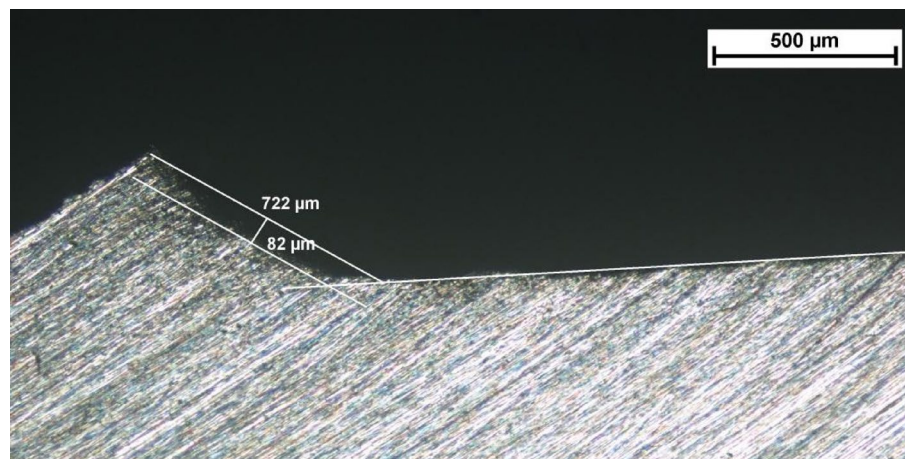
**Fig. 13.** Section parallel to shaft axis with area of cross section change, where the fatigue origin point was located. The lines show the chord and dimensions of the pit due to edge fillet with radius 0,84 mm.

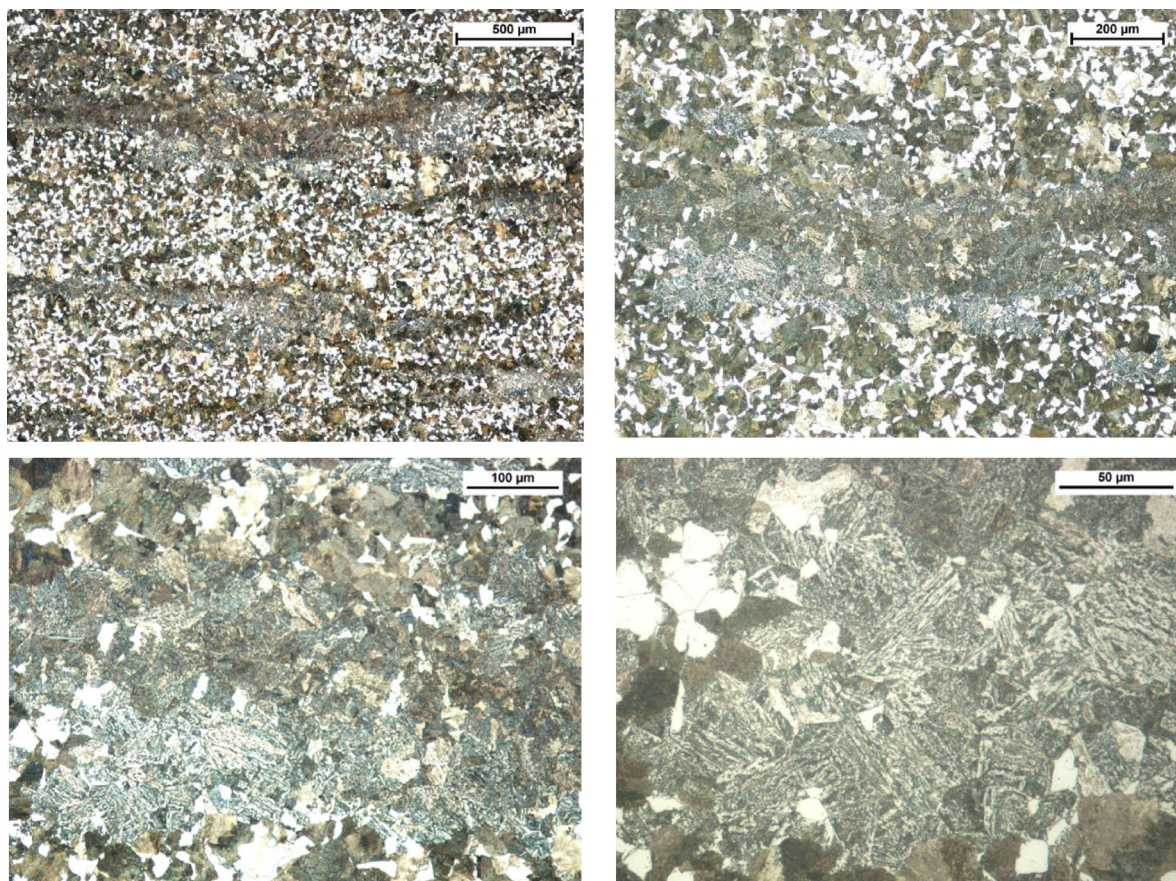
Next step was a microscopic research of samples in transverse axle cross sections. It was realized with the use of the metallographic microscope Olympus CK40M coupled with digital camera, in range of magnification from 50× to 1000×<sup>25,26</sup>. Before this, selected samples were a subject of micro-etching with use of Mi1Fe reagent. Received results showed clearly that microstructure is a nonhomogeneous ferritic-pearlitic structure, coarse-grained with bainite bands and a ferrite acicular structure having features of the Widmanstätten pattern (Fig. 14). Such a structure is a result of the cooling after hot processing. Strictly, such structure is not recommended for carrying structures elements subjected to high load due to the fact that Widmanstätten pattern is very sensitive to initiation and propagation of the fatigue fracture. It is obvious that such structure was responsible for huge decrease of the strength, mainly impact resistance of the axle and was reason of the fatigue crack initiation and growth. Definitely such material is not in accordance with material certificate, which clearly indicates that it should be material after hardening and tempering to hardness 235 ± 241 HB (highly tempered martensite). Brinell hardness tests conducted according to suitable standard showed that tested material has hardness much lower and equal to 211.38 ± 2.02 HB<sup>30</sup>.

**Fig. 14.** Nonhomogeneous ferritic-pearlitic structure, coarse-grained with bainite bands and a ferrite acicular structure having features of the Widmanstätten pattern seen in four different magnification.

Material microstructure verification showed that there was an undesirable ferrite acicular structure with features of the Widmanstätten pattern. Such a structure is not suitable for carrying structural elements subjected to high loads, especially varying loads, because of its sensitivity to the initiation and propagation of fatigue crack. Investigation of the mechanical properties of the axle material proved that it was not compatible with the attached material certificate and should not be used in the case of such a demanding object.

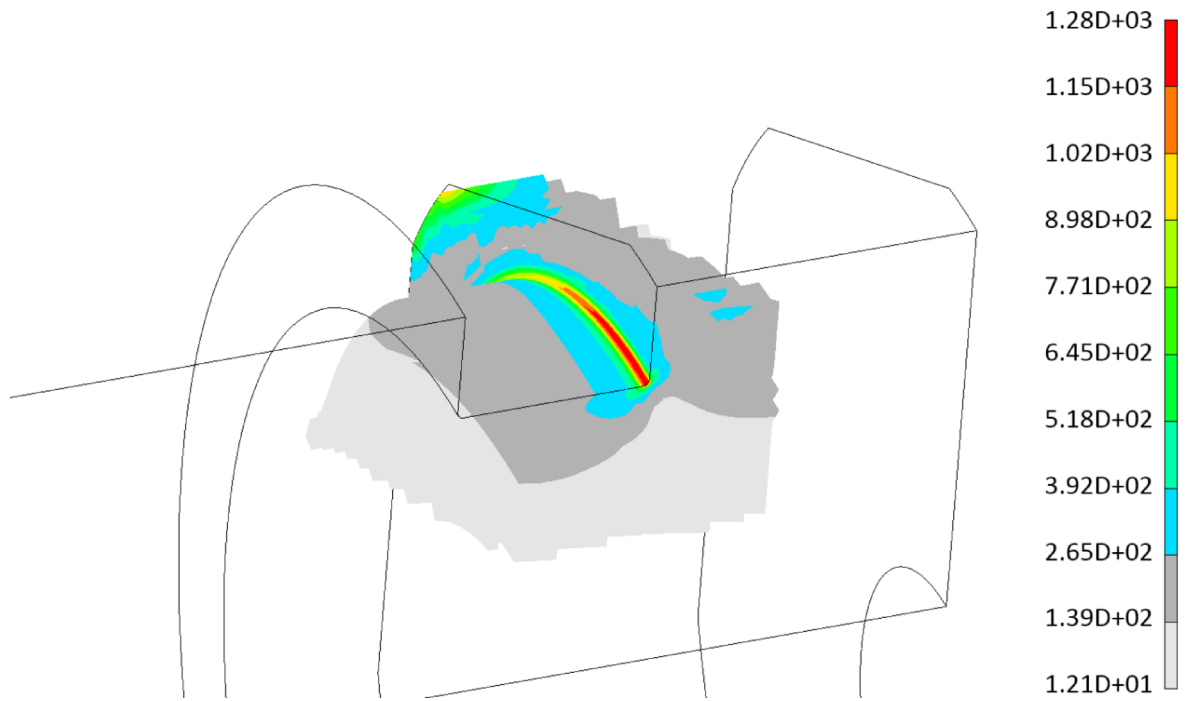
- Linear elastic material (Fig. 19)  $\sigma_{\text{HMHmax}} = 1280 \text{ MPa}$
- Non-linear, elastic–plastic material (Fig. 20)  $\sigma_{\text{HMHmax}} = 471 \text{ MPa}$

**Fig. 19.** Equivalent Von Mises stress distribution in MPa—linear elastic material.

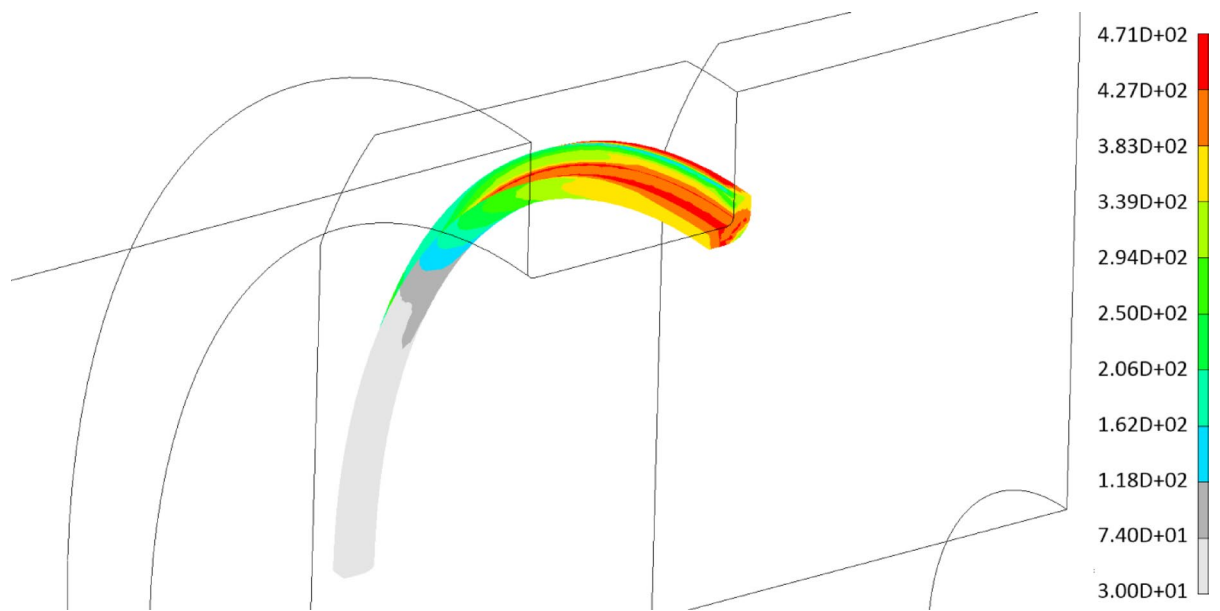
The axle fracture did not occur at the point of highest stress level, but on the other side of the circlip groove. During the geometrical verification of the securing ring, it was found to be deformed due to the way the joint was constructed. As a result, the circlip partially took over the function of the radial bearing and caused an additional bending force at the axle end, generating stress concentration at the fracture site. A diagram of this phenomenon is shown in Fig. 21. Contact marks on both diameters are clearly visible on the protective ring, axle, and protective cover and are shown in Fig. 22.

**Fig. 20.** Equivalent Von Mises stress distribution in MPa—non-linear, elastic–plastic material.

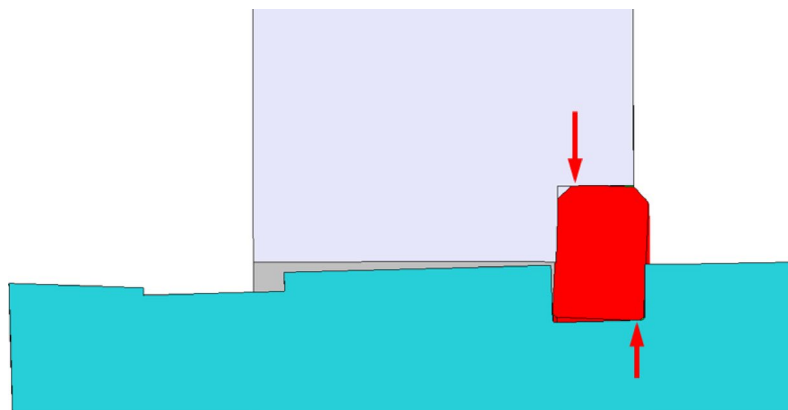
**Fig. 21.** Diagram of the acting forces on the axle and the seat of the deformed circlip.

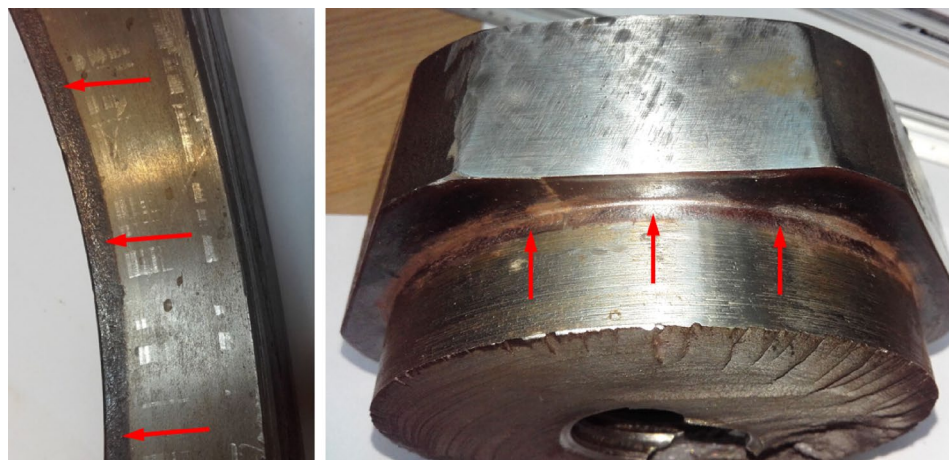
**Fig. 22.** Contact marks on the protective ring and axle circlip groove.

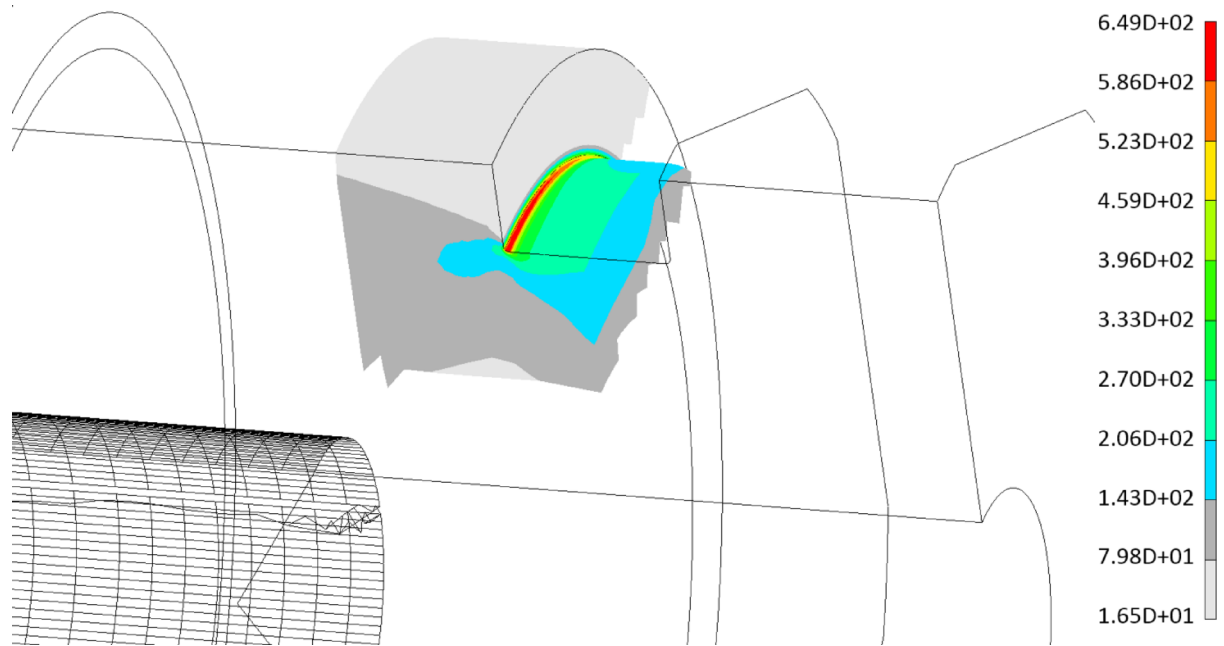
For these types of working conditions, additional numerical simulations were carried out with consideration of non-linear, elastic–plastic material, and the stress effort of the critical region was identified. A variant was used where the discharge boom is in the low position, which corresponds to the maximum value of the total luffing cylinder force  $F$  (Table 2). The maximum stresses level in the fracture region increased by about 40% compared to the initial state (without ring deformation Fig. 20) and amounted to 649 MPa (Fig. 23). Under such operating conditions, at the point of axle breakage, there was a stress level in the low-cycle range, since the value of stresses in a cycle is in excess of the yield strength of a material (described in Table 1). It resulted in limited fatigue strength, which consequently contributed to the occurrence of failure.

**Fig. 23.** Equivalent Von Mises stress distribution in MPa—real boundary conditions.

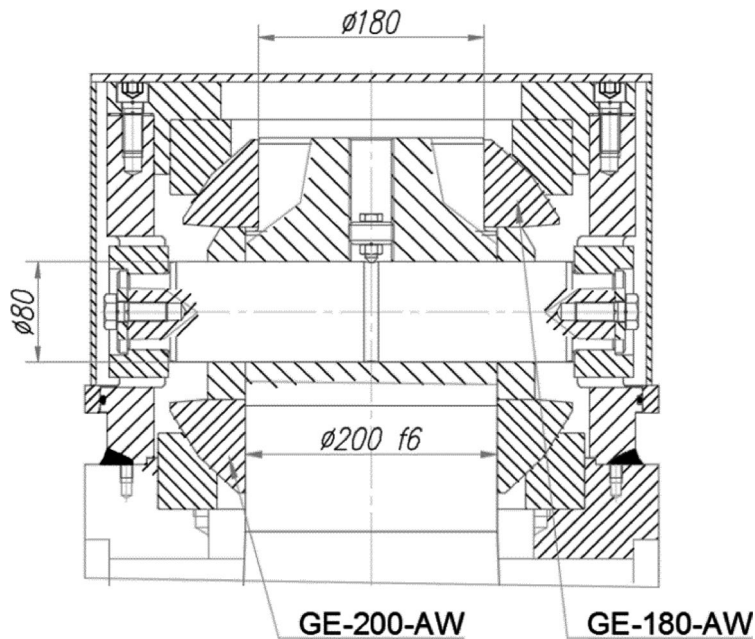
Fig. 26. New design of the vertical axle upper support.

due to replacement of the groove with two spherical bearings (GE-200AW and GE-180-AW Fig. 26) and an additional axle in the most vulnerable joint. The new suspension axle was manufactured from steel 40HM with a suitable microstructure without the Widmanstätten pattern to fulfill PN-EN 10083-3 standard<sup>33</sup> requirements.

vulnerable joint. The new suspension axle was manufactured from material with a suitable microstructure without the Widmanstätten pattern. Also, the design of the axle was changed.

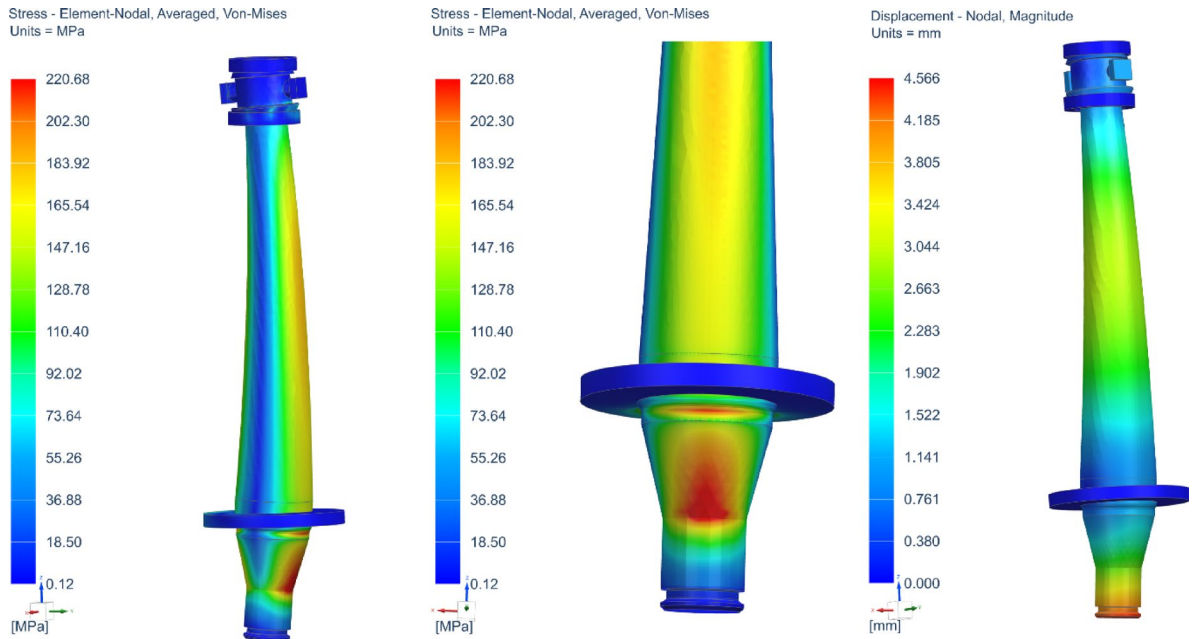
As a result equivalent Von Mises stress distribution has been received, which is shown in Fig. 28. From these calculations it is well visible, that maximal stresses are in the new axle in its lower part and the value of this stresses is much below yield point of the material, which is 643 MPa in case of steel 40HM. These results differ significantly compared to broken axle design, since maximal stresses are much lower and are not located in the notch placed in the upper support nut, close to lower axle support.

$$s_{max} = 212 \text{ MPa} < k_g = 749 * 0.45 = 337 \text{ MPa}$$

It means that the allowable fatigue stress limit is not exceeded in the case of a new axle.

**Fig. 28.** Equivalent Von Mises stress distribution along the structure of newly designed axle (overall view – left, area with maximal stresses—center) and displacement (on the right).

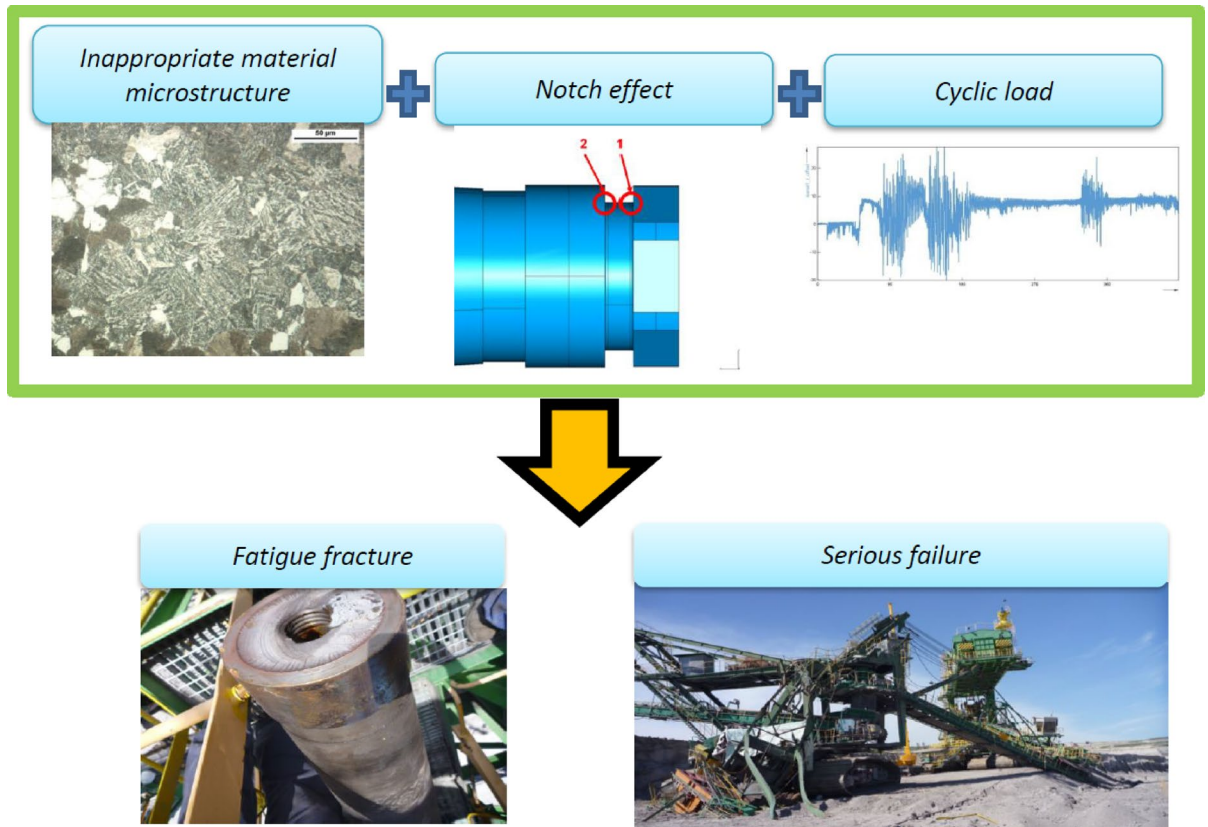
**Fig. 29.** Scheme showing reasons of the serious failure.

Ultimately, it can be stated that the described serious failure was caused by fatigue fracture. It was due to the combination of three important factors, which is schematically shown in Fig. 29. These factors were inappropriate material microstructure, notch effect, and cyclic load.
