# Reassessment of the Penglai III shipwreck and reflections on the wooden artifacts conservation

The conservation of marine archaeological wooden shipwrecks remains a global challenge. The Penglai III shipwreck provides a good case study to examine the state and condition of a wooden shipwreck after nearly 20 years of conservation treatments, especially to assess the effects of PEG hardening treatments and mineral in the wood. Analytical techniques, including ultra-deep far-field 3D microscopy, environmental scanning electron microscopy (ESEM-EDS), micro-Raman spectrometry (Raman), and Fourier transform infrared spectroscopy (FT-IR), were employed. Results indicated that PEG initially aided in drying and strengthening the wood, but prolonged air exposure caused darkening, affecting its visual appearance. This triggered the assessment of the drying and strengthening treatment of wooden shipwrecks and the selection of materials. Wood was rich in iron deposits and calcium deposits, which may lead to acidification and further degradation over time. Environmental control is recommended as a priority for future conservation efforts. This study provides valuable insights into the conserv

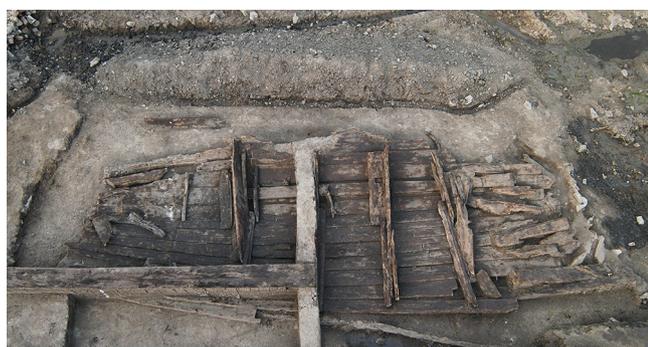
At the excavation site, when the surface of the ship's hull had been exposed (Fig. 2), the lower part was still buried in the silt. The conservators took the measure of spraying medical alcohol on the surface of the ship's timber to inhibit the growth of bacteria on the surface of the ship's wood. Then, they started to spray 5% ~ 10% PEG2000 to strengthen the hull. After that, they sprayed a mixture of 12.5% PEG4000 and 0.4% borax to dehydrate the wreck and reinforced wood. This prevented rapid evaporation of water from the wood and prevented microbial growth on the hull surface. The wreck was dismantled before the winter of 2005, and the timbers were moved indoors (museum) to continue conservation work<sup>3</sup>.

**Fig. 2** | A photo of the Penglai III shipwreck after it has been archaeologically excavated and cleaned up.

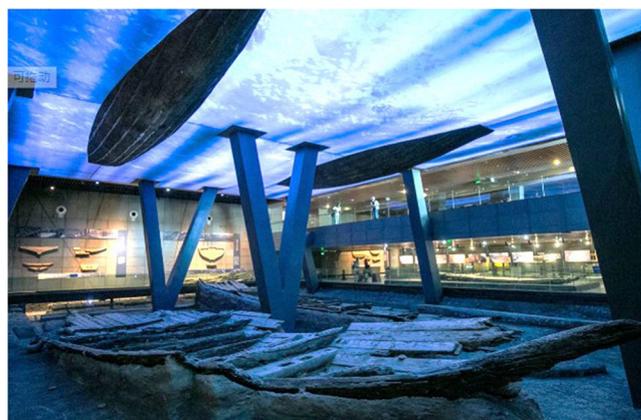
**Fig. 3** | A photo about the Penglai III shipwreck on display in the museum.
