Extreme river flood exposes latent erosion risk

<https://doi.org/10.1038/s41586-025-09305-3>

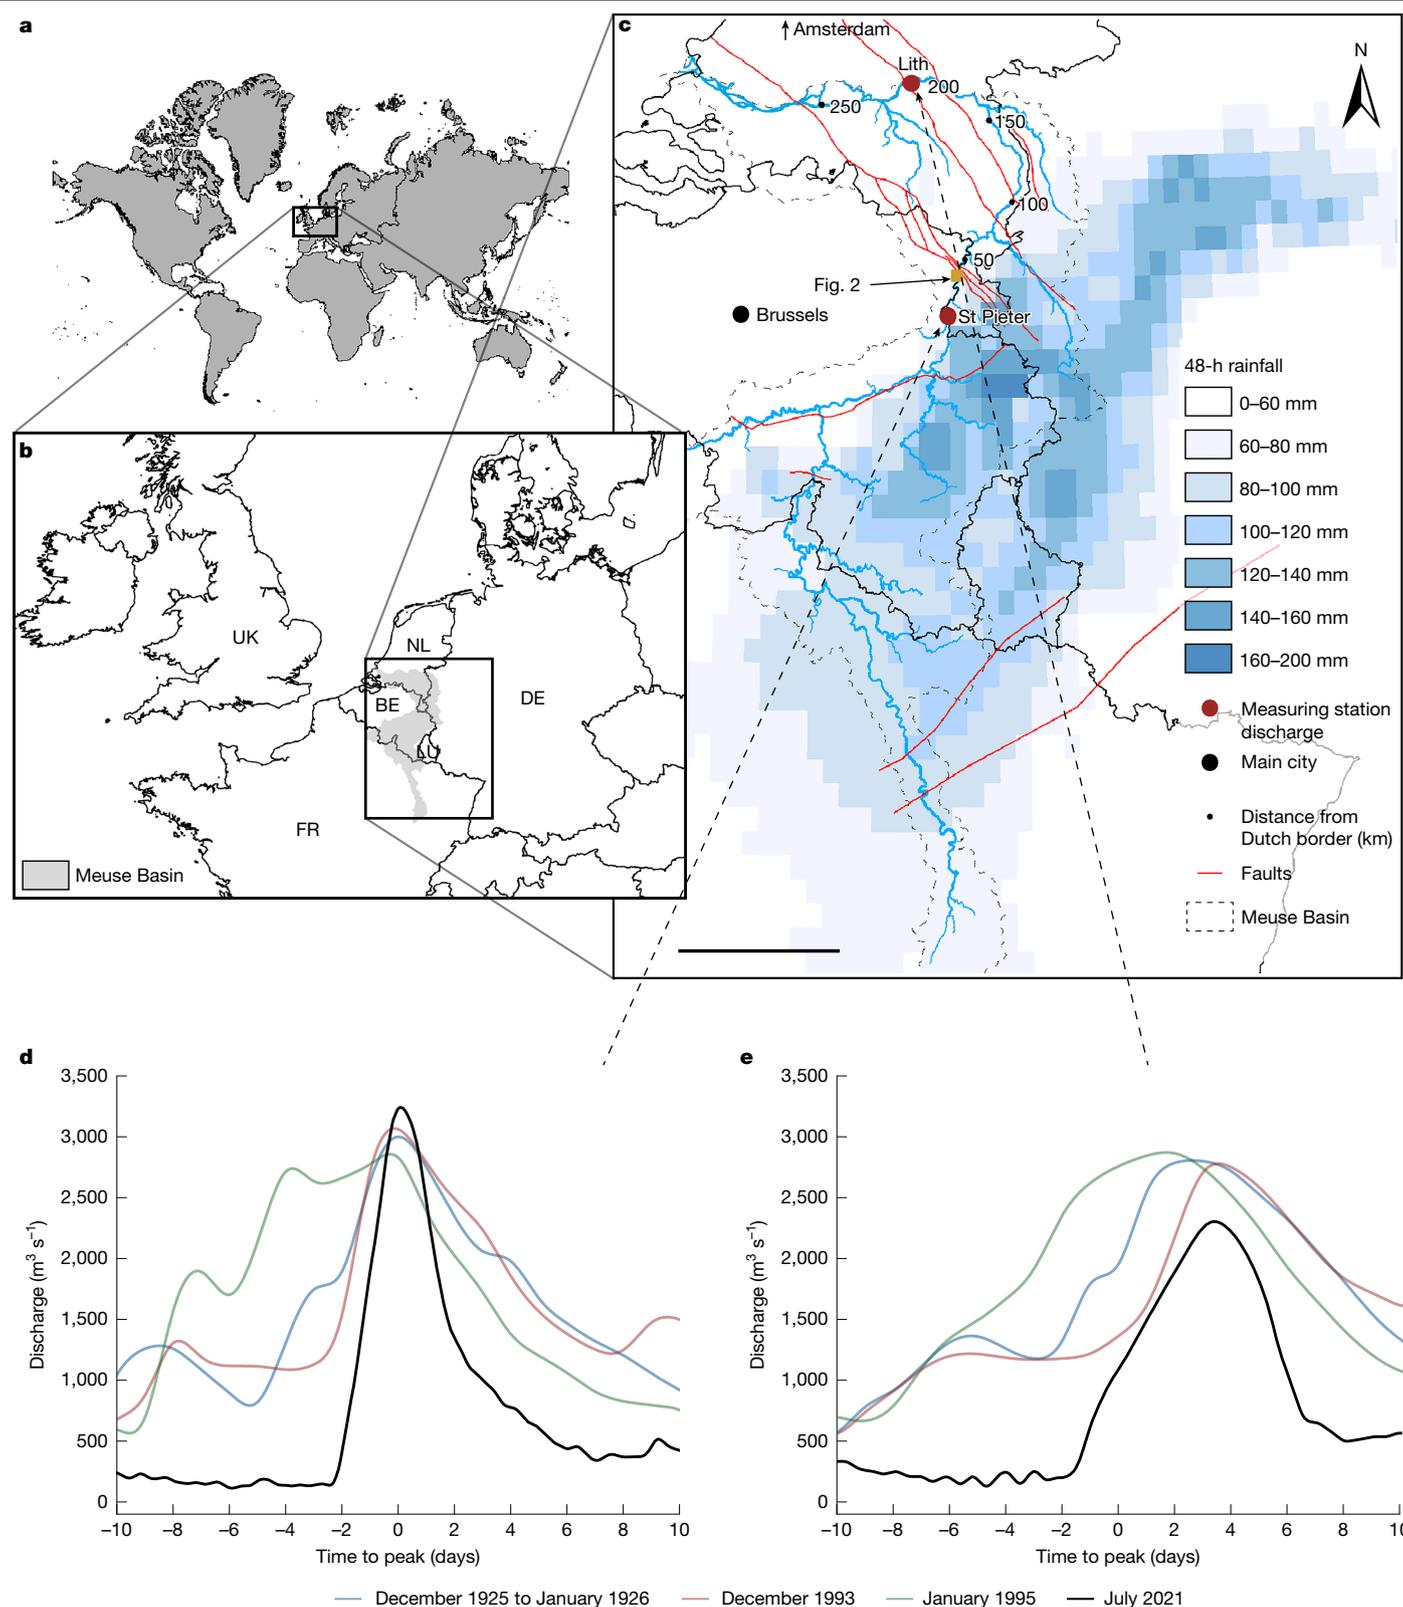
Fig. 1 | The extreme 2021 summer flood in the Meuse Basin. a, Location of Western Europe. **b**, Location of Meuse Basin. BE, Belgium; DE, Germany; FR, France; NL, the Netherlands. **c**, Meuse Basin with the cumulative 48-h rainfall on 13–14 July 2021 in millimetres, locally assessed as a 1,000-year event³⁷. Numbers in the map show river kilometres from the Dutch border. Scale bar, 80 km.

d, Observed discharges at St Pieter, Maastricht, km 10.8, for floods in 1926, 1993, 1995 and 2021. **e**, Observed discharges at Lith, km 202.4, according to the moment of the peak at St Pieter, showing larger wave damping for the 2021 flood. Geographical details of the Dutch Meuse River, such as slope, incision trend and sediment composition, are presented in Extended Data Fig. 1a–d.

In July 2021, the stationary, cold-core low-pressure system Bernd developed over Western Europe, accompanied by an upper-level cold pool of air, attracting humid air^{37,38} and causing extreme precipitation (Fig. 1a). A World Weather Attribution study³⁷ found this event to be consistent with the extremes expected in a warming climate, with human-induced climate change almost certainly increasing its likelihood and intensity. The resulting floods in tributaries of the rivers Rhine and Meuse killed approximately 240 people and caused more than US \$43 billion in damage¹⁰.

Within 2 days, the Meuse River discharge near Maastricht (the Netherlands) increased from less than $50\text{ m}^3\text{ s}^{-1}$ to a peak of $3,310\text{ m}^3\text{ s}^{-1}$. The peak of the approximately 100-year flood^{39,40} exceeded the three highest discharge peaks of the past century (Fig. 1d). In the steep Common Meuse, the flood wave travelled fast and relatively undistorted. Downstream, the more gentle, wider river valley and multiple large lakes damped and delayed the sharp-peaked 2021 flood more than the broader historical floods (Fig. 1d,e), conveying it as a 10- to 15-year flood to the downstream reach.

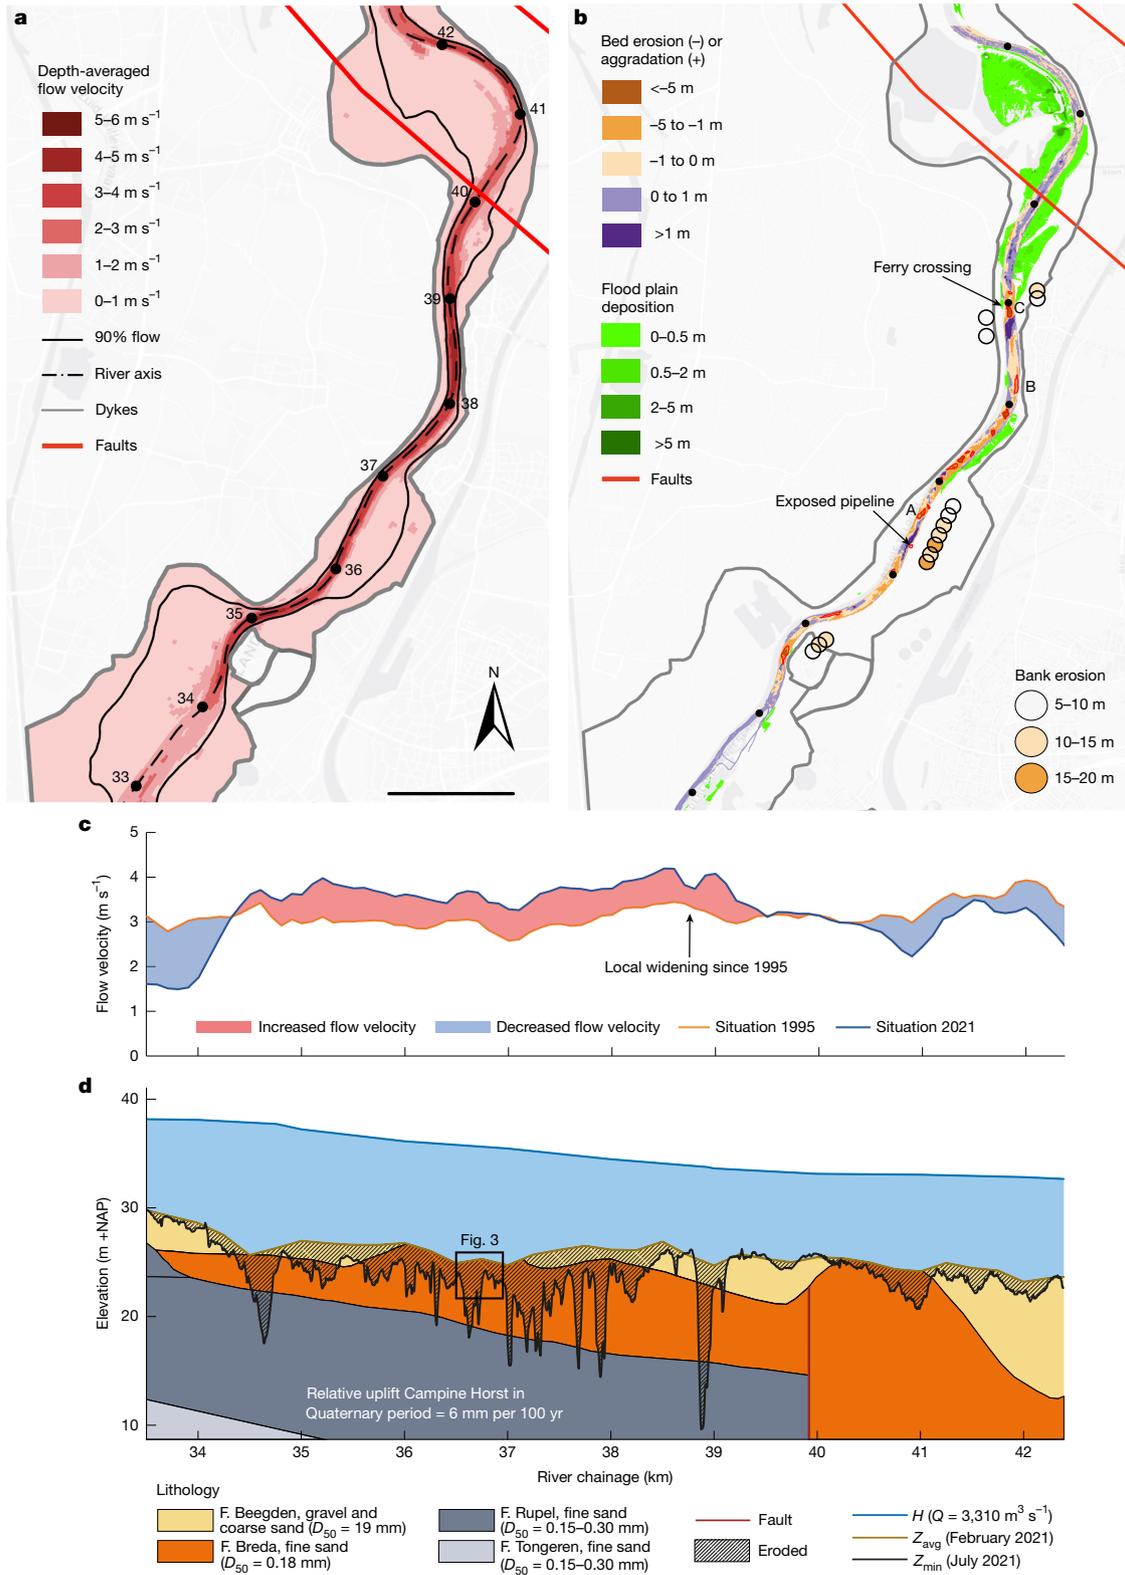
Fig. 2 | Simulated flow conditions and observed erosion in the river reach with deep scours during the 2021 flood. a, Simulated peak flow velocities and bounds of the area where 90% of the flow passes, revealing bottlenecks between km 35 and 39 (location indicated in Fig. 1c) due to uneven widening (Extended Data Fig. 2c). Scale bar, 1.3 km. **b**, Scour holes (red contours), bank erosion and floodplain deposits in the Common Meuse. Bed and bank scour appear to alternate (for example, along km 34.5–35.5, 36–37 and 38.5–39.2). Locations A–C refer to Fig. 3. Extended Data Figs. 4–6 provide erosion and deposition volumes and composition for the entire Dutch Meuse. **c**, Simulated maximum flow velocities and differences in the main channel, averaged over depth and 50 m

of width, for the river geometries in 1995 and 2021, showing acceleration in the bottleneck section (km 35–39), and velocity reduction in widened sections (upstream km 34, at km 38.7 and downstream km 40). **d**, Bed levels (Z), erosion and water levels (H) at the peak discharge (Q) of $3.310 \text{ m}^3 \text{ s}^{-1}$ in the reach of the Campine Horst. Levels relative to the Dutch reference level NAP. The deepest points (thalweg) in July 2021 are compared to the cross-section-averaged bed levels every 250 m in February 2021. Lithology with formations (F.) from Extended Data Fig. 2b. Despite the thin gravel layer at km 40–41, erosion is limited owing to reduced flow velocities in the widened section. D_{50} , median grain diameter.

During the flood, flow velocities locally exceeded 5 m s^{-1} (Fig. 2a). Narrow sections experienced substantial riverbank erosion and riverbed deepening, damaging ferry landings and exposing crucial pipelines³⁹. Chemical transport through the pipelines was halted, and extensive emergency repairs had to be carried out.

A bed level survey 3 days after the flood peak revealed 16 deep scour holes, 1 more than 15 m deep, in a 6-km-long, narrow section of the Common Meuse (Fig. 2b,d). The observed alternation of bank and riverbed erosion in Fig. 2b suggests that the weakest of those two determines which is more likely to erode. At the chemical pipeline, crossing near km 36.3, the riverbed was protected to prevent vertical erosion. However, the bank eroded laterally over more than 30 m, beyond the limits of the bed protection, and then scoured vertically, exposing the buried pipeline.

The depths of the scour holes locally reached 200% of the flow depth, and were similar to scours in other rivers^{41,42}. Nearly 500,000 m^3 of sediment was eroded from the riverbed (90%) and banks (10%) of the Common Meuse, exceeding the estimated average annual flux of sand and gravel tenfold (ref. 43). Fine-grained marine sands of Neogene age eroded from the scour holes. Fieldwork and laser altimetry (LiDAR) showed that 50% of this material was deposited on the floodplains and in lakes within 5 km of the last scour hole, locally over 3 m thick (Fig. 2b). An additional 30% of the eroded sand was deposited within the next 25 km. The remaining 20% travelled downstream in suspension, deposited on the floodplains further downstream, as was substantiated by the granulometric composition and chemical properties of floodplain deposits (Extended Data Fig. 5).

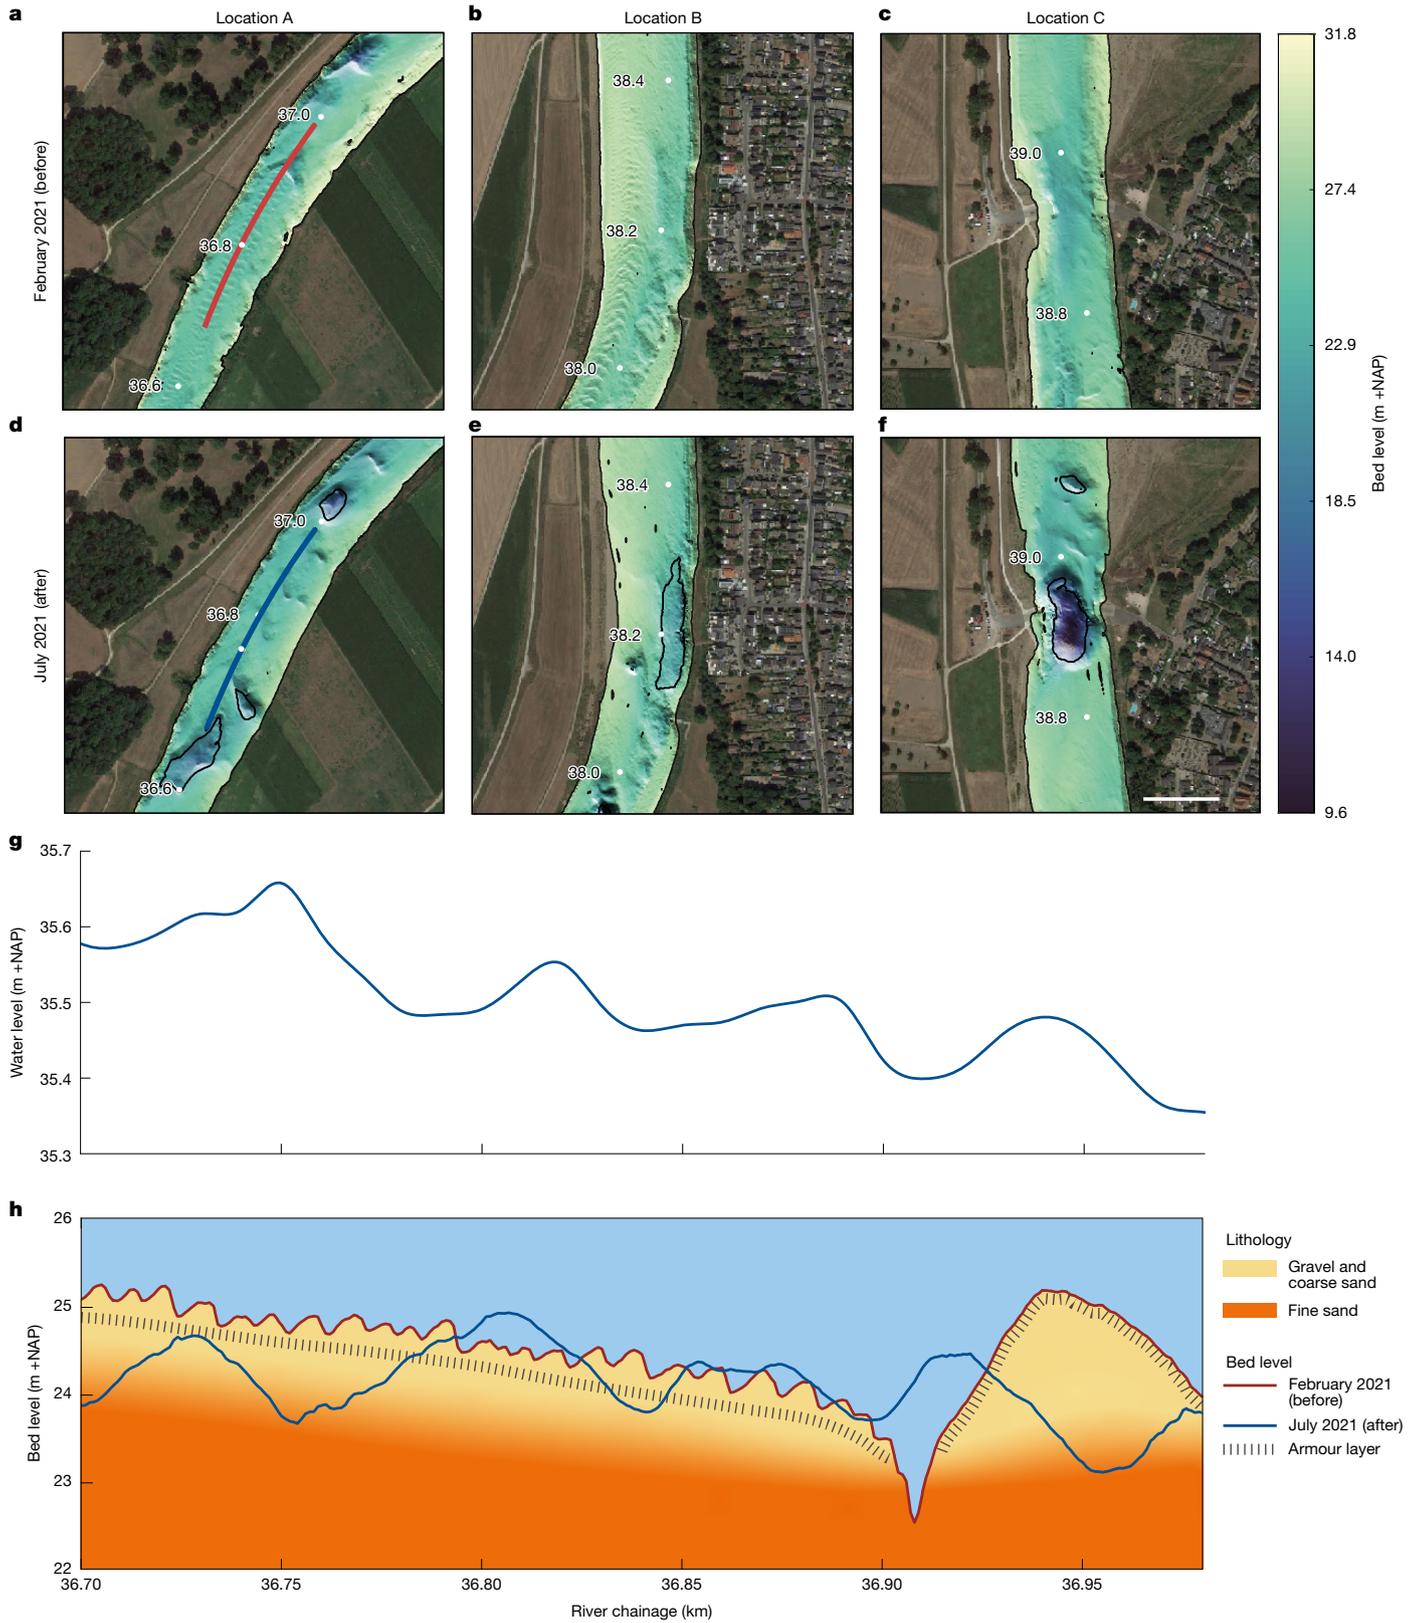
Fig. 3 | Examples of riverbed erosion during the flood. Illustrated by bed levels before (February 2021, maximum discharge $1,300 \text{ m}^3 \text{ s}^{-1}$) and just after the July 2021 flood. **a, d**, Example of riverbed erosion due to dune development (location A in Fig. 2b), flow direction from bottom to top. **b, e**, Riverbed erosion in outer bend (km 38.2, B in Fig. 2b). **c, f**, Constriction scour in the narrow ferry crossing (km 38.9, C in Fig. 2b). Scale bar, 100 m. **g**, Water level profile from a

LiDAR flight on 16 July, showing the presence of dunes. **h**, Detail of Fig. 2d, observed bed level and sedimentological profile along the lines in **a, d**, showing small (February 2021) and large (19 July 2021) dunes. The shifts in peak locations of water level (**g**) and dune troughs (**h**) are due to dune propagation between the LiDAR and riverbed surveys. The gravel and coarse sand layer thickness was estimated using the geological profile in Extended Data Fig. 1b.

Hydrodynamic simulations for conditions mimicking the flood event underestimated peak water levels by up to 0.5 m in the reach with the scour holes³⁹. Although dense summer vegetation, crops and thick floodplain deposits may explain part of this discrepancy, large riverbed dunes may have played a role as well. LiDAR water surface observations (Fig. 3g and Extended Data Fig. 2f), taken just after the flood peak, and the post-flood bathymetry (Fig. 3d,h) indicate that dunes of 1 m or higher occurred, which is much larger than the

approximately 0.2-m-high bedforms during normal floods (Fig. 3h, February 2021 bed). We calculated that energy losses due to the development of large dunes in the main channel could have raised the peak water levels by up to 0.25 m.

The formation of a flow conveyance bottleneck due to uneven widening was the most likely cause of the formation of deep scours, which was exacerbated by the local geologic structure, bedforms that broke through the top gravel layer, and other local factors, including natural deepening at river bend pools (Fig. 3b,e) and the main channel constriction (Fig. 3c,f).

Gravel dunes have previously been described^{45,61}. We calculated dune dimensions during the flood using the sand dune predictor of ref. 62, adopting a water depth h of 8 m, a bed slope l of 5×10^{-4} , a median grain diameter D_{50} of 0.025 m (based on Extended Data Fig. 1c) and a value of 0.045 for τ_c^* , the critical Shields number for entrainment in gravel mixtures⁶¹. The calculated dimensions agreed well with the observed dune height of 1–2 m and length of 50–90 m (Fig. 3h), despite the application

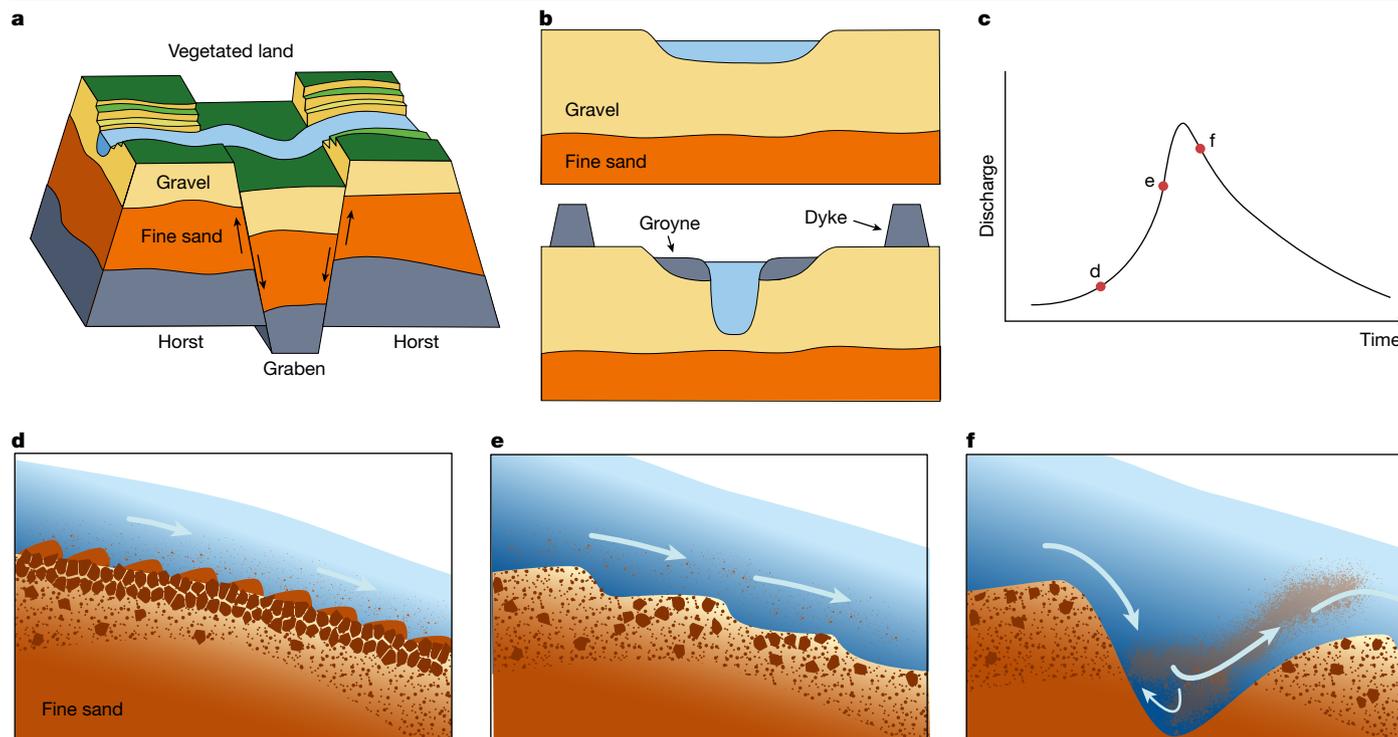
Fig. 4 | Long- and short-term processes that contribute to sudden scour hole formation. **a**, Geological timescale, with typical uplift and subsidence rates of horsts and grabens up to centimetres per century; rivers incise into horsts. **b**, Engineering timescale in which natural rivers (upper panel) are engineered (lower panel) and sediment transport is modified, leading to incision rates up to centimetres per year. **c**, Event timescale during which flow conditions change rapidly and erosion and deposition processes develop fast; labels d, e and f

along the plot line refer to moments of the processes in panels **d**, **e** and **f**, respectively. **d**, Armoured bed with increased suspended load from upstream and developed small sand dunes. Underneath the armour, a thin mixture of gravel and sand overlays a thick layer of fine sand. **e**, Increased flow disrupting the armour and forming gravel dunes. **f**, Rapid development of scour hole in fine sands^{58,59}.

Heterogeneity of the subsurface stratum and recent uneven widening explain the occurrence of extreme scour in the Common Meuse (Fig. 4). Similar scour holes have been reported in the Mekong⁴⁸, Mississippi⁴⁹, Saskatchewan⁵⁰, Mahakam⁵¹, Tisza⁴¹, Petit Rhône¹³, Rhine⁵² and Salzach (tributary to Danube)⁵³ rivers, as well as in the Mackenzie⁵⁴ and Rhine–Meuse^{22,55} deltas. In 8 out of 11 reported cases, scouring is linked to human interference or excessive sediment mining. In 8 cases, the scours are linked to subsurface sediment heterogeneity (Extended Data Fig. 7), which results from tectonics and, possibly, glaciation,

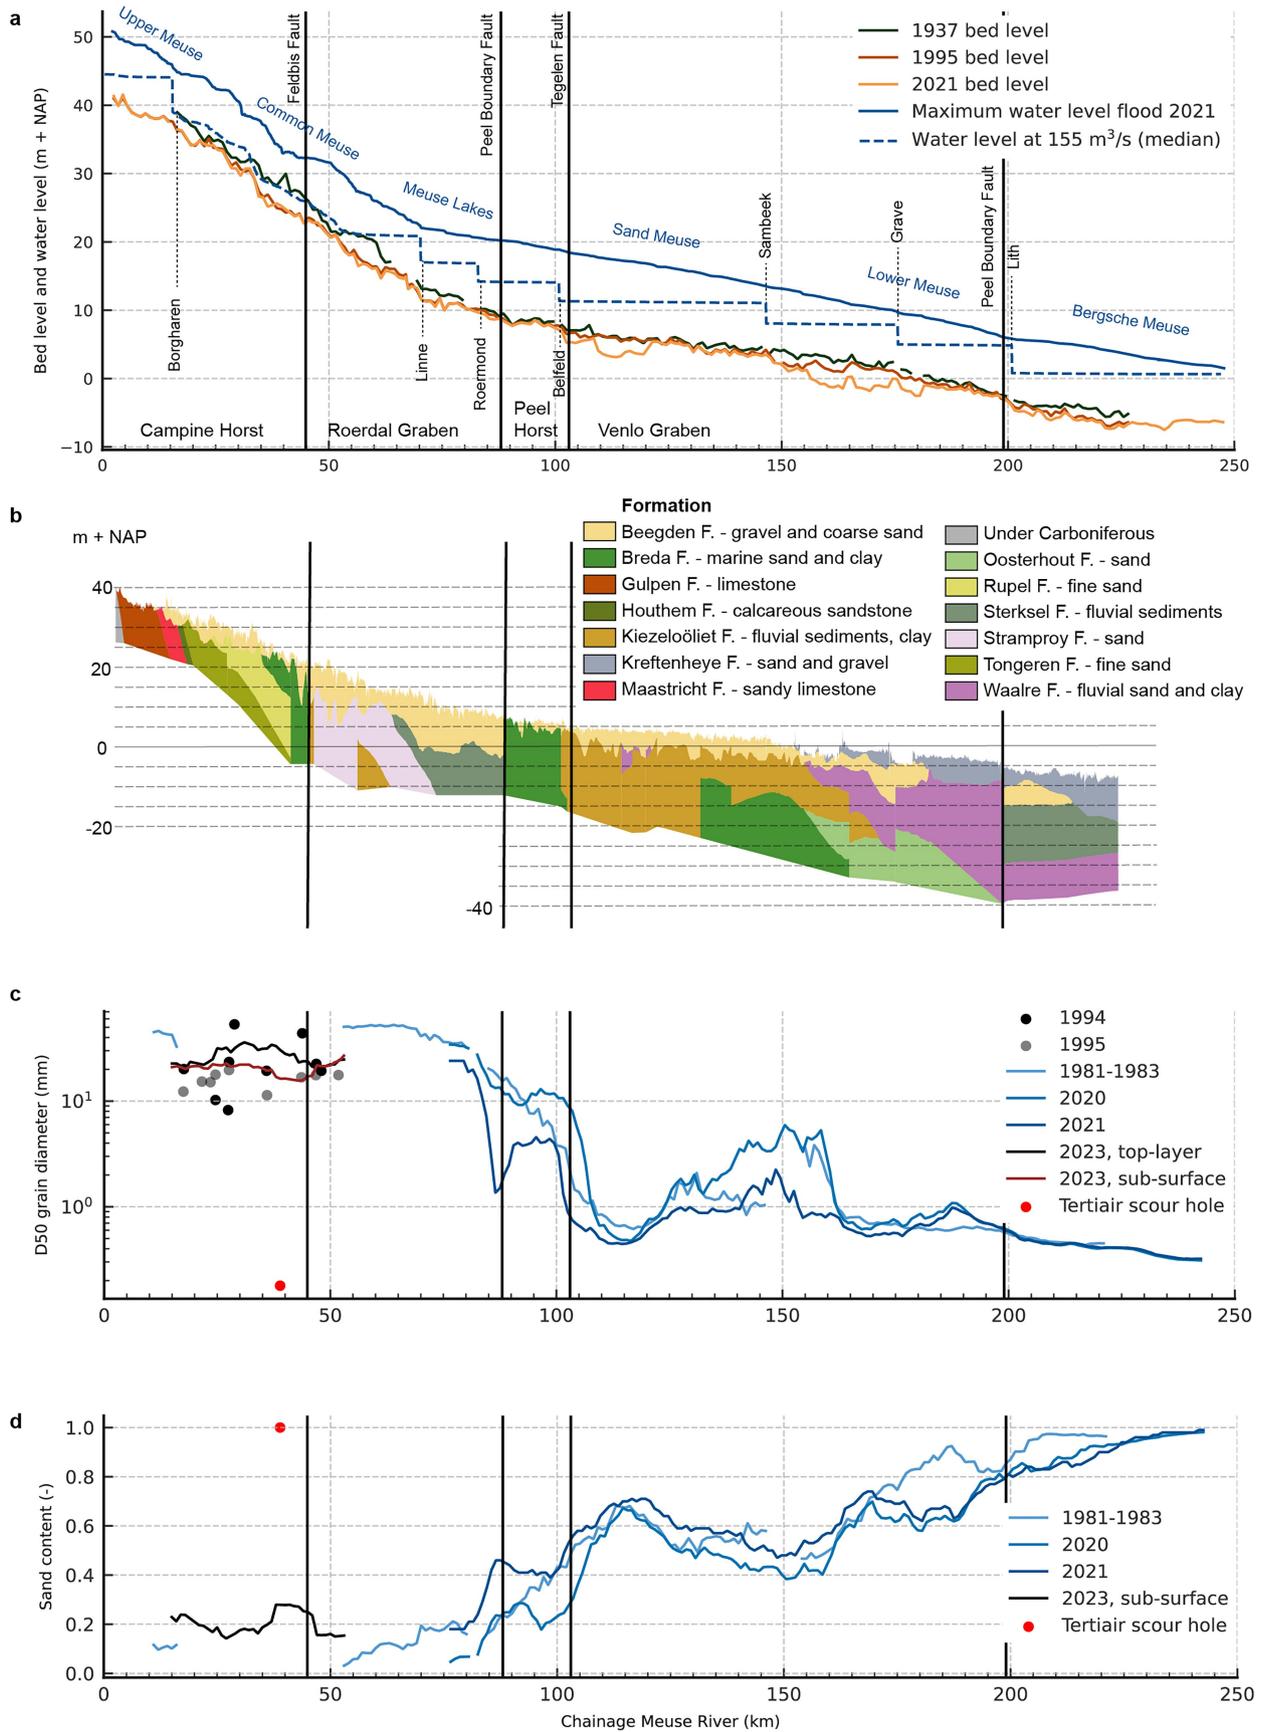
Extended Data Fig. 1 | See next page for caption.

Extended Data Fig. 1 | Geology, bed profile development and riverbed composition of the Meuse River. **a.** Longitudinal bed level profiles in 1937, 1995 and 2021 averaged over 1 km (yearly survey Rijkswaterstaat), peak water level profile July 2021 (Rijkswaterstaat) and locations of faults (vertical lines), graben and blocks⁷⁵. The riverbed incises due to barrages, narrowing, bank protection, bend cut-offs and sediment extraction. **b.** Geological profile based on drillings in banks and floodplains, indicating gravel in yellow⁷⁶. The Campine Horst rises approximately $6 \text{ mm}/100 \text{ yr}^{34}$, relative to the slowly subsiding Roerdal Graben, explaining that, over millions of years, the incision thinned the gravel layer in the Campine Horst. The green colours underneath the gravel layer in the reach km

20-40 indicate fine marine sands from the Miocene (23-5 million B.P.), Rupelian (34-28 million years B.P.) or Late Eocene/Early Oligocene (37-30 million years B.P.). **c.** Characteristic grain size diameter D_{50} from riverbed top layer (10 cm) and development in time (data Rijkswaterstaat). Data from 1981-1983, 2020 and 2021 (after the flood) are based on samples every 500 m; lines show a moving average over 10 km. **d.** Sand content top-layer in time (data Rijkswaterstaat), as a moving average over 10 km. The composition and location of the gravel-sand transition in the reach km 90-105 remained stable over the past 50 years. In parts of the Meuse River with a gravel bed, an armour layer on the riverbed is formed outside periods of high flows.

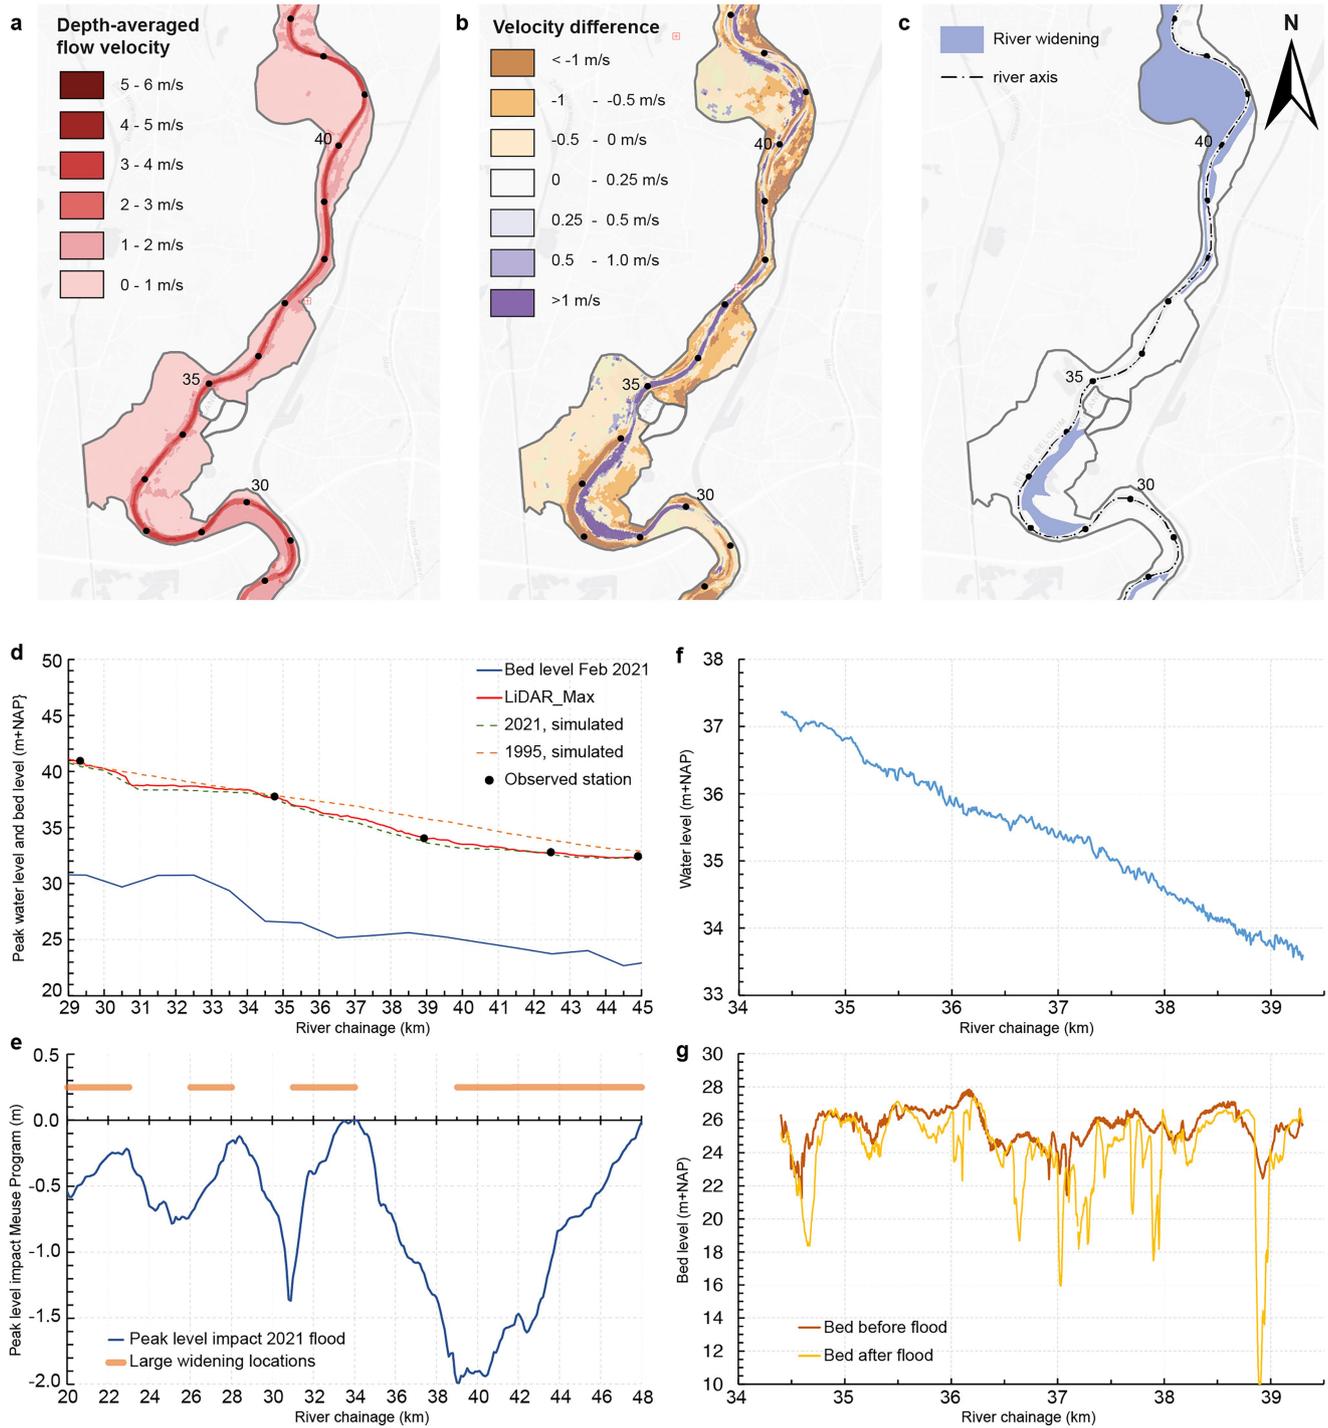
Extended Data Fig. 2 | Hydrodynamic simulations and observations of the peak event. **a**, Depth-averaged maximum flow velocities in simulations with the river geometry from 1995 (before Meuse Program), obtained with the 2-dimensional Delft3D-FM model and the 2021 flood discharge as boundary condition. **b**, Difference in maximum flow velocity for the same discharge wave in simulations adopting the river geometry of 2021 before the flood, revealing much higher peak velocities in the main channel of reach km 34–39. **c**, Meuse Program measures implemented up to 2021 in reach km 34–39. **d**, Predicted (based on 2-dimensional WAQUA-simulations) and observed peak water levels at gauging stations and from the LiDAR-campaign (source Rijkswaterstaat). River widening has drawn down water levels in the narrow reach at km 34–40,

increasing the flow velocities there (panel b). 2021 predicted water levels underestimate measured water levels by up to 0.5 m^{39} . **e**, Impact of the Meuse Program river widening on peak water levels under 2021 discharge conditions. The flood level lowering varies strongly along the river, reducing to zero where the river was not widened over several kilometers. **f**, LiDAR based water levels along the river axis, 15 h after the peak passed. The regular water level fluctuations between the scours indicate the presence of dunes. **g**, bed level along the river axis (horizontal scale identical to panel f) in February 2021 (Bed before flood) and July 2021, 3 days after the flood peak. The scour holes and large dunes in between them are clearly visible after the flood.

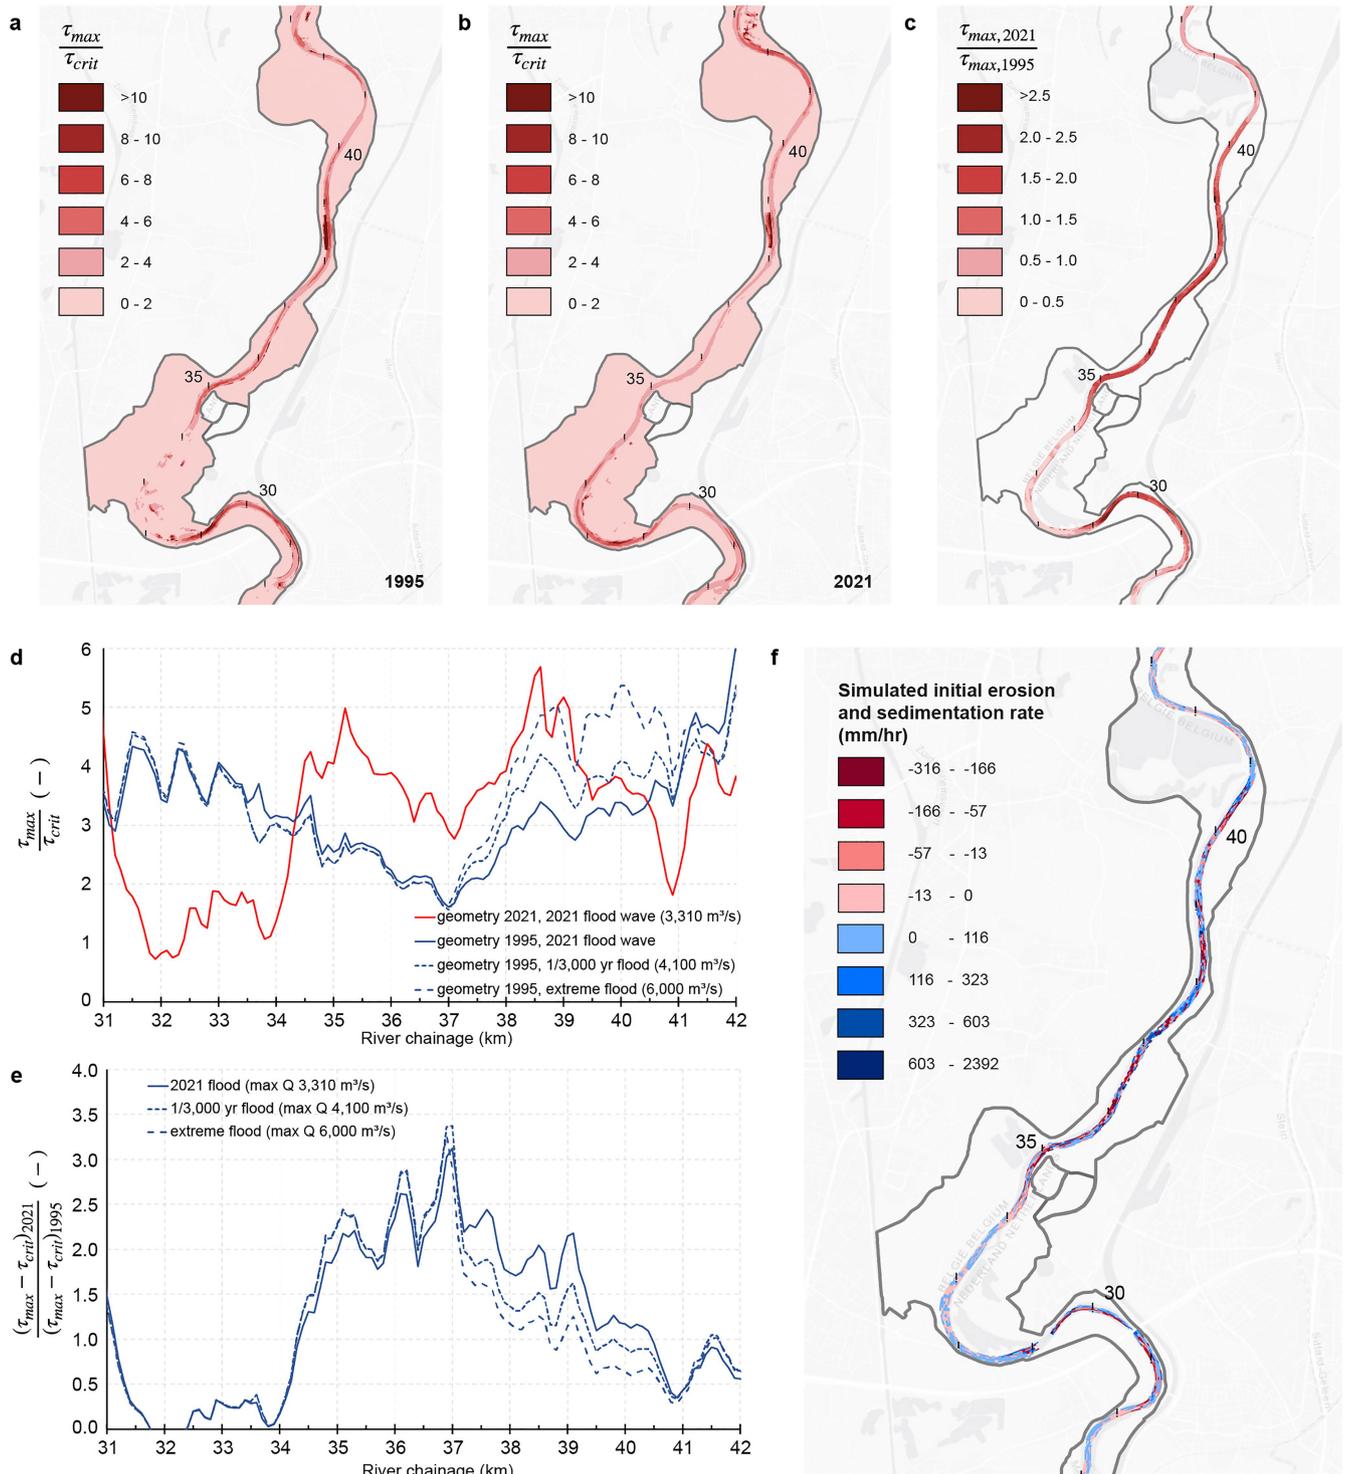
Extended Data Fig. 3 | Bed shear stress variation and sediment transport capacity in 2021 and 1995. **a.** Ratio of simulated maximum to critical shear stress in the 1995 geometry (before widening) under 2021 flood conditions. **b.** Same as (a), yet adopting the 2021 river geometry, before the flood. **c.** Ratio of simulated maximum shear stress in 2021 and 1995 geometries in the main channel, adopting 2021 flood event discharge time series. **d.** Ratios of panel a. and b. projected on the river axis (average value in a 50 m circle). The ratio of maximum to critical shear stress is plotted for a 1/3000 per year flood event (peak discharge 4,100 m³/s) and an extreme 6,000 m³/s flood event, if these would have taken place in 1995. Even for more extreme flood events in the 1995 geometry, shear stresses are predominantly lower than during the 2021 flood event ($T = 100$ yr). **e.** Ratios of sediment transport capacity in 2021 and 1995

based on simulated bed shear stresses, adopting the Meyer-Peter and Müller (MPM) transport formula which relates sediment transport capacity to exceedance of critical shear stress to the power 1.5⁷⁷. Values > 1 indicate that the mobility of the top sediment layer in 2021 was larger than in 1995 for similar or even more extreme flood events. The sharp increase and peaks in the sections km 34.5–35, 35.5–36, 36.5–37, 37.5–38, 38.5 and 39 correspond to the locations of the 2021 scours (Fig. 2b and d). **f.** Initial erosion and deposition rates based on a simulation with the steady peak discharge of 2021, top layer grain diameters (monitoring campaign 2023), adopting the MPM transport predictor with hiding and exposure⁷³, and no morphological changes. The locations with large initial erosion (bright red) correspond well to the scour locations (Fig. 2b).

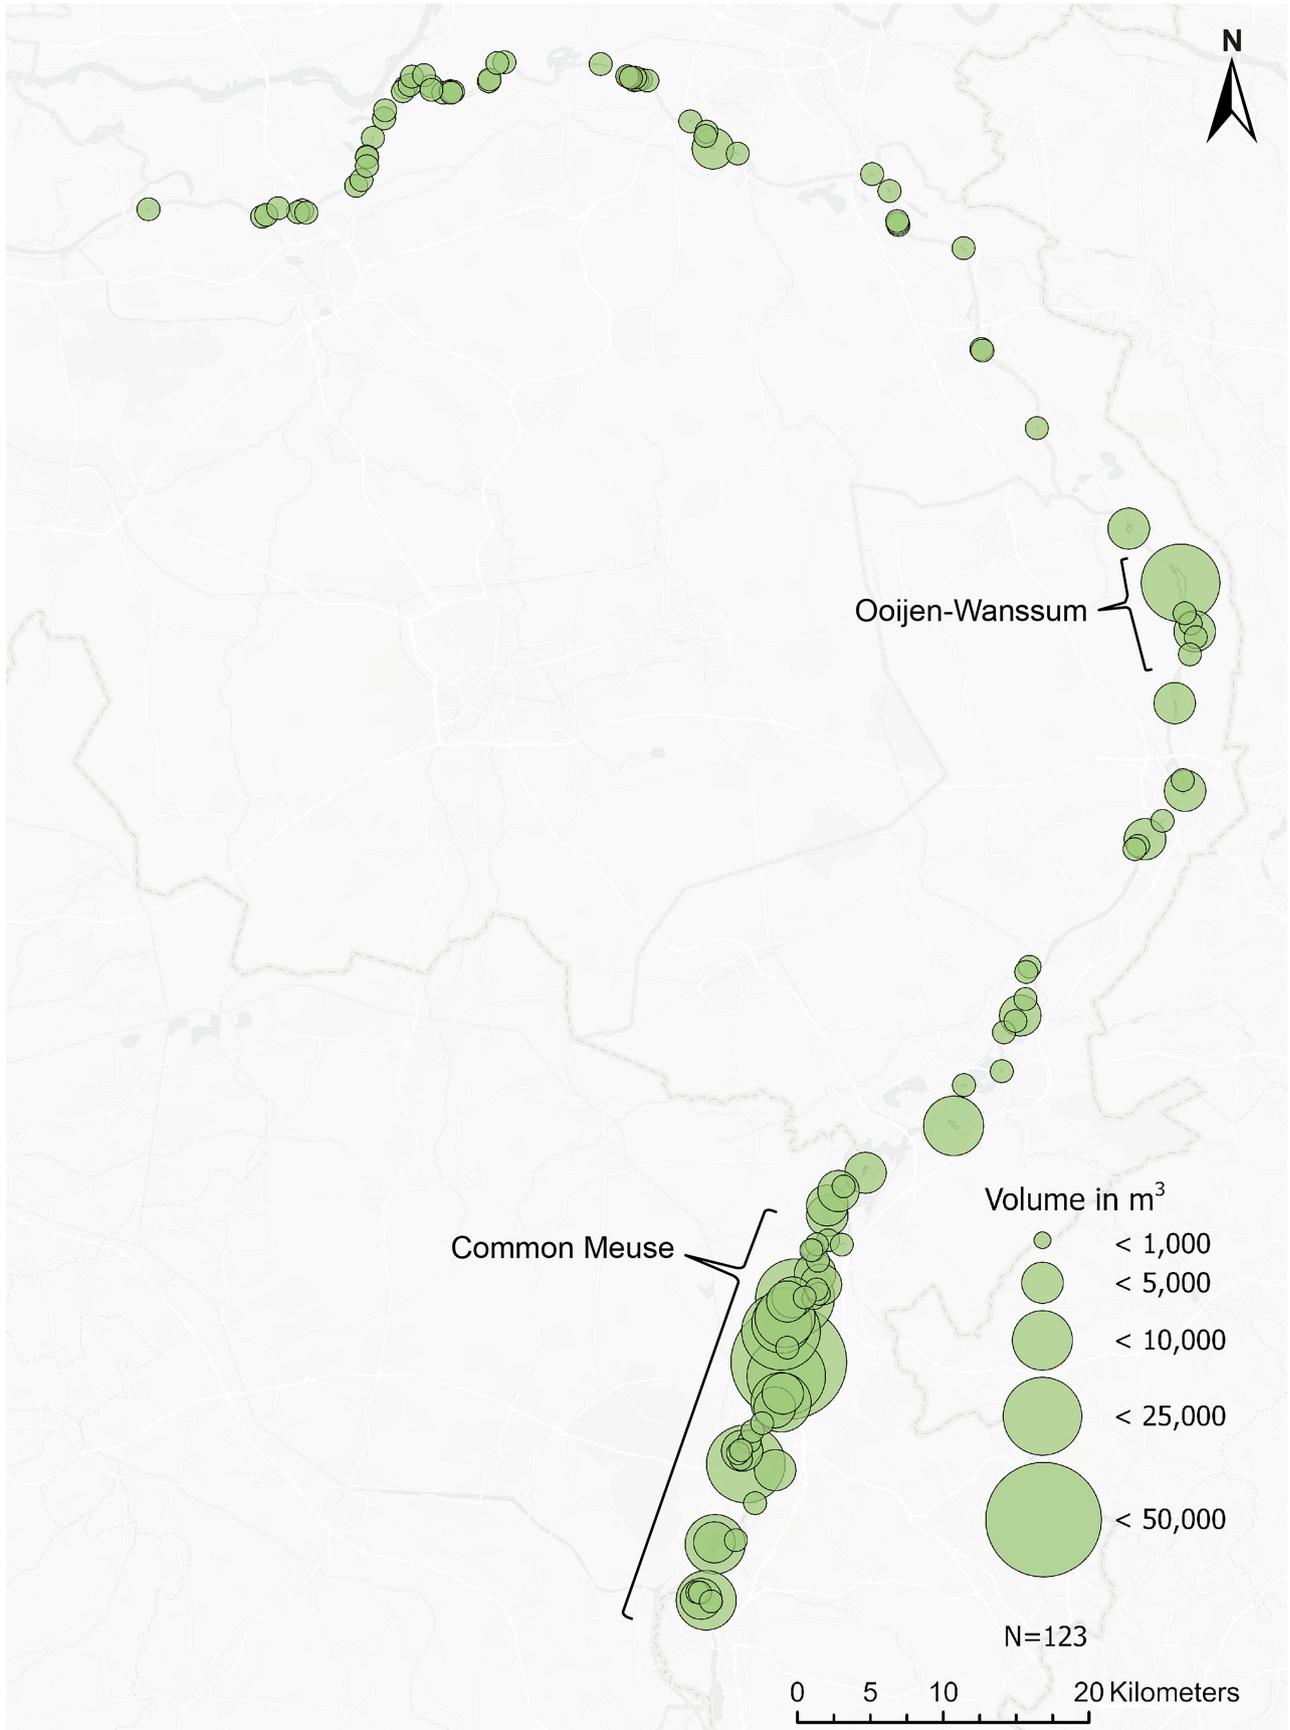
Extended Data Fig. 4 | Sand volumes of deposits during the July 2021 flood based on field measurements and LiDAR data. The 89 fieldwork floodplains contained 123 deposition areas. The largest deposits occurred in the Common Meuse and in the Ooijen-Wanssum trajectory, where a large river widening

project was completed in 2020. Sand deposits were predominantly found close to the river, particularly on inner bend overbank zones (67%), consistent with typical floodplain deposition patterns⁷⁸.

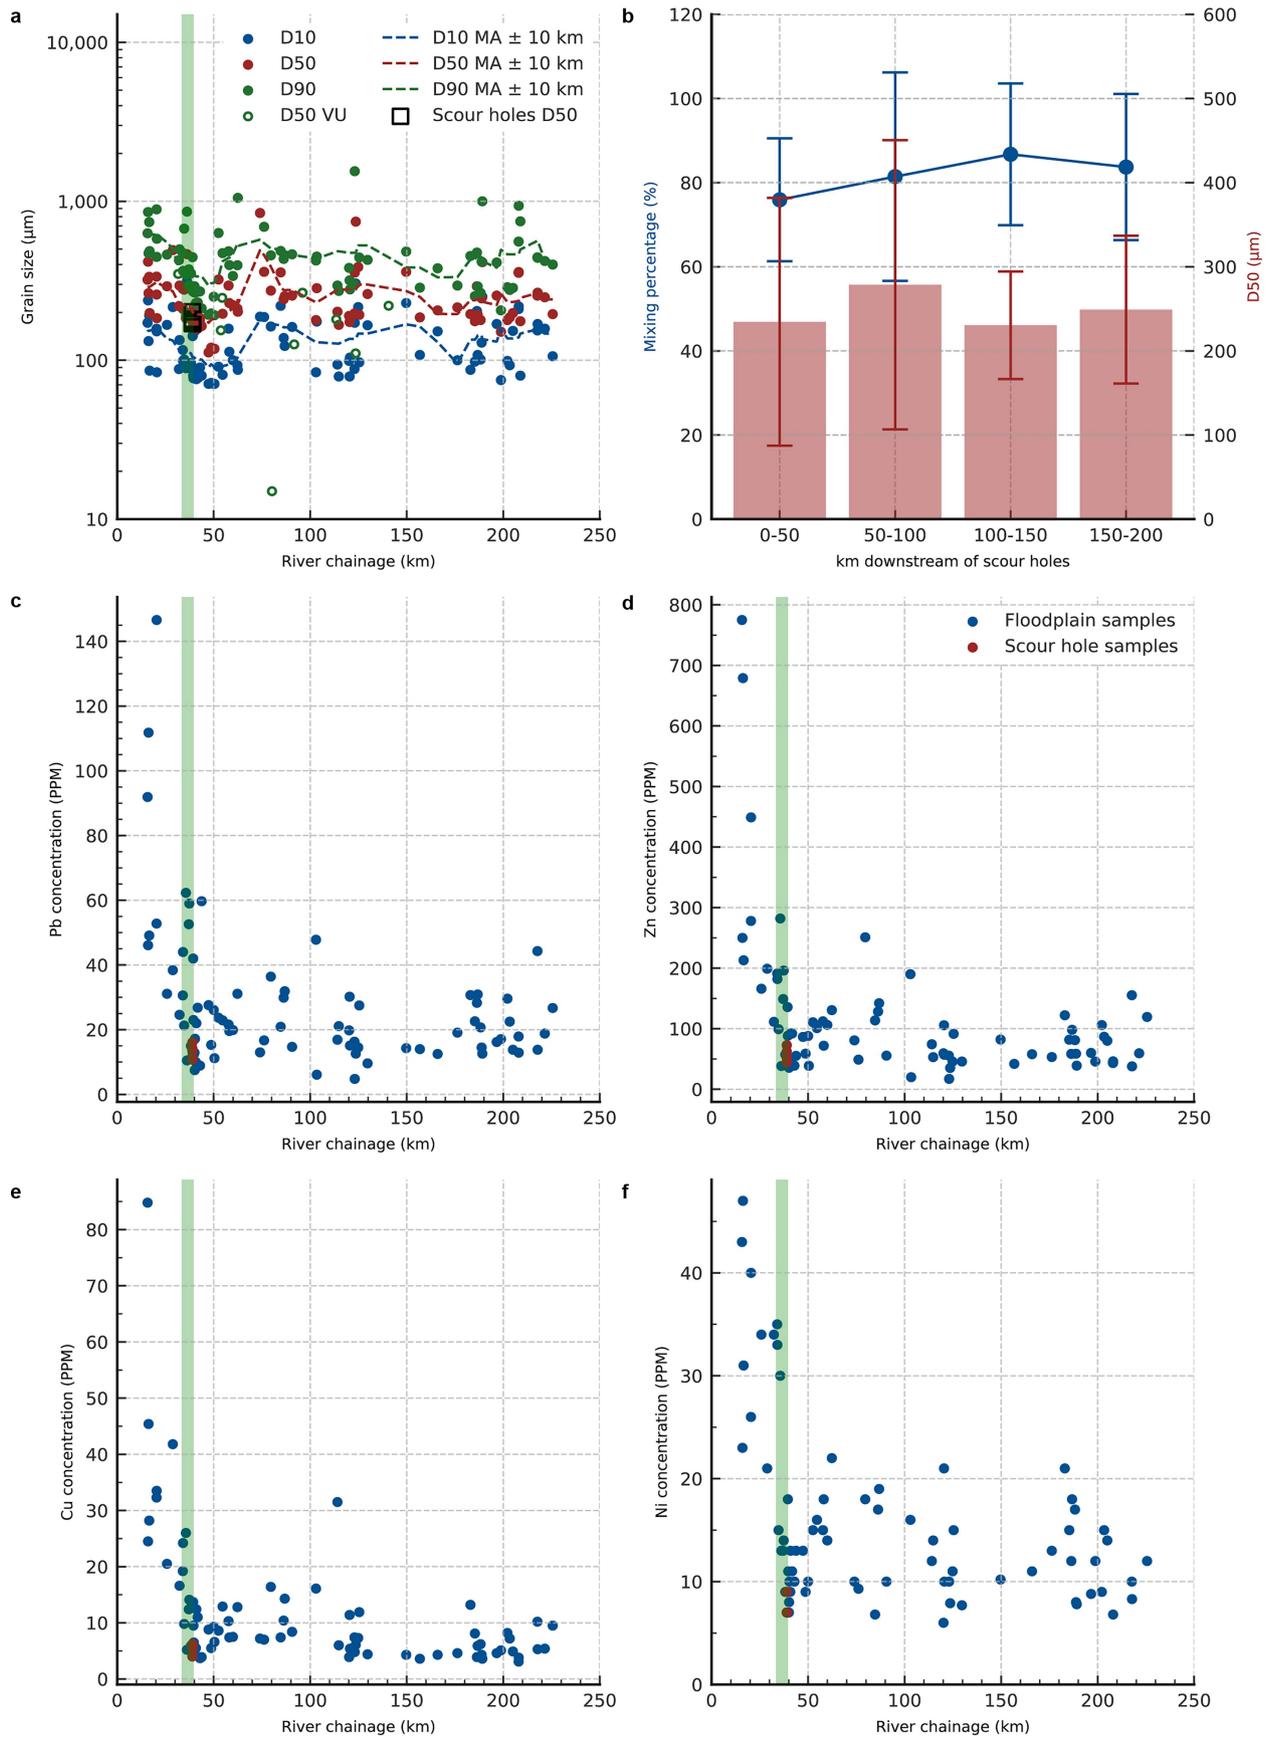
Extended Data Fig. 5 | See next page for caption.

Extended Data Fig. 5 | Sand deposit characteristics. **a**, Grain size distribution metrics for proximal zone floodplain deposits (mixed samples, see Methods) with moving average values. D_{50} values for samples from one scour hole (□) and near-river samples (○, "D50 VU" from Extended Data Fig. 9) are added for comparison. In a 20 km section downstream of the scour holes, deposits contain only fine sediment. **b**, Average mixing percentages and average D_{50} grain size of floodplain samples, including the standard deviations, for sections of 50 km downstream of the scour holes, showing no significant trend in

composition for downstream reaches. **c-f**, Concentrations of Pb, Zn, Cu and Ni in sediment samples from XRF analyses. Green bars indicate the scour hole section in the river; scour hole samples were taken at km 39, in the most downstream scour hole. Low concentrations in the scour holes show eroded Neogene sediments (23-5 million B.P.) to be uncontaminated, upstream deposits to be of more recent origin and the Neogene sediments to be deposited on downstream floodplains. Panels b-f are based on Van der Niet⁷⁹.
