Extreme river flood exposes latent erosion risk

<https://doi.org/10.1038/s41586-025-09305-3>

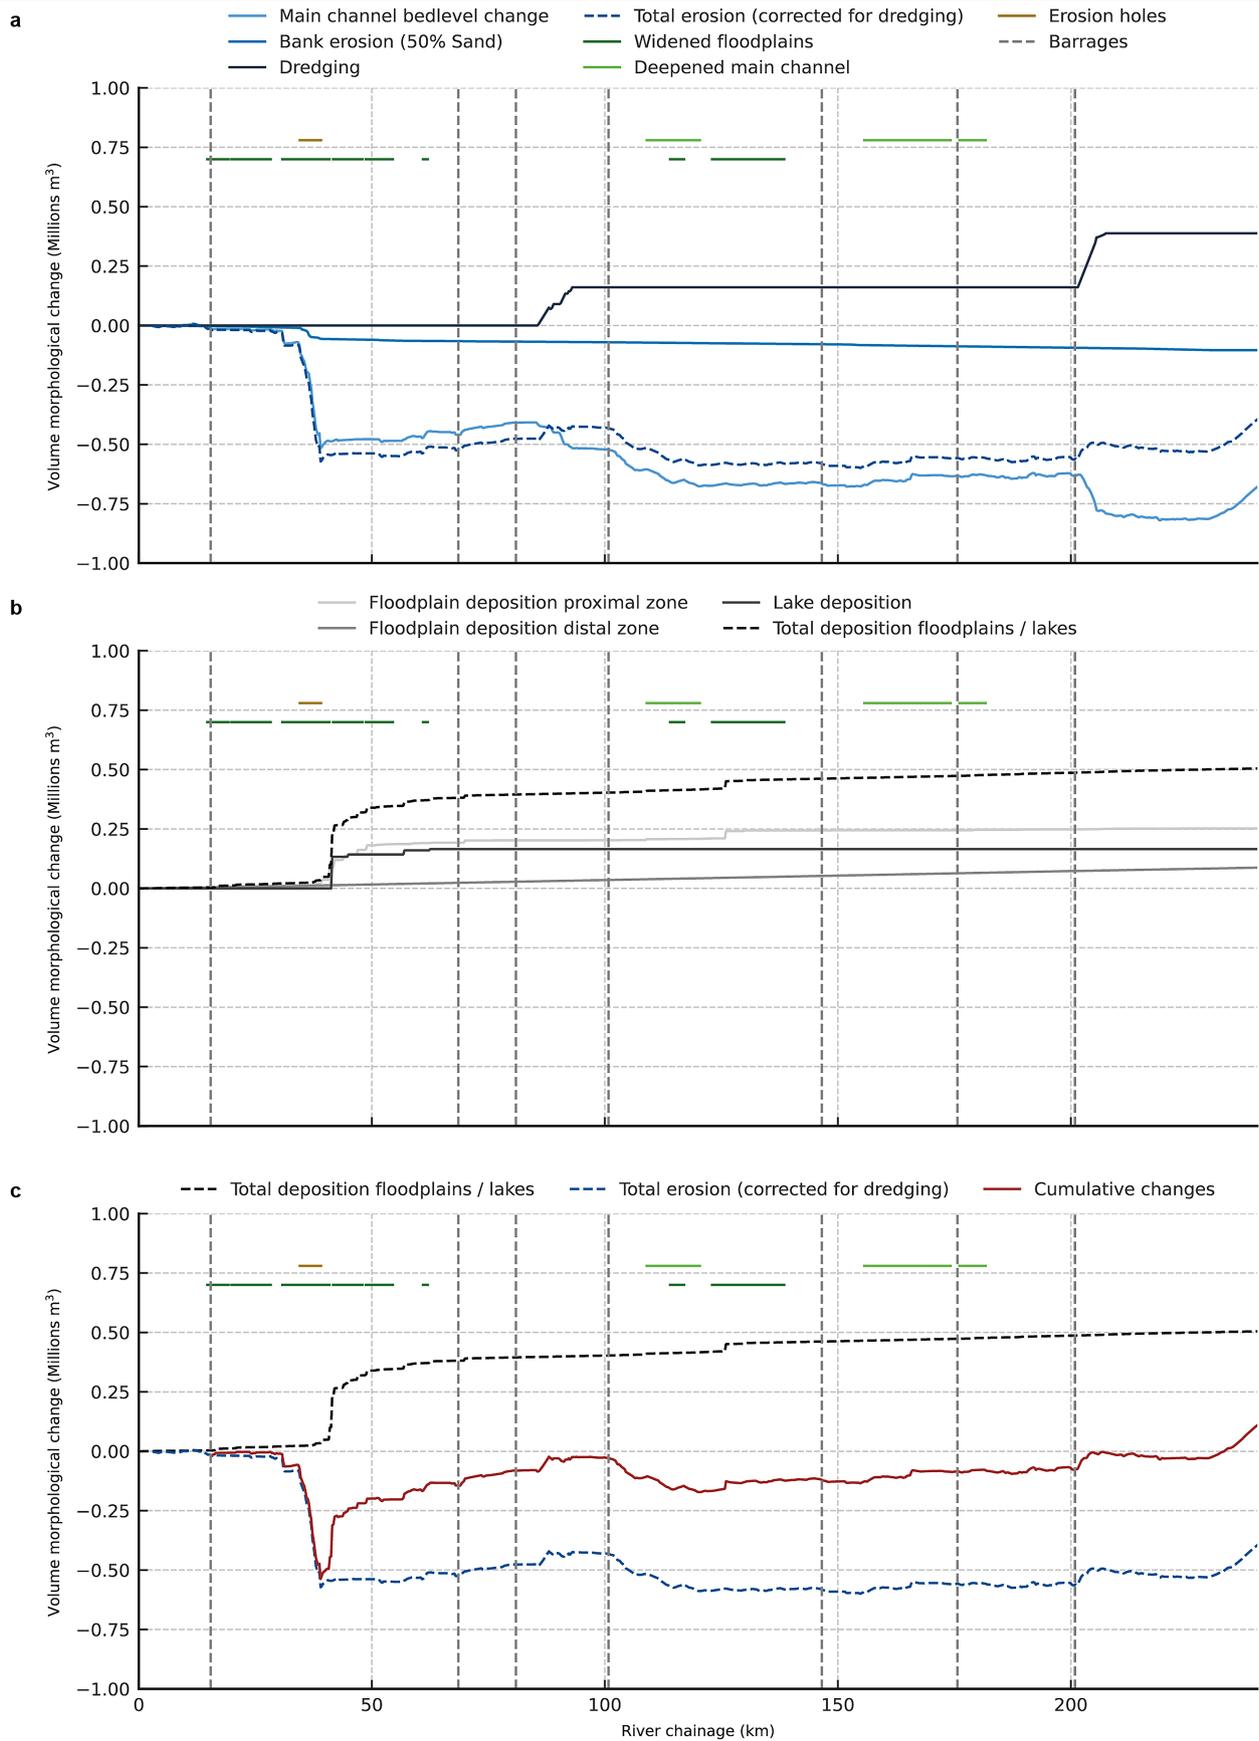
Extended Data Fig. 6 | See next page for caption.

Extended Data Fig. 6 | Cumulative Erosion and Deposition Volumes along the Meuse River. **a**, Erosion based on riverbed level information from February and July 2021, LiDAR data from April and August 2021 (for bank erosion), and dredged volumes between February and July 2021 (data Rijkswaterstaat). **b**, Deposition of sand on floodplains (field work and LiDAR) and in several

main lakes (multi beam measurements). **c**, Cumulative changes based on information in panels a and b, showing that 50% of the sand eroded from the scour holes was deposited within 5 km downstream of the last scour hole and an additional 30% in the succeeding 25 km.

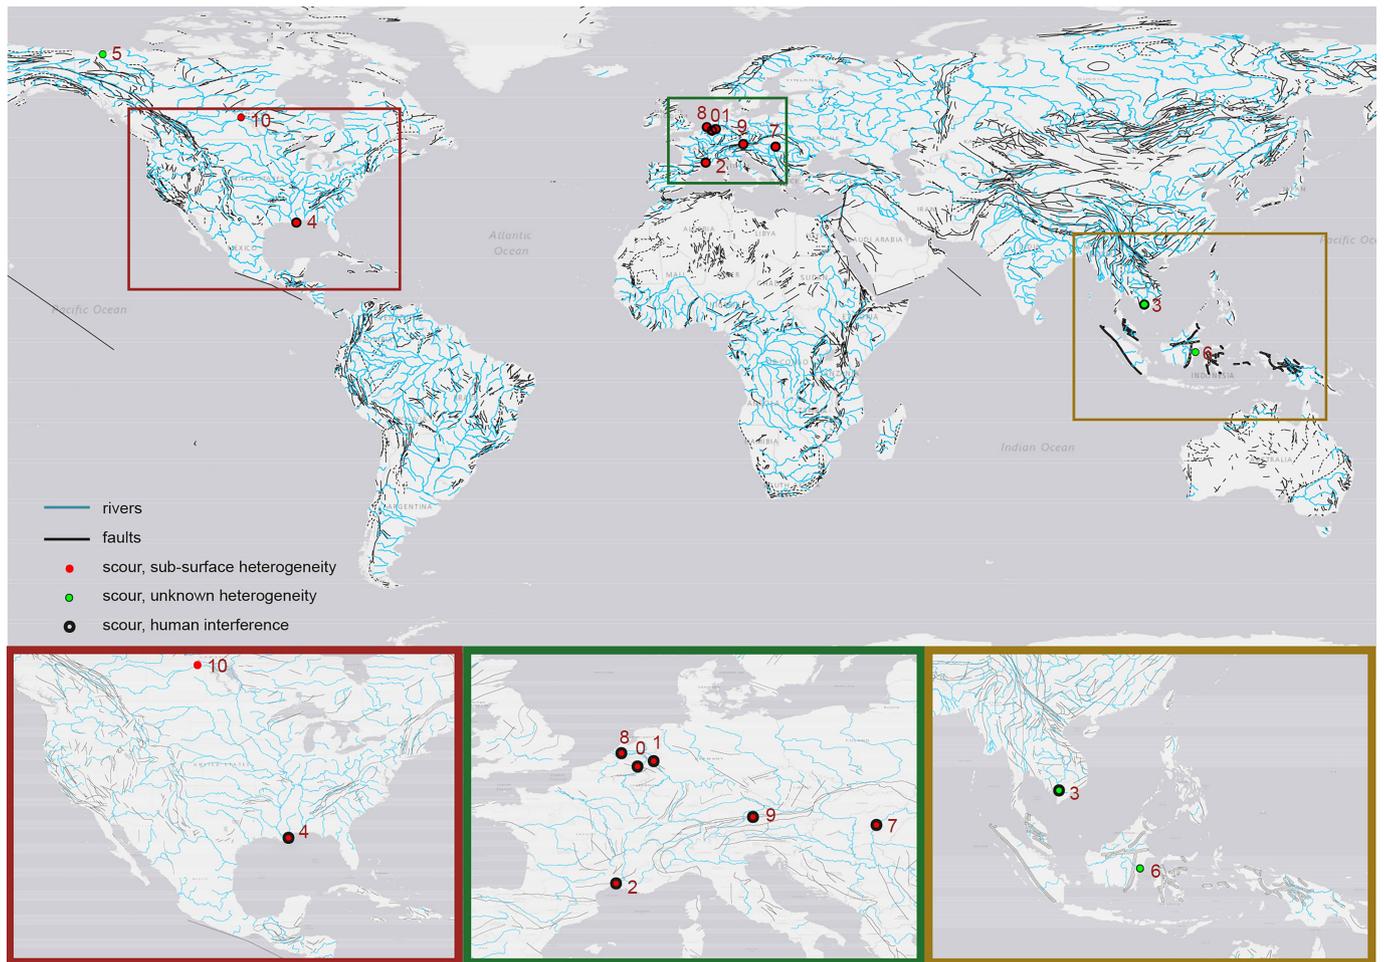
Extended Data Fig. 7 | Riverbed scour and tectonic faults. World map with faults⁸⁰ and the 11 cases of riverbed scour referred to in this manuscript (details in bottom panels): 0 – Meuse River, the Netherlands; 1 – Rhine River, Germany; 2 – Petit Rhone, France; 3 – Mekong River, Vietnam; 4 – Lower Mississippi, United States; 5 – Mackenzie Delta, United States; 6 – Mahakam River, Indonesia; 7 – Middle Tisza, Hungary; 8 – Rhine Meuse Delta, the Netherlands; 9 – Salzach River, Austria; 10 – Saskatchewan River, Canada. Markers indicate scour in regions with high subsoil heterogeneity and strong human interference. Many rivers are located in regions with tectonic faults, where irregular sedimentary composition of the subsoil can be expected. The scour cases 0, 1, 6 and 9 correspond to the existence of faults.

River, Austria; 10 – Saskatchewan River, Canada. Markers indicate scour in regions with high subsoil heterogeneity and strong human interference. Many rivers are located in regions with tectonic faults, where irregular sedimentary composition of the subsoil can be expected. The scour cases 0, 1, 6 and 9 correspond to the existence of faults.

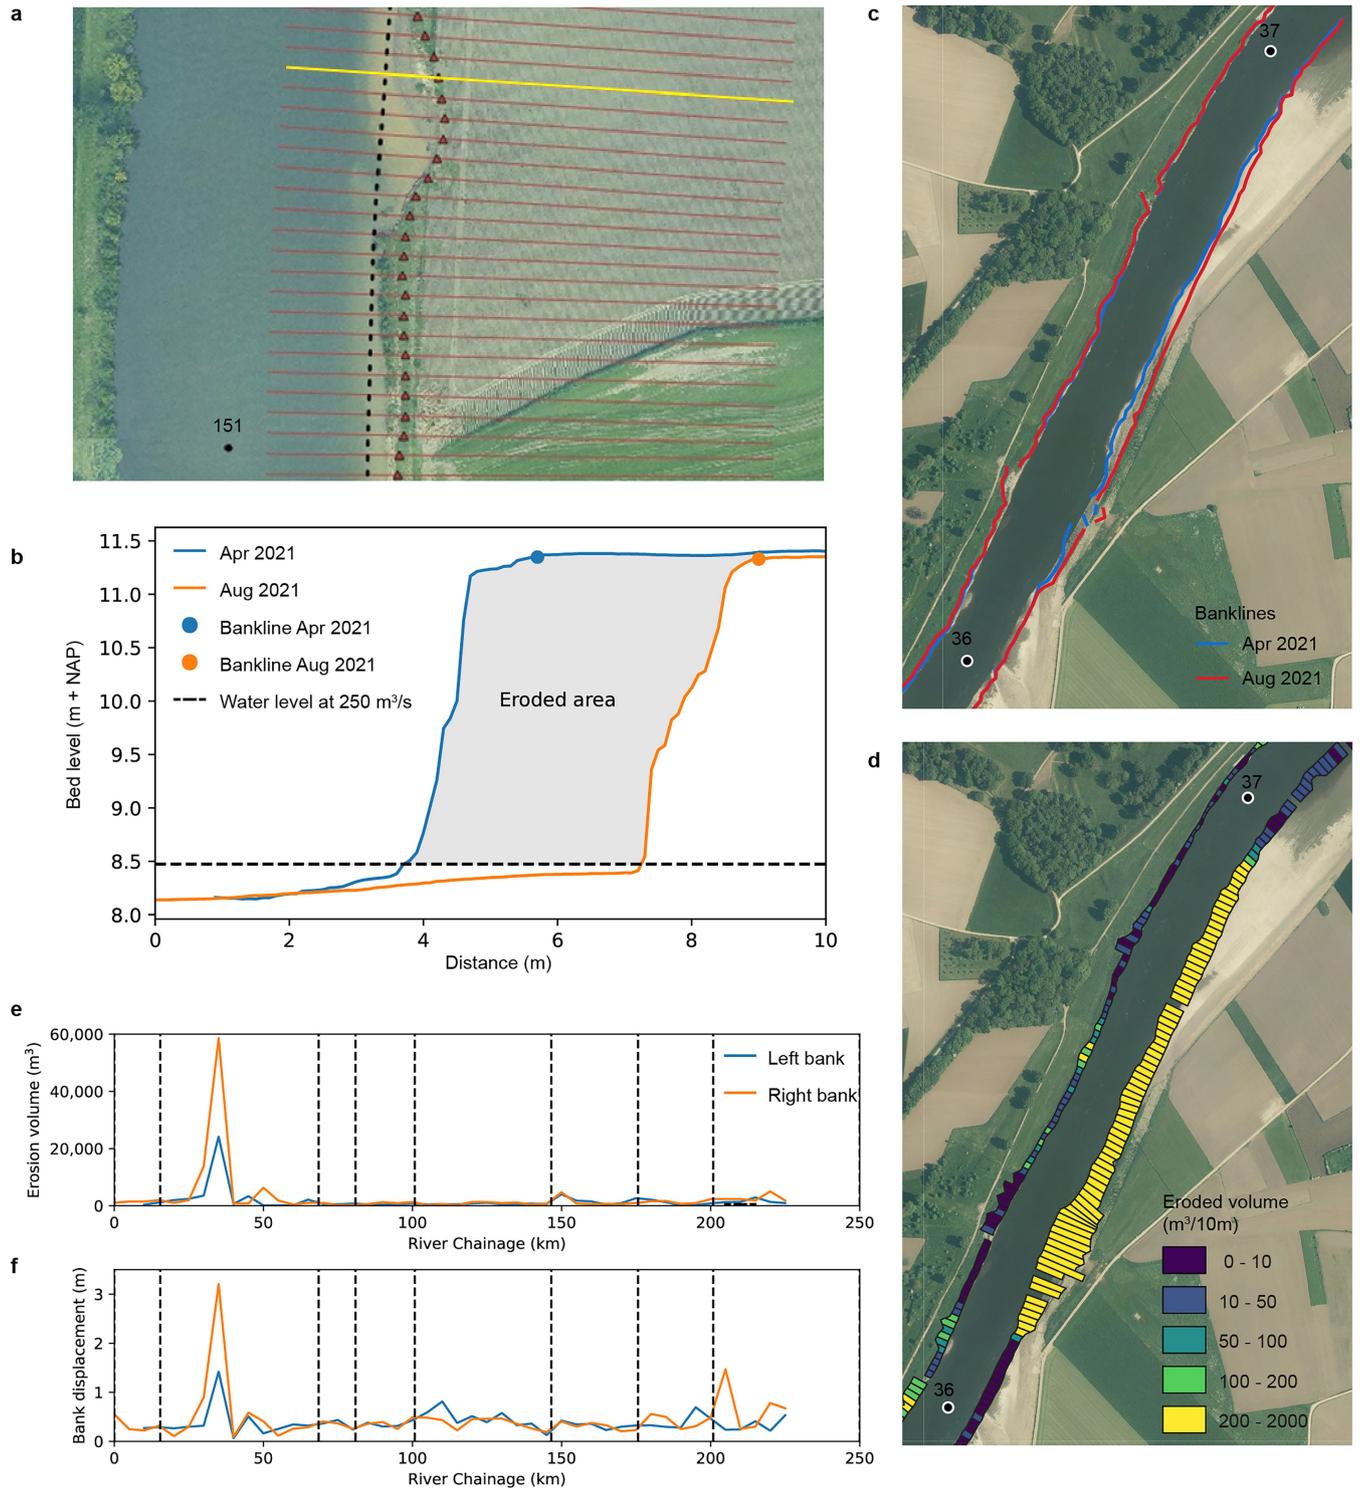
Extended Data Fig. 8 | Bank erosion assessment. **a**, Example cross-sections on the right bank near km 151 with estimated erosion line (red triangles). **b**, Cross-section at km 151.14 (yellow line in panel a) and eroded area based on cross-sectional profiles and impoundment level. **c**, Example erosion lines before (blue) and after (red) the flood. **d**, Matching erosion volumes per section of 10 m long (distance in flow direction). **e**, Erosion volume per 5 km river length at the left and right banks. Dotted black lines show the locations of 7 barrages in the river. **f**, Average bank displacement per 5 km river length at the left and right banks.

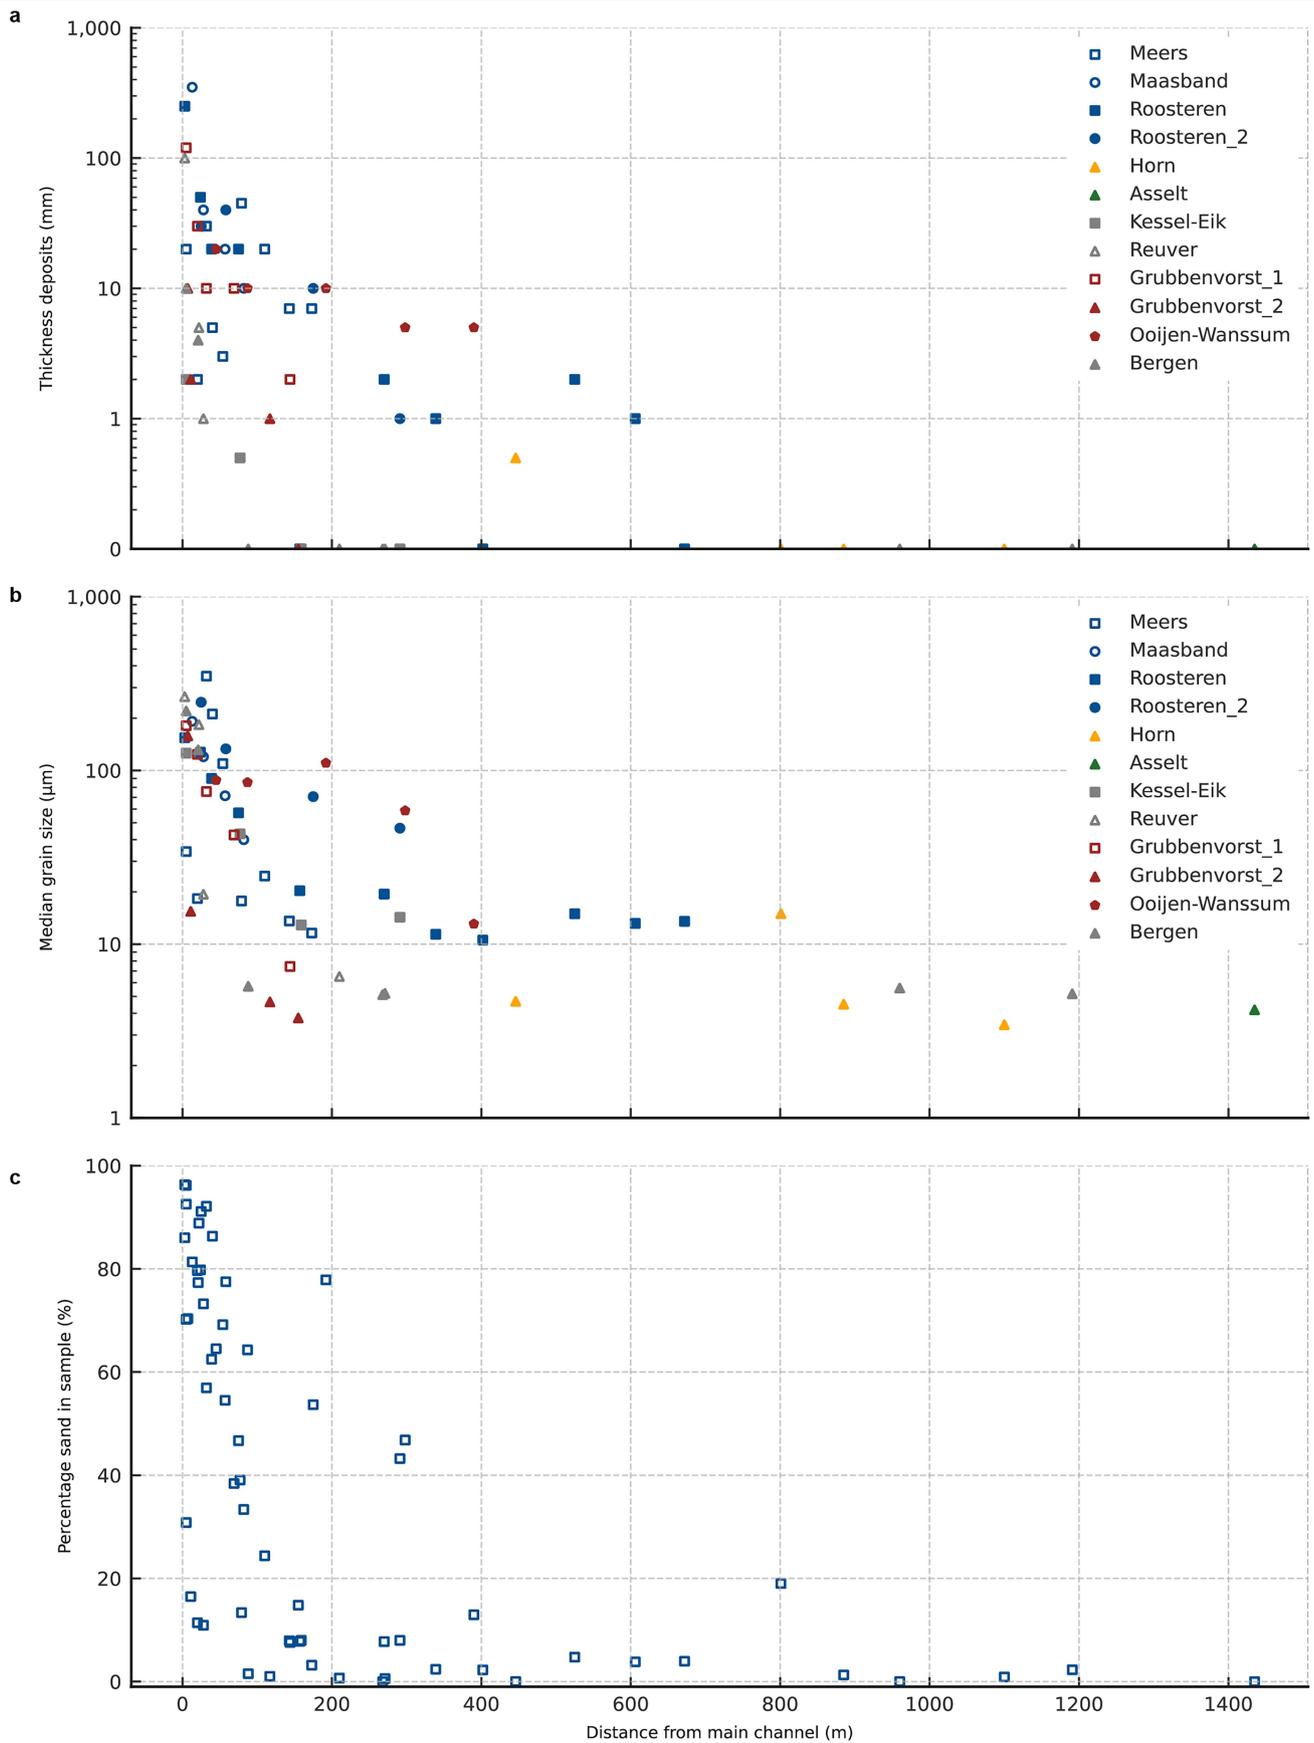
Extended Data Fig. 9 | Composition of samples in transverse direction from the main channel at 10 locations. a. Thickness of deposits. **b.** Median grain diameter of samples. In panels a and b, locations in the legend are sorted from

upstream to downstream. Square, circle and triangle markers indicate respectively inner bends, outer bends, and straight sections in samples.

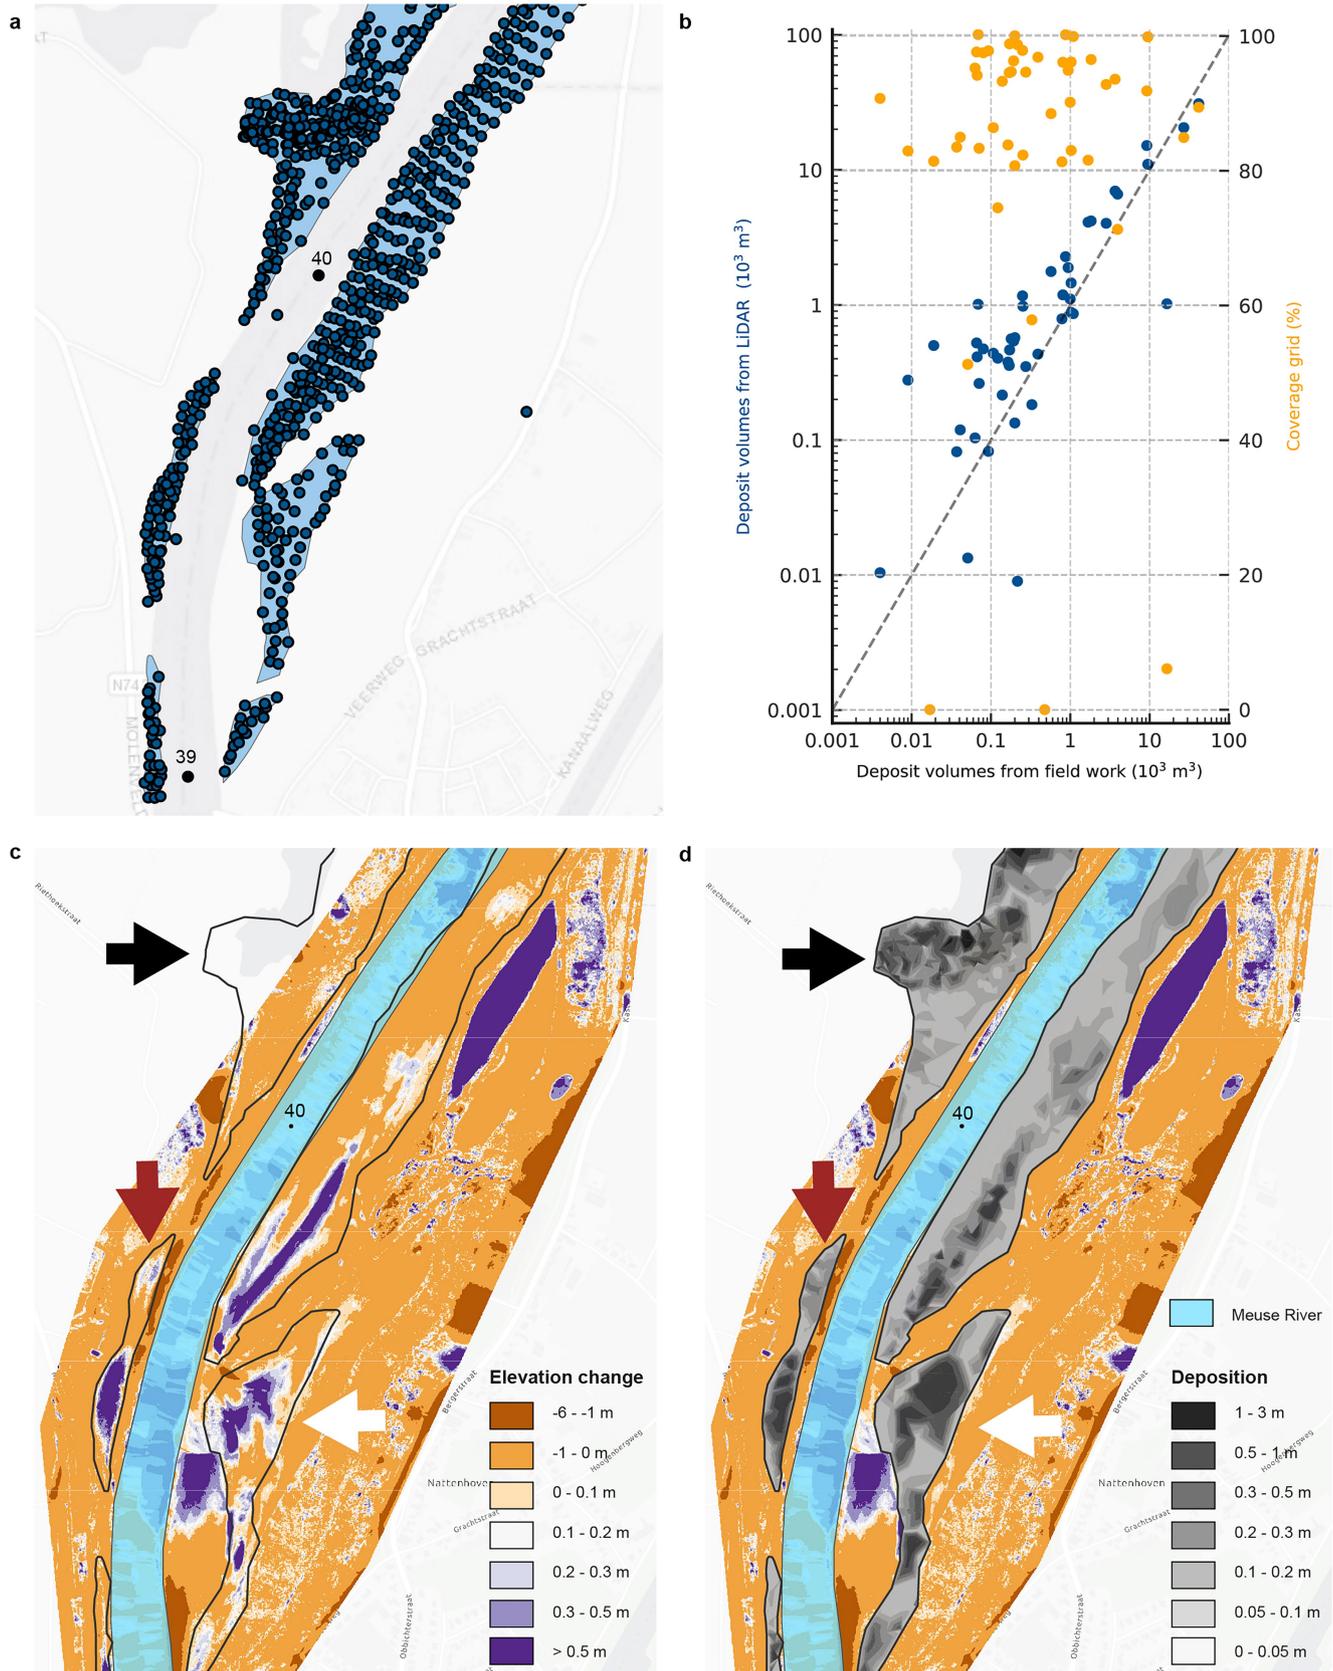
Extended Data Fig. 10 | See next page for caption.

Extended Data Fig. 10 | Deposit volumes from field sampling and LiDAR.
