# Extreme river flood exposes latent erosion risk

<https://doi.org/10.1038/s41586-025-09305-3>

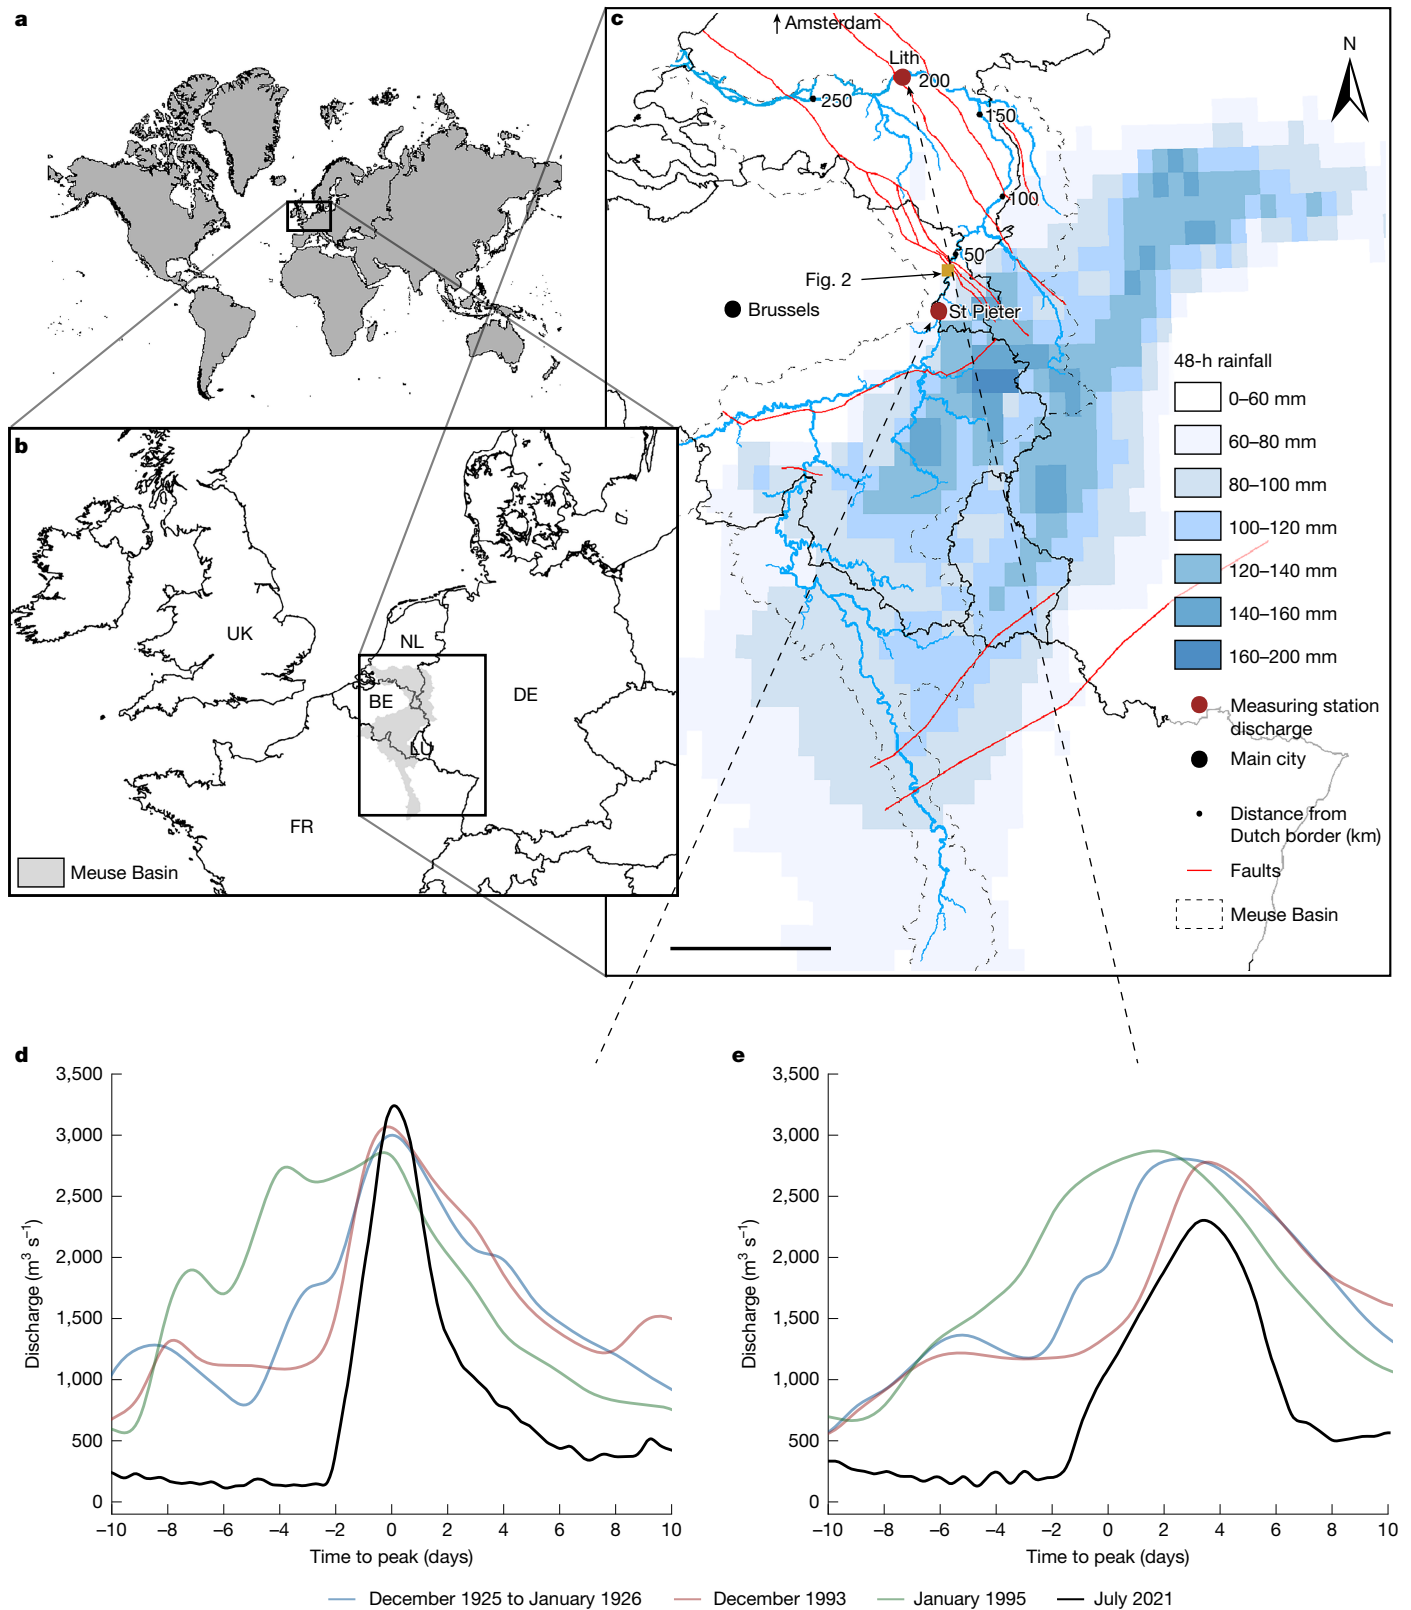
**Fig. 1 | The extreme 2021 summer flood in the Meuse Basin.** **a**, Location of Western Europe. **b**, Location of Meuse Basin. BE, Belgium; DE, Germany; FR, France; NL, the Netherlands. **c**, Meuse Basin with the cumulative 48-h rainfall on 13–14 July 2021 in millimetres, locally assessed as a 1,000-year event<sup>37</sup>. Numbers in the map show river kilometres from the Dutch border. Scale bar, 80 km.

**d**, Observed discharges at St Pieter, Maastricht, km 10.8, for floods in 1926, 1993, 1995 and 2021. **e**, Observed discharges at Lith, km 202.4, according to the moment of the peak at St Pieter, showing larger wave damping for the 2021 flood. Geographical details of the Dutch Meuse River, such as slope, incision trend and sediment composition, are presented in Extended Data Fig. 1a–d.

In July 2021, the stationary, cold-core low-pressure system Bernd developed over Western Europe, accompanied by an upper-level cold pool of air, attracting humid air<sup>37,38</sup> and causing extreme precipitation (Fig. 1a). A World Weather Attribution study<sup>37</sup> found this event to be consistent with the extremes expected in a warming climate, with human-induced climate change almost certainly increasing its likelihood and intensity. The resulting floods in tributaries of the rivers Rhine and Meuse killed approximately 240 people and caused more than US \$43 billion in damage<sup>10</sup>.

Within 2 days, the Meuse River discharge near Maastricht (the Netherlands) increased from less than  $50\text{ m}^3\text{ s}^{-1}$  to a peak of  $3,310\text{ m}^3\text{ s}^{-1}$ . The peak of the approximately 100-year flood<sup>39,40</sup> exceeded the three highest discharge peaks of the past century (Fig. 1d). In the steep Common Meuse, the flood wave travelled fast and relatively undistorted. Downstream, the more gentle, wider river valley and multiple large lakes damped and delayed the sharp-peaked 2021 flood more than the broader historical floods (Fig. 1d,e), conveying it as a 10- to 15-year flood to the downstream reach.

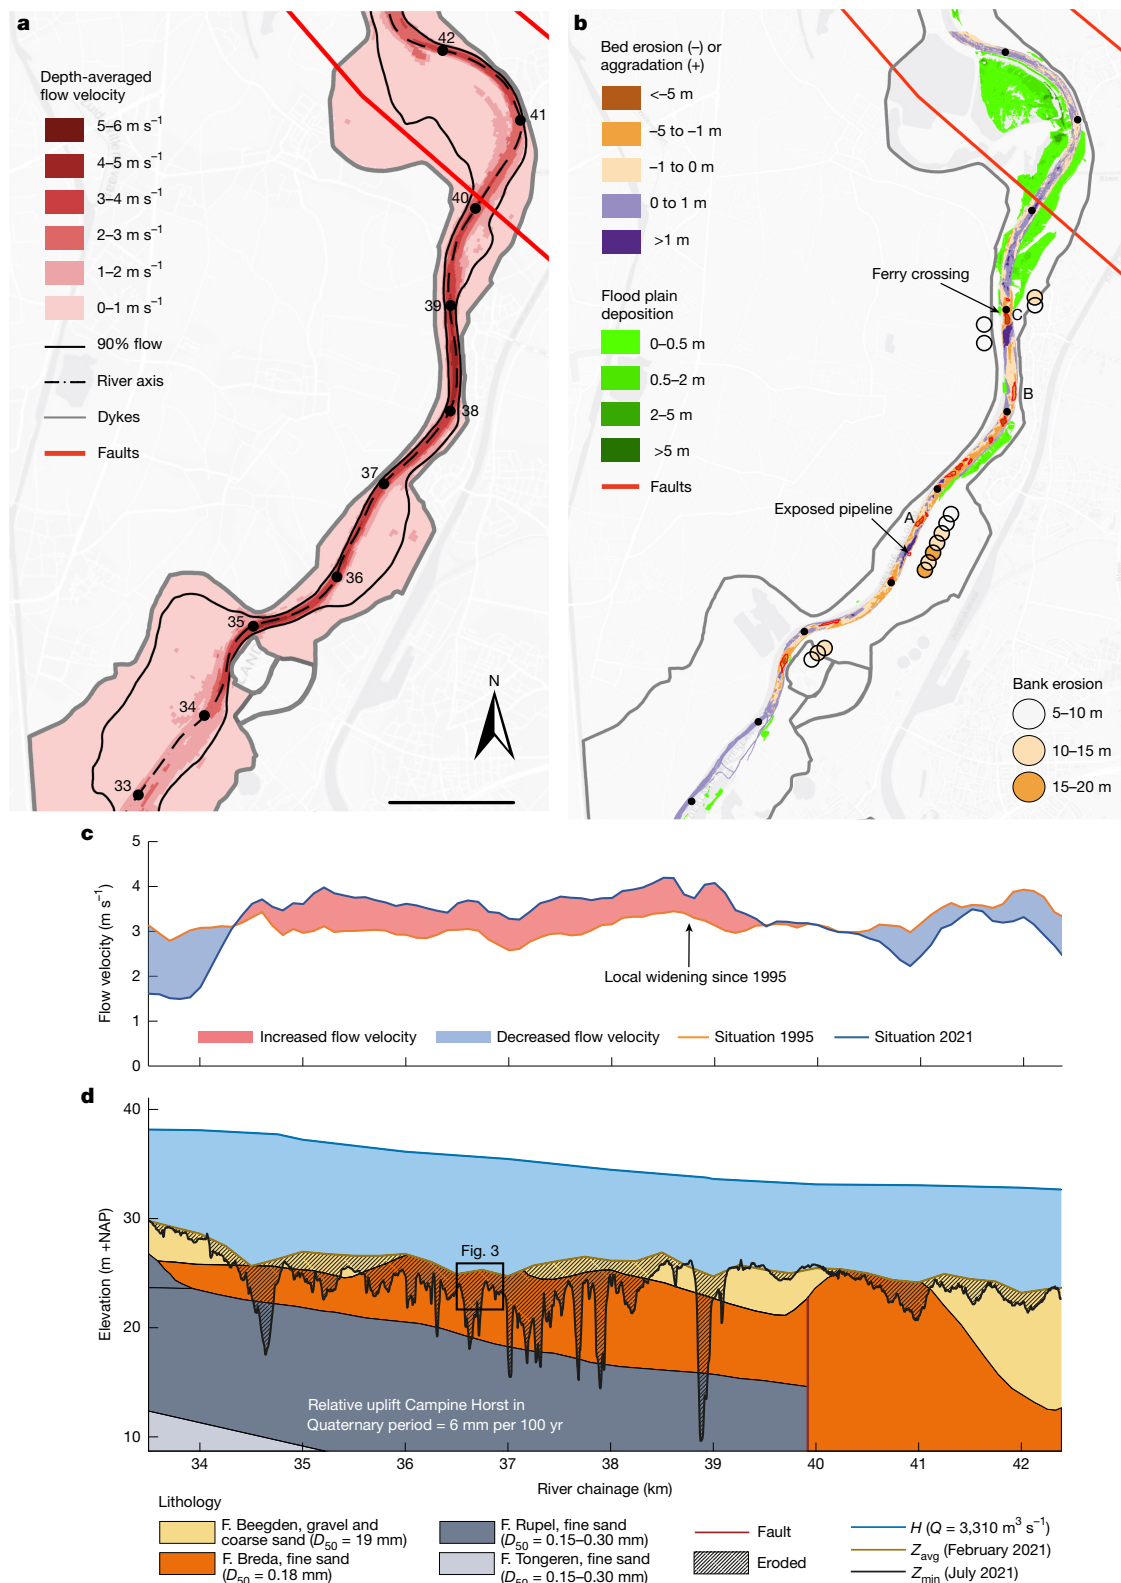
**Fig. 2 | Simulated flow conditions and observed erosion in the river reach with deep scours during the 2021 flood. a**, Simulated peak flow velocities and bounds of the area where 90% of the flow passes, revealing bottlenecks between km 35 and 39 (location indicated in Fig. 1c) due to uneven widening (Extended Data Fig. 2c). Scale bar, 1.3 km. **b**, Scour holes (red contours), bank erosion and floodplain deposits in the Common Meuse. Bed and bank scour appear to alternate (for example, along km 34.5–35.5, 36–37 and 38.5–39.2). Locations A–C refer to Fig. 3. Extended Data Figs. 4–6 provide erosion and deposition volumes and composition for the entire Dutch Meuse. **c**, Simulated maximum flow velocities and differences in the main channel, averaged over depth and 50 m

of width, for the river geometries in 1995 and 2021, showing acceleration in the bottleneck section (km 35–39), and velocity reduction in widened sections (upstream km 34, at km 38.7 and downstream km 40). **d**, Bed levels ( $Z$ ), erosion and water levels ( $H$ ) at the peak discharge ( $Q$ ) of 3,310 m<sup>3</sup> s<sup>-1</sup> in the reach of the Campine Horst. Levels relative to the Dutch reference level NAP. The deepest points (thalweg) in July 2021 are compared to the cross-section-averaged bed levels every 250 m in February 2021. Lithology with formations (F.) from Extended Data Fig. 2b. Despite the thin gravel layer at km 40–41, erosion is limited owing to reduced flow velocities in the widened section.  $D_{50}$ , median grain diameter.

During the flood, flow velocities locally exceeded  $5\text{ m s}^{-1}$  (Fig. 2a). Narrow sections experienced substantial riverbank erosion and riverbed deepening, damaging ferry landings and exposing crucial pipelines<sup>39</sup>. Chemical transport through the pipelines was halted, and extensive emergency repairs had to be carried out.

A bed level survey 3 days after the flood peak revealed 16 deep scour holes, 1 more than 15 m deep, in a 6-km-long, narrow section of the Common Meuse (Fig. 2b,d). The observed alternation of bank and riverbed erosion in Fig. 2b suggests that the weakest of those two determines which is more likely to erode. At the chemical pipeline, crossing near km 36.3, the riverbed was protected to prevent vertical erosion. However, the bank eroded laterally over more than 30 m, beyond the limits of the bed protection, and then scoured vertically, exposing the buried pipeline.

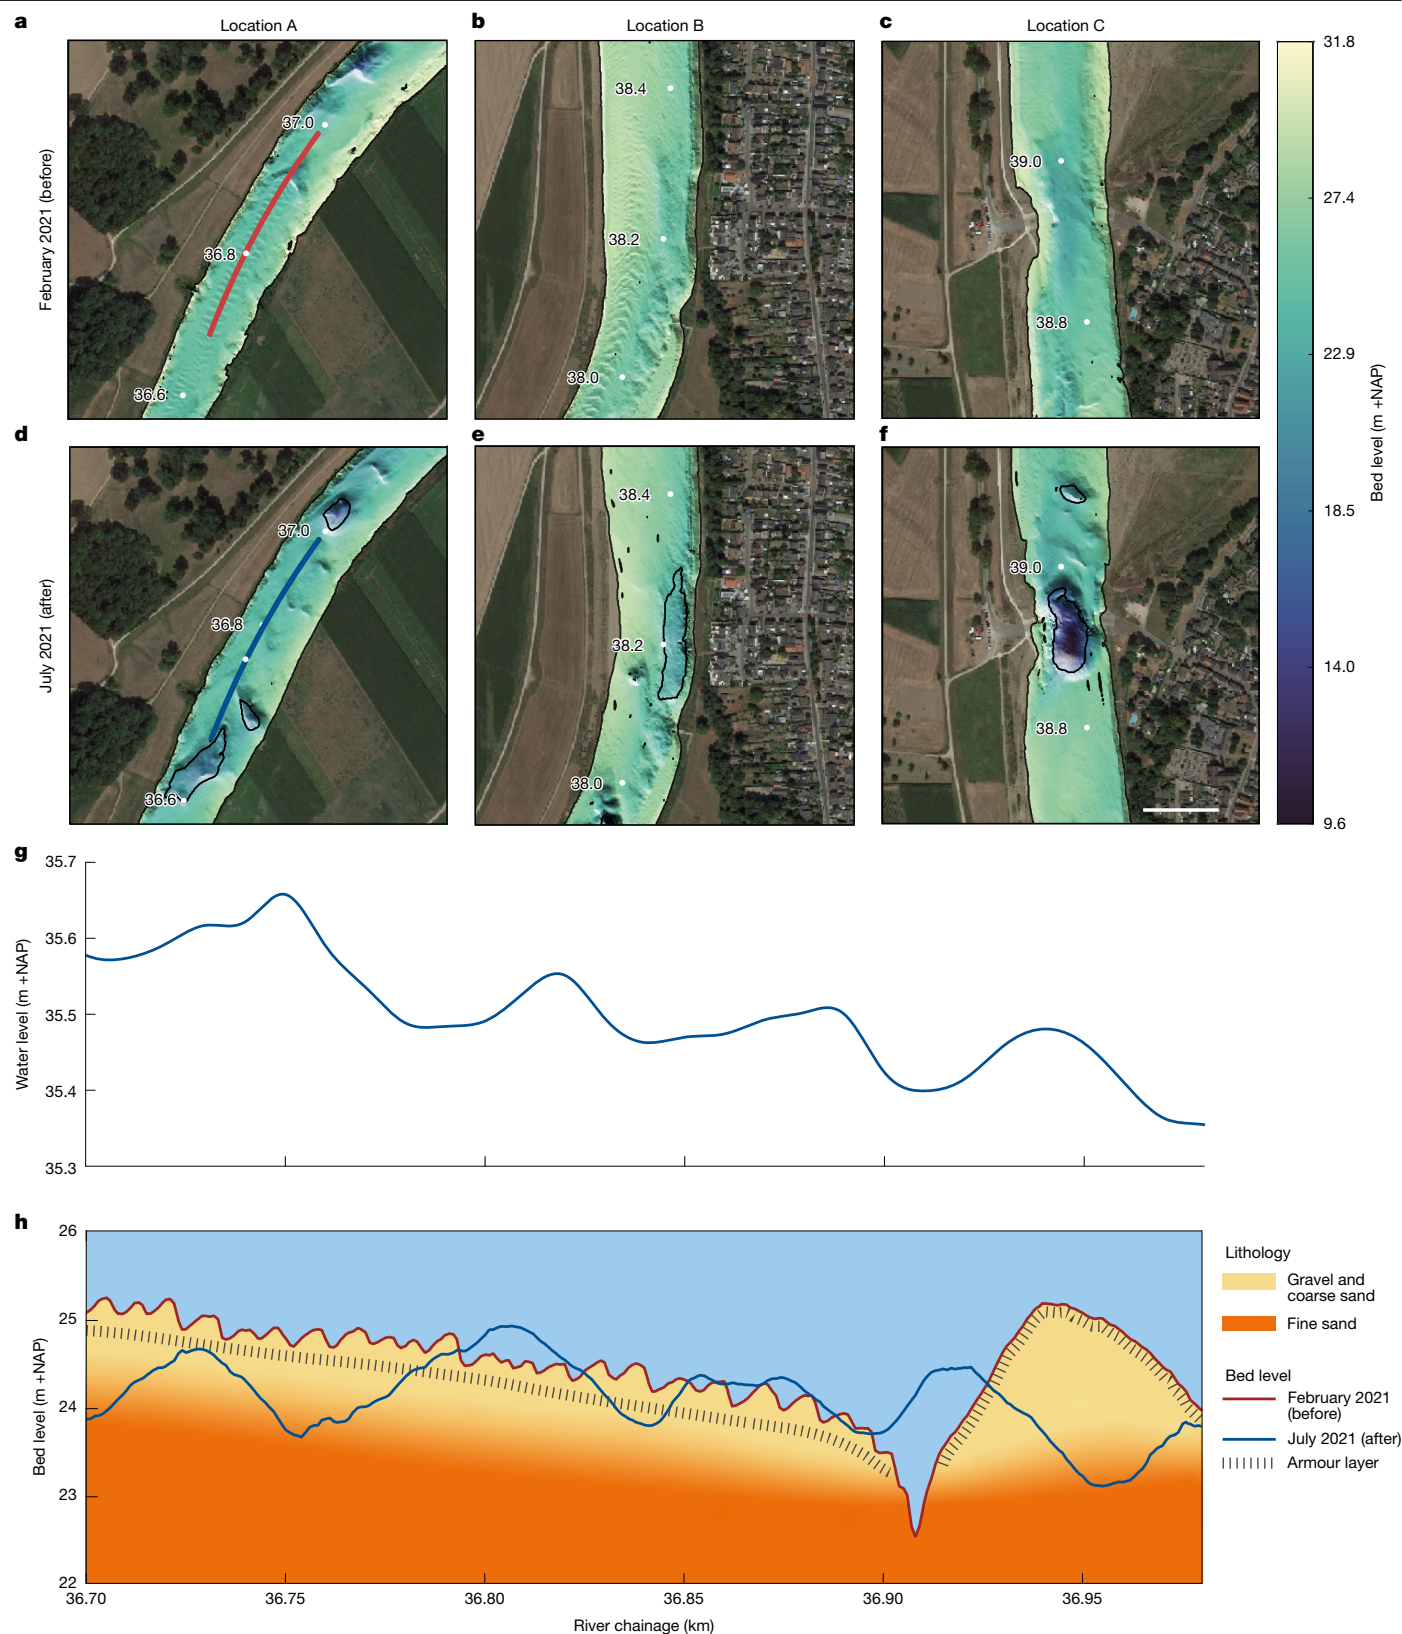
**Fig. 3 | Examples of riverbed erosion during the flood.** Illustrated by bed levels before (February 2021, maximum discharge  $1,300 \text{ m}^3 \text{ s}^{-1}$ ) and just after the July 2021 flood. **a,d**, Example of riverbed erosion due to dune development (location A in Fig. 2b), flow direction from bottom to top. **b,e**, Riverbed erosion in outer bend (km 38.2, B in Fig. 2b). **c,f**, Constriction scour in the narrow ferry crossing (km 38.9, C in Fig. 2b). Scale bar, 100 m. **g**, Water level profile from a

LiDAR flight on 16 July, showing the presence of dunes. **h**, Detail of Fig. 2d, observed bed level and sedimentological profile along the lines in **a,d**, showing small (February 2021) and large (19 July 2021) dunes. The shifts in peak locations of water level (**g**) and dune troughs (**h**) are due to dune propagation between the LiDAR and riverbed surveys. The gravel and coarse sand layer thickness was estimated using the geological profile in Extended Data Fig. 1b.

Hydrodynamic simulations for conditions mimicking the flood event underestimated peak water levels by up to 0.5 m in the reach with the scour holes<sup>39</sup>. Although dense summer vegetation, crops and thick floodplain deposits may explain part of this discrepancy, large riverbed dunes may have played a role as well. LiDAR water surface observations (Fig. 3g and Extended Data Fig. 2f), taken just after the flood peak, and the post-flood bathymetry (Fig. 3d,h) indicate that dunes of 1 m or higher occurred, which is much larger than the

approximately 0.2-m-high bedforms during normal floods (Fig. 3h, February 2021 bed). We calculated that energy losses due to the development of large dunes in the main channel could have raised the peak water levels by up to 0.25 m.

The formation of a flow conveyance bottleneck due to uneven widening was the most likely cause of the formation of deep scours, which was exacerbated by the local geologic structure, bedforms that broke through the top gravel layer, and other local factors, including natural deepening at river bend pools (Fig. 3b,e) and the main channel constriction (Fig. 3c,f).

Gravel dunes have previously been described<sup>45,61</sup>. We calculated dune dimensions during the flood using the sand dune predictor of ref. 62, adopting a water depth  $h$  of 8 m, a bed slope  $l$  of  $5 \times 10^{-4}$ , a median grain diameter  $D_{50}$  of 0.025 m (based on Extended Data Fig. 1c) and a value of 0.045 for  $\tau^*$ , the critical Shields number for entrainment in gravel mixtures<sup>61</sup>. The calculated dimensions agreed well with the observed dune height of 1–2 m and length of 50–90 m (Fig. 3h), despite the application

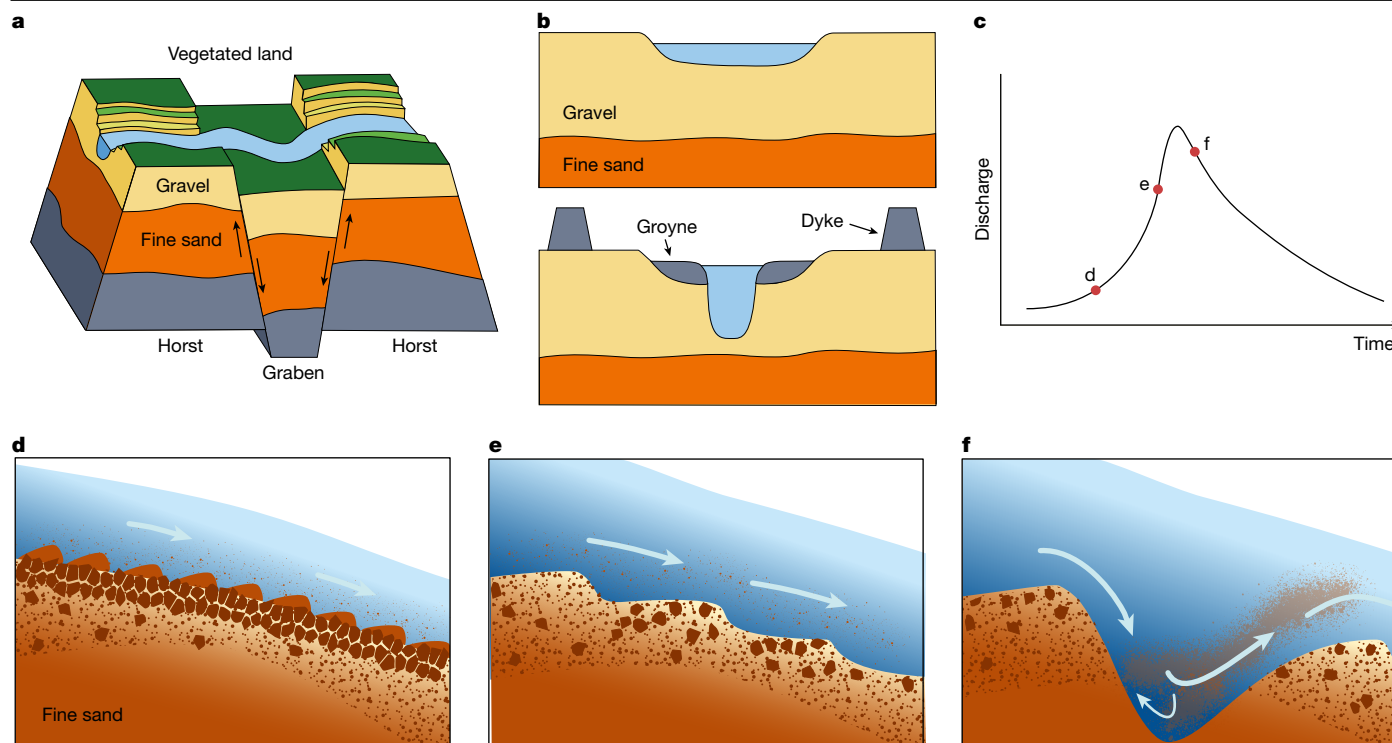
**Fig. 4 | Long- and short-term processes that contribute to sudden scour hole formation.** **a**, Geological timescale, with typical uplift and subsidence rates of horsts and grabens up to centimetres per century; rivers incise into horsts. **b**, Engineering timescale in which natural rivers (upper panel) are engineered (lower panel) and sediment transport is modified, leading to incision rates up to centimetres per year. **c**, Event timescale during which flow conditions change rapidly and erosion and deposition processes develop fast; labels d, e and f

along the plot line refer to moments of the processes in panels **d**, **e** and **f**, respectively. **d**, Armoured bed with increasing suspended load from upstream and developed small sand dunes. Underneath the armour, a thin mixture of gravel and sand overlays a thick layer of fine sand. **e**, Increased flow disrupting the armour and forming gravel dunes. **f**, Rapid development of scour hole in fine sands<sup>58,59</sup>.

Heterogeneity of the subsurface stratum and recent uneven widening explain the occurrence of extreme scour in the Common Meuse (Fig. 4). Similar scour holes have been reported in the Mekong<sup>48</sup>, Mississippi<sup>49</sup>, Saskatchewan<sup>50</sup>, Mahakam<sup>51</sup>, Tisza<sup>41</sup>, Petit Rhône<sup>13</sup>, Rhine<sup>52</sup> and Salzach (tributary to Danube)<sup>53</sup> rivers, as well as in the Mackenzie<sup>54</sup> and Rhine–Meuse<sup>22,55</sup> deltas. In 8 out of 11 reported cases, scouring is linked to human interference or excessive sediment mining. In 8 cases, the scours are linked to subsurface sediment heterogeneity (Extended Data Fig. 7), which results from tectonics and, possibly, glaciation,

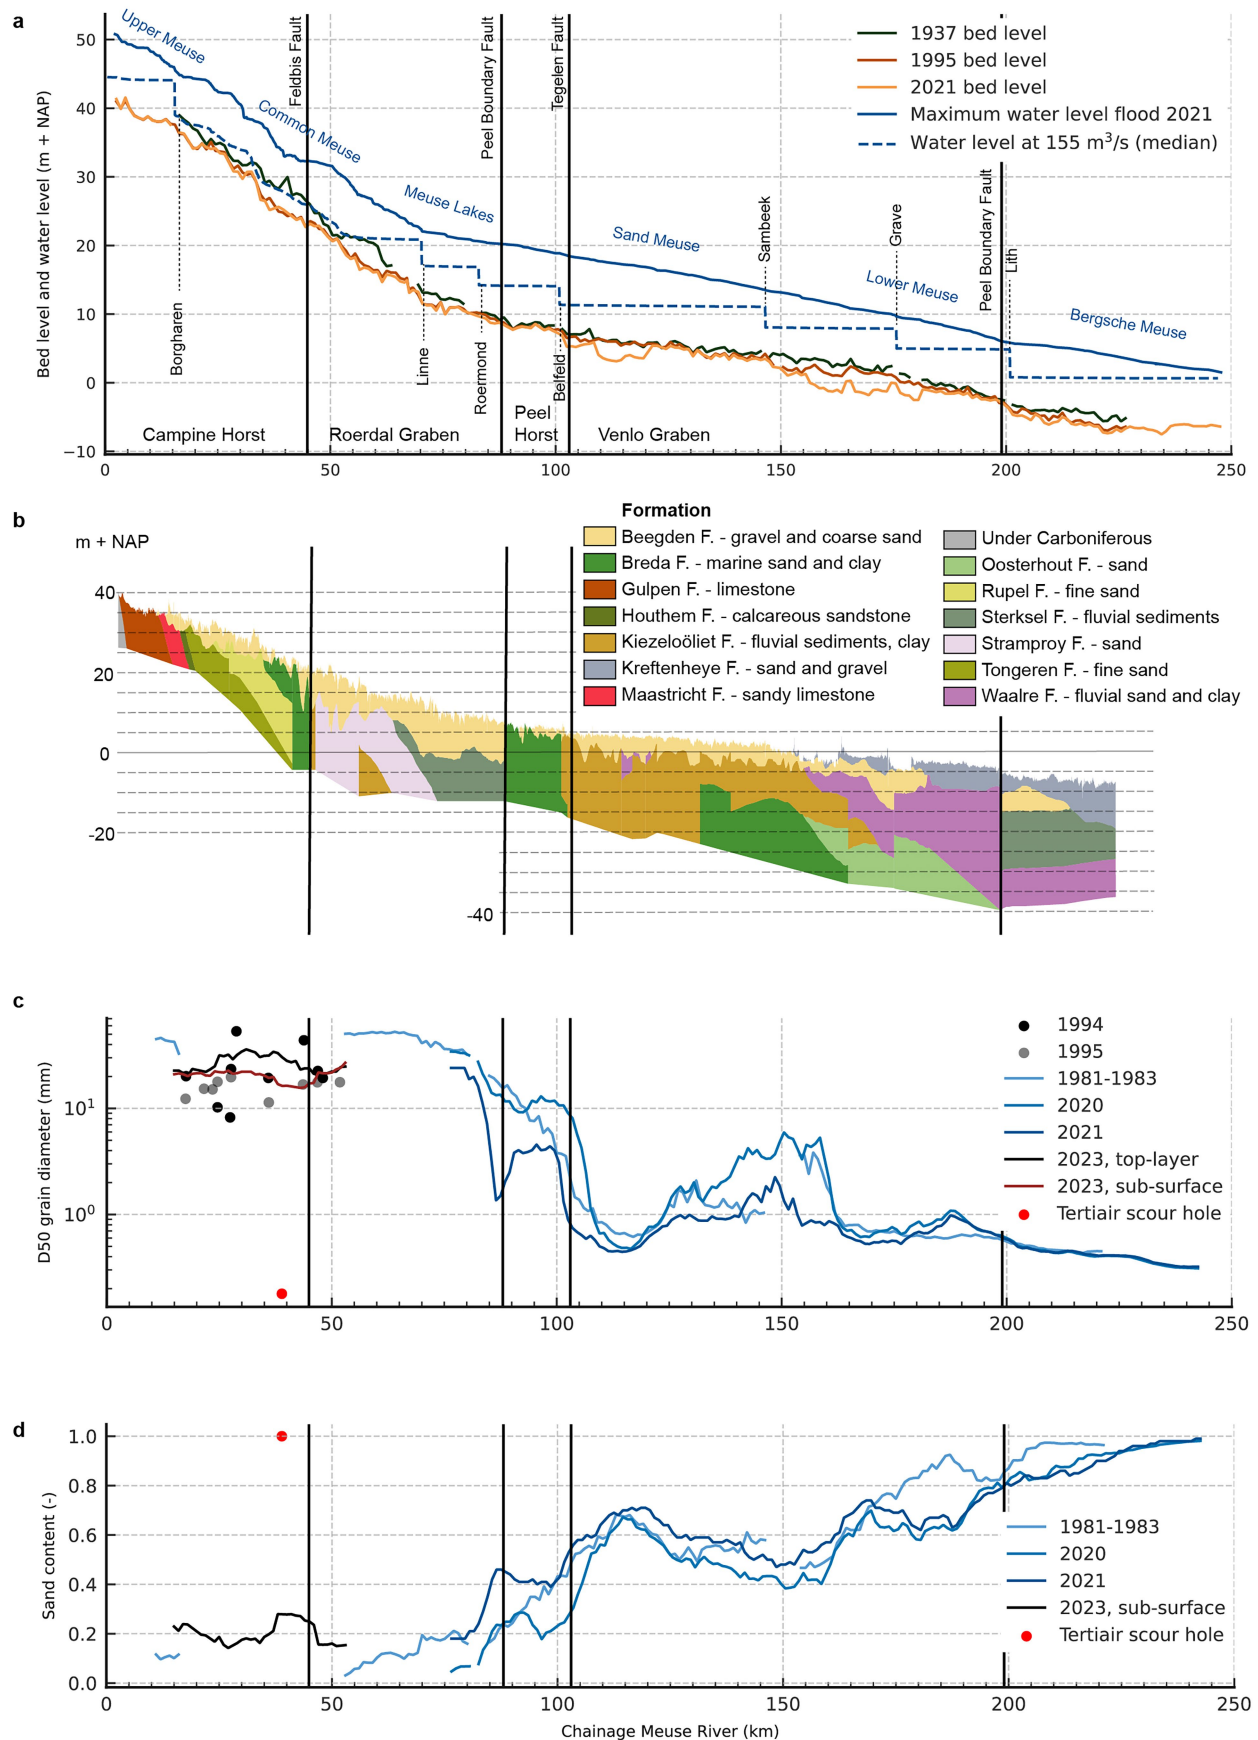
Extended Data Fig. 1 | See next page for caption.

**Extended Data Fig. 1 | Geology, bed profile development and riverbed composition of the Meuse River.** **a**, Longitudinal bed level profiles in 1937, 1995 and 2021 averaged over 1 km (yearly survey Rijkswaterstaat), peak water level profile July 2021 (Rijkswaterstaat) and locations of faults (vertical lines), graben and blocks<sup>75</sup>. The riverbed incises due to barrages, narrowing, bank protection, bend cut-offs and sediment extraction. **b**, Geological profile based on drillings in banks and floodplains, indicating gravel in yellow<sup>76</sup>. The Campine Horst rises approximately 6 mm/100 yr<sup>34</sup>, relative to the slowly subsiding Roerdal Graben, explaining that, over millions of years, the incision thinned the gravel layer in the Campine Horst. The green colours underneath the gravel layer in the reach km

20-40 indicate fine marine sands from the Miocene (23-5 million B.P.), Rupelian (34-28 million years B.P.) or Late Eocene/Early Oligocene (37-30 million years B.P.). **c**, Characteristic grain size diameter  $D_{50}$  from riverbed top layer (10 cm) and development in time (data Rijkswaterstaat). Data from 1981–1983, 2020 and 2021 (after the flood) are based on samples every 500 m; lines show a moving average over 10 km. **d**, Sand content top-layer in time (data Rijkswaterstaat), as a moving average over 10 km. The composition and location of the gravel-sand transition in the reach km 90–105 remained stable over the past 50 years. In parts of the Meuse River with a gravel bed, an armour layer on the riverbed is formed outside periods of high flows.

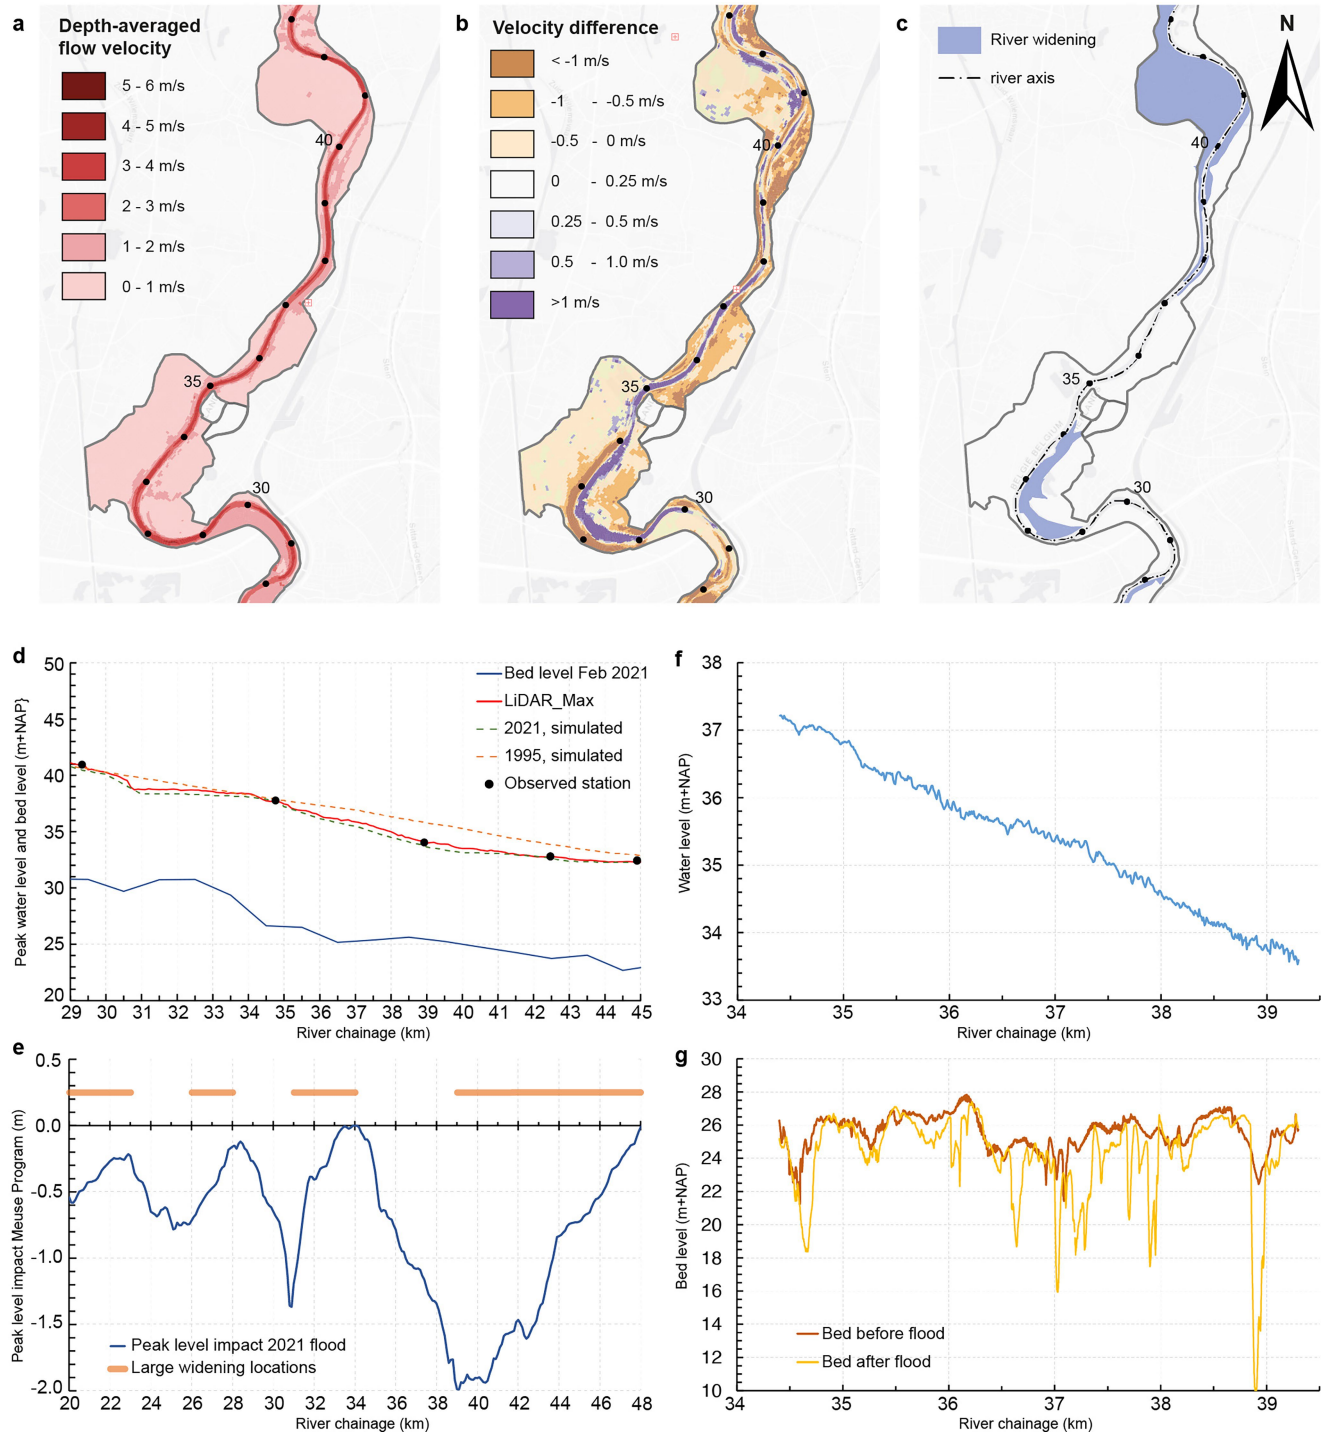
**Extended Data Fig. 2 | Hydrodynamic simulations and observations of the peak event.** **a**, Depth-averaged maximum flow velocities in simulations with the river geometry from 1995 (before Meuse Program), obtained with the 2-dimensional Delft3D-FM model and the 2021 flood discharge as boundary condition. **b**, Difference in maximum flow velocity for the same discharge wave in simulations adopting the river geometry of 2021 before the flood, revealing much higher peak velocities in the main channel of reach km 34–39. **c**, Meuse Program measures implemented up to 2021 in reach km 34–39. **d**, Predicted (based on 2-dimensional WAQUA-simulations) and observed peak water levels at gauging stations and from the LiDAR-campaign (source Rijkswaterstaat). River widening has drawn down water levels in the narrow reach at km 34–40,

increasing the flow velocities there (panel b). 2021 predicted water levels underestimate measured water levels by up to 0.5 m<sup>39</sup>. **e**, Impact of the Meuse Program river widening on peak water levels under 2021 discharge conditions. The flood level lowering varies strongly along the river, reducing to zero where the river was not widened over several kilometers. **f**, LiDAR based water levels along the river axis, 15 h after the peak passed. The regular water level fluctuations between the scours indicate the presence of dunes. **g**, bed level along the river axis (horizontal scale identical to panel f) in February 2021 (Bed before flood) and July 2021, 3 days after the flood peak. The scour holes and large dunes in between them are clearly visible after the flood.

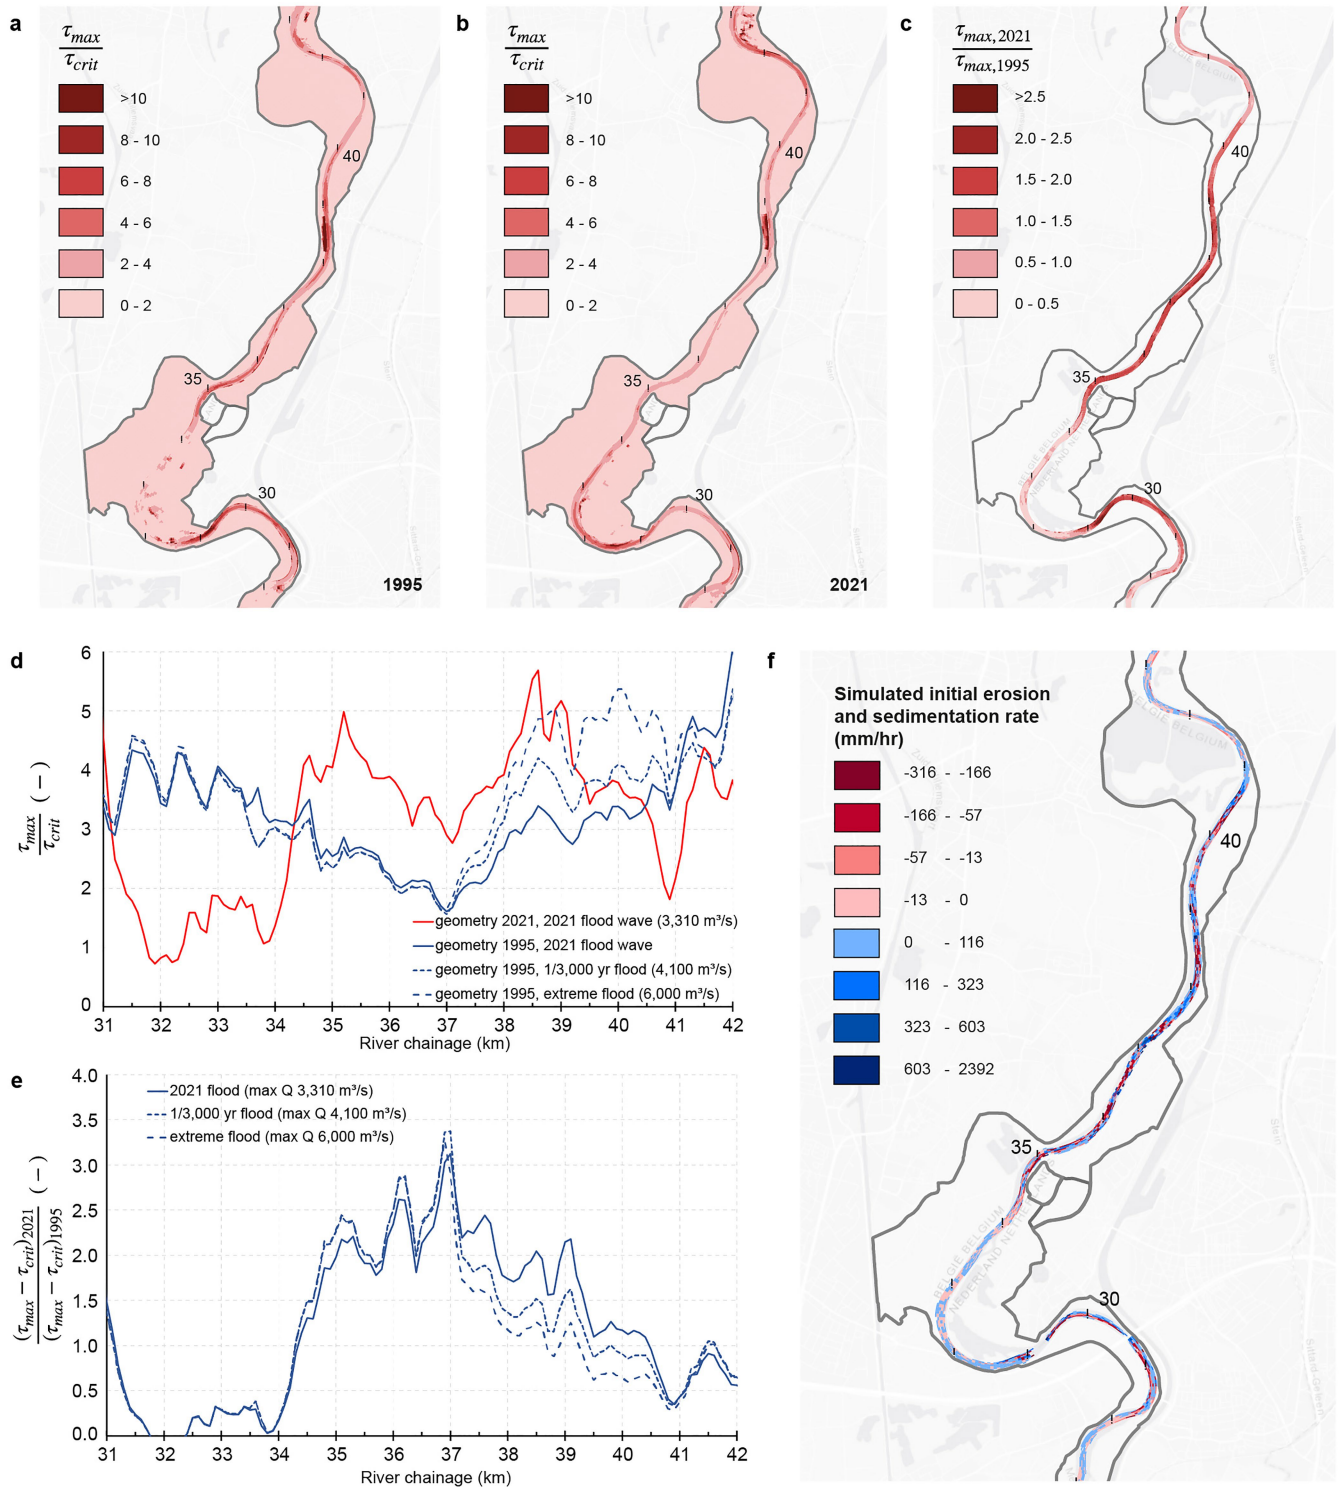
**Extended Data Fig. 3 | Bed shear stress variation and sediment transport capacity in 2021 and 1995.** **a.** Ratio of simulated maximum to critical shear stress in the 1995 geometry (before widening) under 2021 flood conditions. **b.** Same as (a), yet adopting the 2021 river geometry, before the flood. **c.** Ratio of simulated maximum shear stress in 2021 and 1995 geometries in the main channel, adopting 2021 flood event discharge time series. **d.** Ratios of panel a. and b. projected on the river axis (average value in a 50 m circle). The ratio of maximum to critical shear stress is plotted for a 1/3000 per year flood event (peak discharge 4,100 m<sup>3</sup>/s) and an extreme 6,000 m<sup>3</sup>/s flood event, if these would have taken place in 1995. Even for more extreme flood events in the 1995 geometry, shear stresses are predominantly lower than during the 2021 flood event (T = 100 yr). **e.** Ratios of sediment transport capacity in 2021 and 1995

based on simulated bed shear stresses, adopting the Meyer-Peter and Müller (MPM) transport formula which relates sediment transport capacity to exceedance of critical shear stress to the power 1.5<sup>77</sup>. Values > 1 indicate that the mobility of the top sediment layer in 2021 was larger than in 1995 for similar or even more extreme flood events. The sharp increase and peaks in the sections km 34.5–35, 35.5–36, 36.5–37, 37.5–38, 38.5 and 39 correspond to the locations of the 2021 scours (Fig. 2b and d). **f.** Initial erosion and deposition rates based on a simulation with the steady peak discharge of 2021, top layer grain diameters (monitoring campaign 2023), adopting the MPM transport predictor with hiding and exposure<sup>73</sup>, and no morphological changes. The locations with large initial erosion (bright red) correspond well to the scour locations (Fig. 2b).

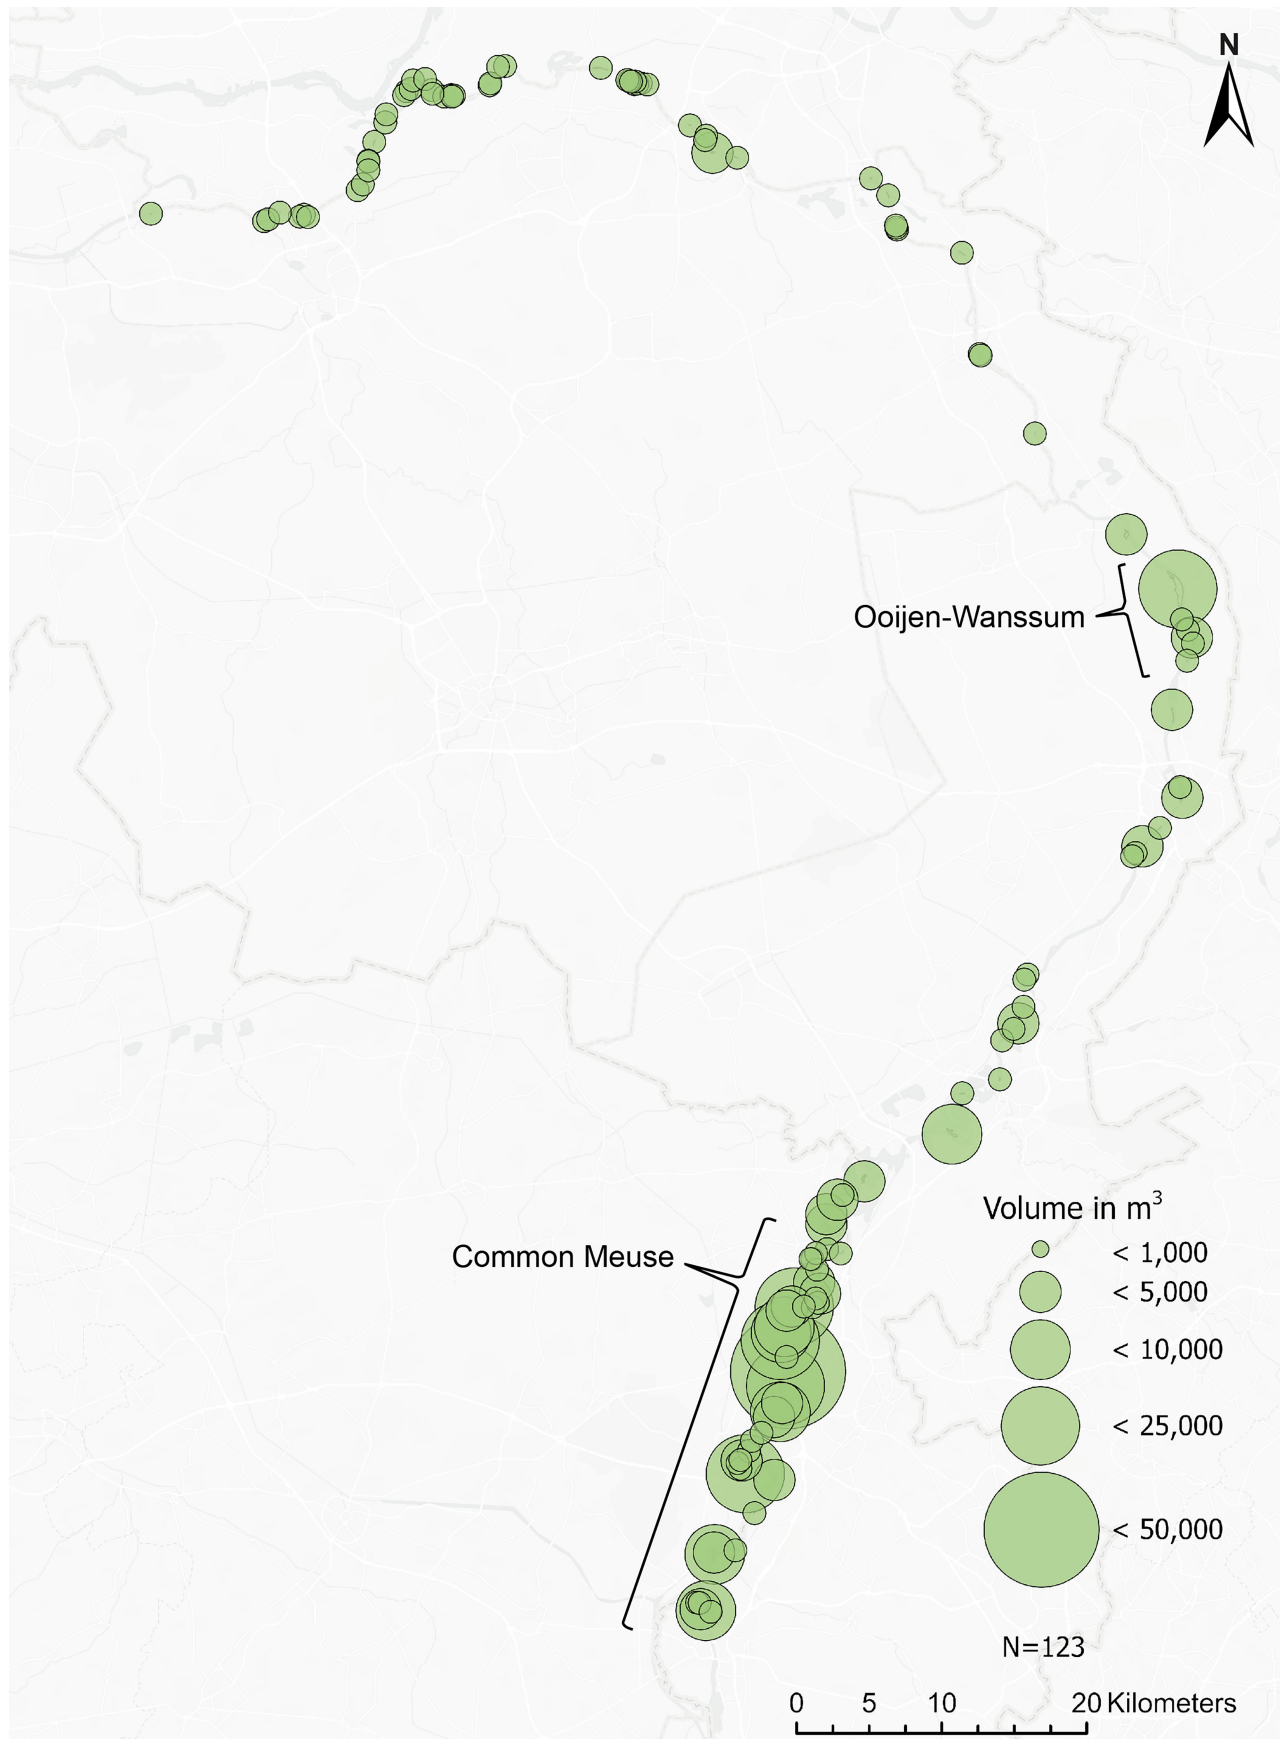
**Extended Data Fig. 4 | Sand volumes of deposits during the July 2021 flood based on field measurements and LiDAR data.** The 89 fieldwork floodplains contained 123 deposition areas. The largest deposits occurred in the Common Meuse and in the Ooijen-Wanssum trajectory, where a large river widening

project was completed in 2020. Sand deposits were predominantly found close to the river, particularly on inner bend overbank zones (67%), consistent with typical floodplain deposition patterns<sup>78</sup>.

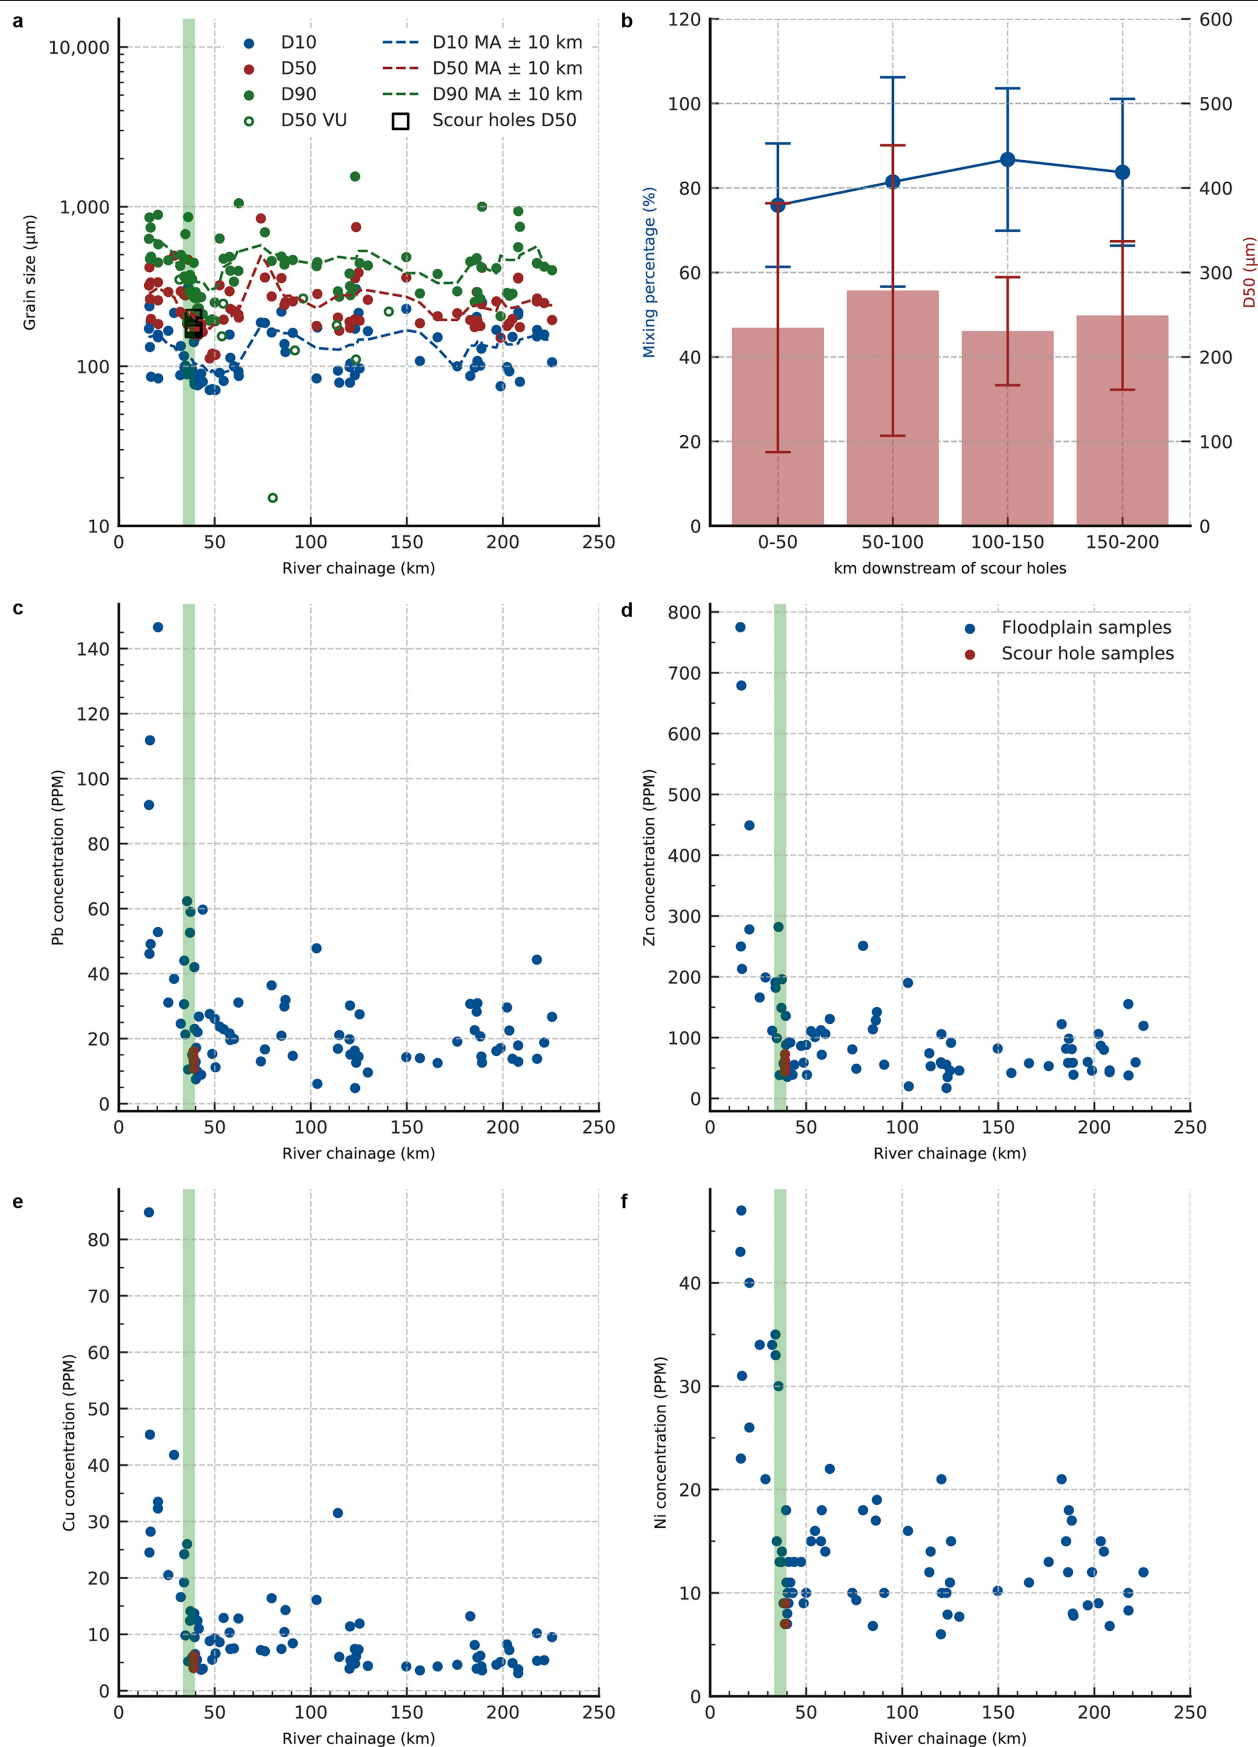
**Extended Data Fig. 5** | See next page for caption.

**Extended Data Fig. 5 | Sand deposit characteristics.** **a**, Grain size distribution metrics for proximal zone floodplain deposits (mixed samples, see Methods) with moving average values.  $D_{50}$  values for samples from one scour hole (□) and near-river samples (○, “D50 VU” from Extended Data Fig. 9) are added for comparison. In a 20 km section downstream of the scour holes, deposits contain only fine sediment. **b**, Average mixing percentages and average  $D_{50}$  grain size of floodplain samples, including the standard deviations, for sections of 50 km downstream of the scour holes, showing no significant trend in composition for downstream reaches. **c-f**, Concentrations of Pb, Zn, Cu and Ni in sediment samples from XRF analyses. Green bars indicate the scour hole section in the river; scour hole samples were taken at km 39, in the most downstream scour hole. Low concentrations in the scour holes show eroded Neogene sediments (23-5 million B.P.) to be uncontaminated, upstream deposits to be of more recent origin and the Neogene sediments to be deposited on downstream floodplains. Panels b-f are based on Van der Niet<sup>79</sup>.

The depths of the scour holes locally reached 200% of the flow depth, and were similar to scours in other rivers<sup>41,42</sup>. Nearly  $500,000\text{ m}^3$  of sediment was eroded from the riverbed (90%) and banks (10%) of the Common Meuse, exceeding the estimated average annual flux of sand and gravel tenfold (ref. 43). Fine-grained marine sands of Neogene age eroded from the scour holes. Fieldwork and laser altimetry (LiDAR) showed that 50% of this material was deposited on the floodplains and in lakes within 5 km of the last scour hole, locally over 3 m thick (Fig. 2b). An additional 30% of the eroded sand was deposited within the next 25 km. The remaining 20% travelled downstream in suspension, deposited on the floodplains further downstream, as was substantiated by the granulometric composition and chemical properties of floodplain deposits (Extended Data Fig. 5).
