# Extreme river flood exposes latent erosion risk

<https://doi.org/10.1038/s41586-025-09305-3>

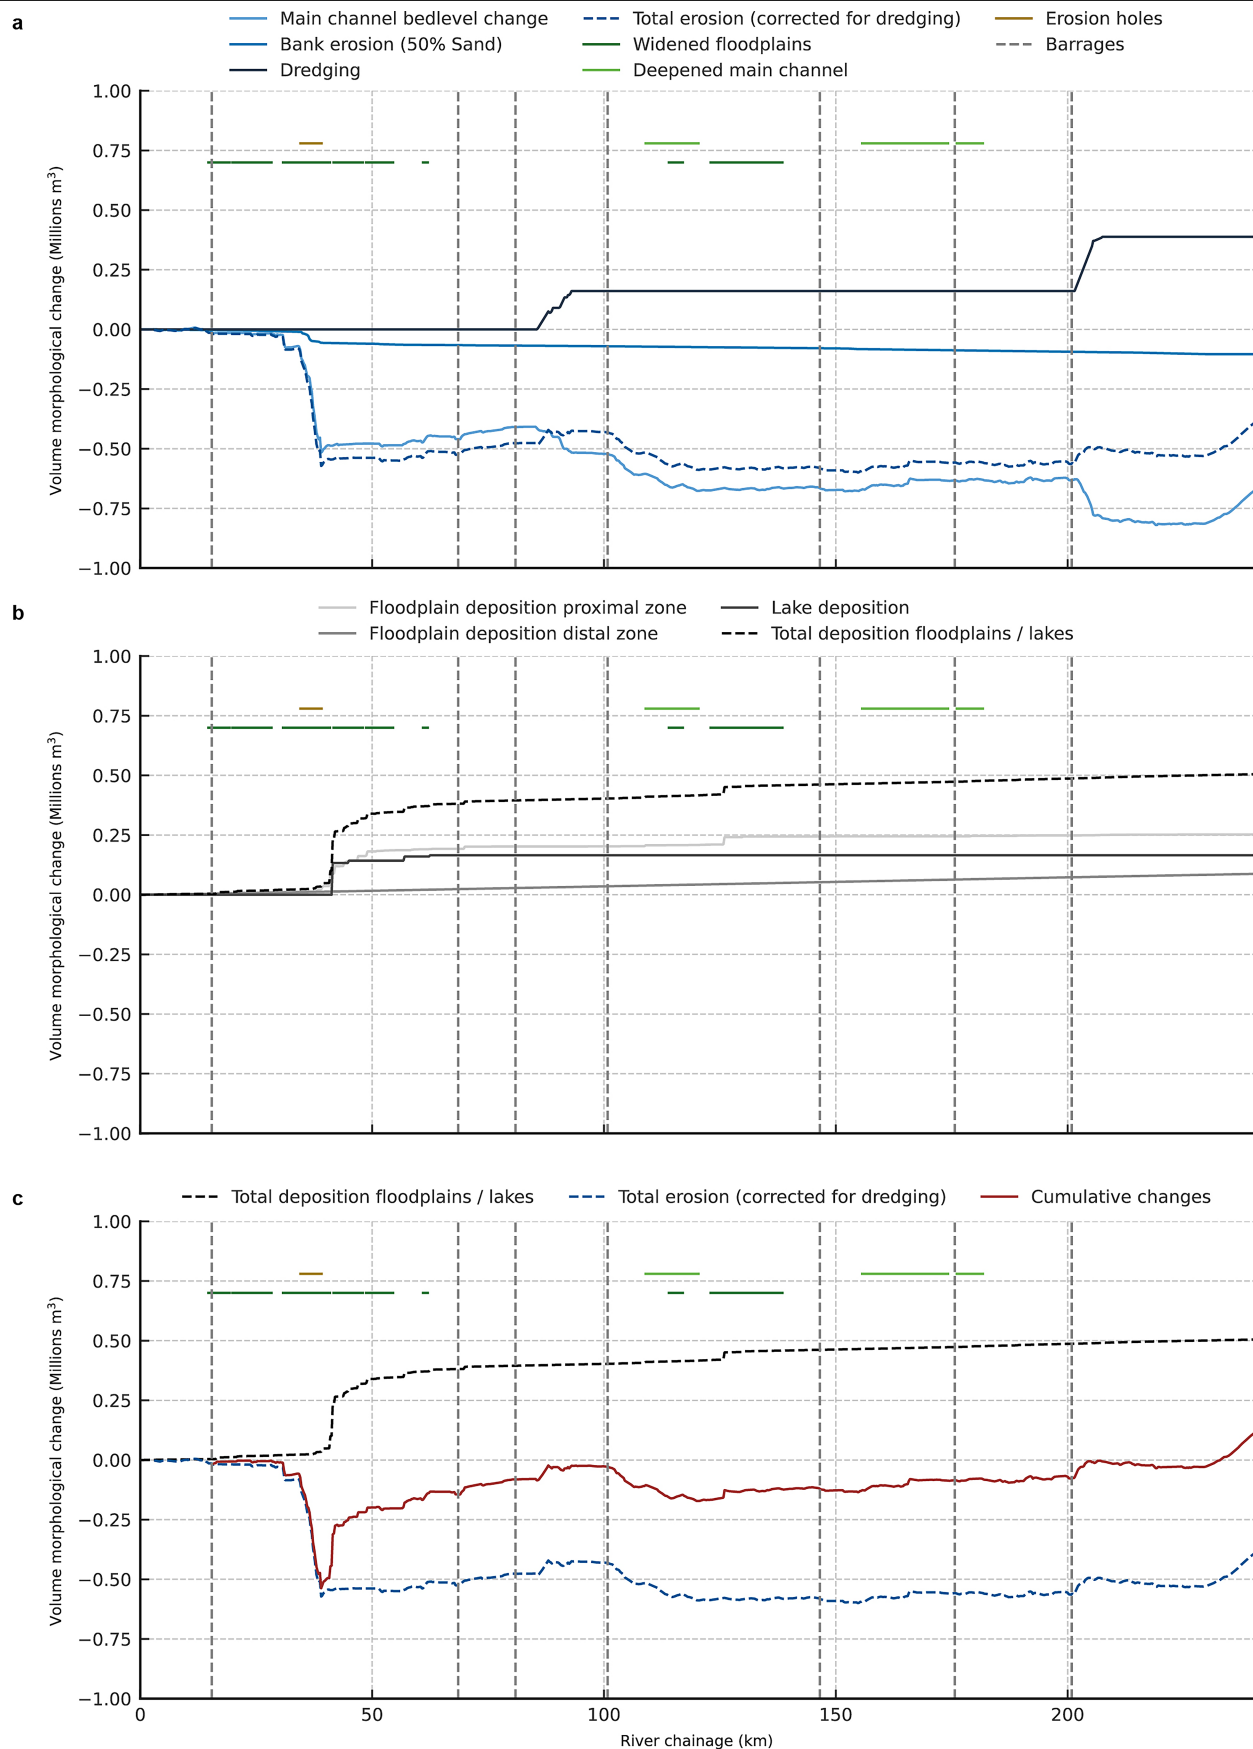
**Extended Data Fig. 6** | See next page for caption.

**Extended Data Fig. 6 | Cumulative Erosion and Deposition Volumes along the Meuse River.** **a**, Erosion based on riverbed level information from February and July 2021, LiDAR data from April and August 2021 (for bank erosion), and dredged volumes between February and July 2021 (data Rijkswaterstaat). **b**, Deposition of sand on floodplains (field work and LiDAR) and in several main lakes (multi beam measurements). **c**, Cumulative changes based on information in panels a and b, showing that 50% of the sand eroded from the scour holes was deposited within 5 km downstream of the last scour hole and an additional 30% in the succeeding 25 km.

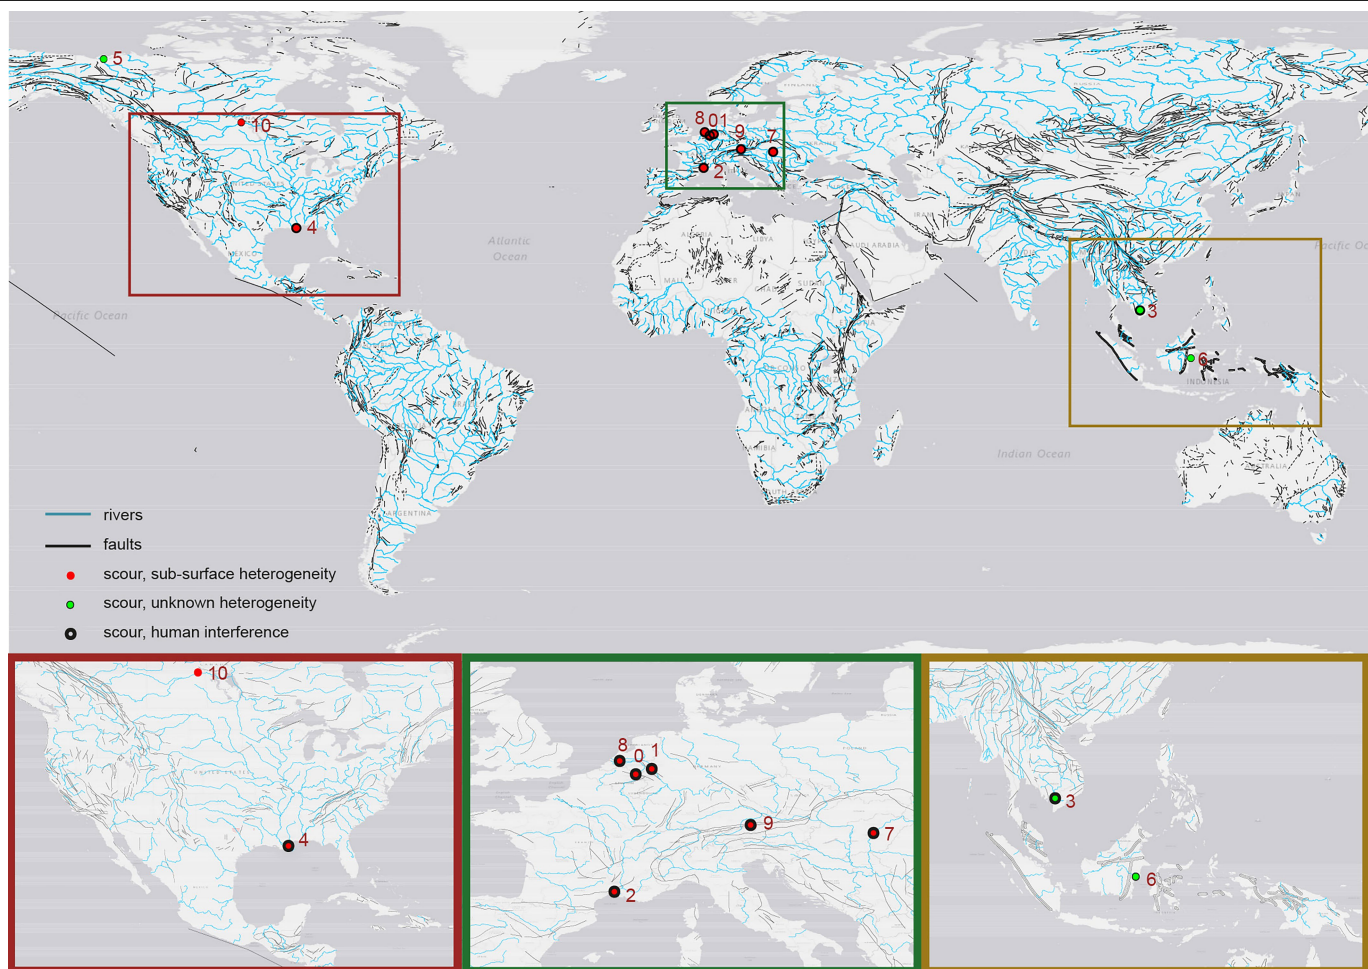
**Extended Data Fig. 7 | Riverbed scour and tectonic faults.** World map with faults<sup>80</sup> and the 11 cases of riverbed scour referred to in this manuscript (details in bottom panels): 0 – Meuse River, the Netherlands; 1 – Rhine River, Germany; 2 – Petit Rhone, France; 3 – Mekong River, Vietnam; 4 – Lower Mississippi, United States; 5 – Mackenzie Delta, United States; 6 – Mahakam River, Indonesia; 7 – Middle Tisza, Hungary; 8 – Rhine Meuse Delta, the Netherlands; 9 – Salzach

River, Austria; 10 – Saskatchewan River, Canada. Markers indicate scour in regions with high subsoil heterogeneity and strong human interference. Many rivers are located in regions with tectonic faults, where irregular sedimentary composition of the subsoil can be expected. The scour cases 0, 1, 6 and 9 correspond to the existence of faults.

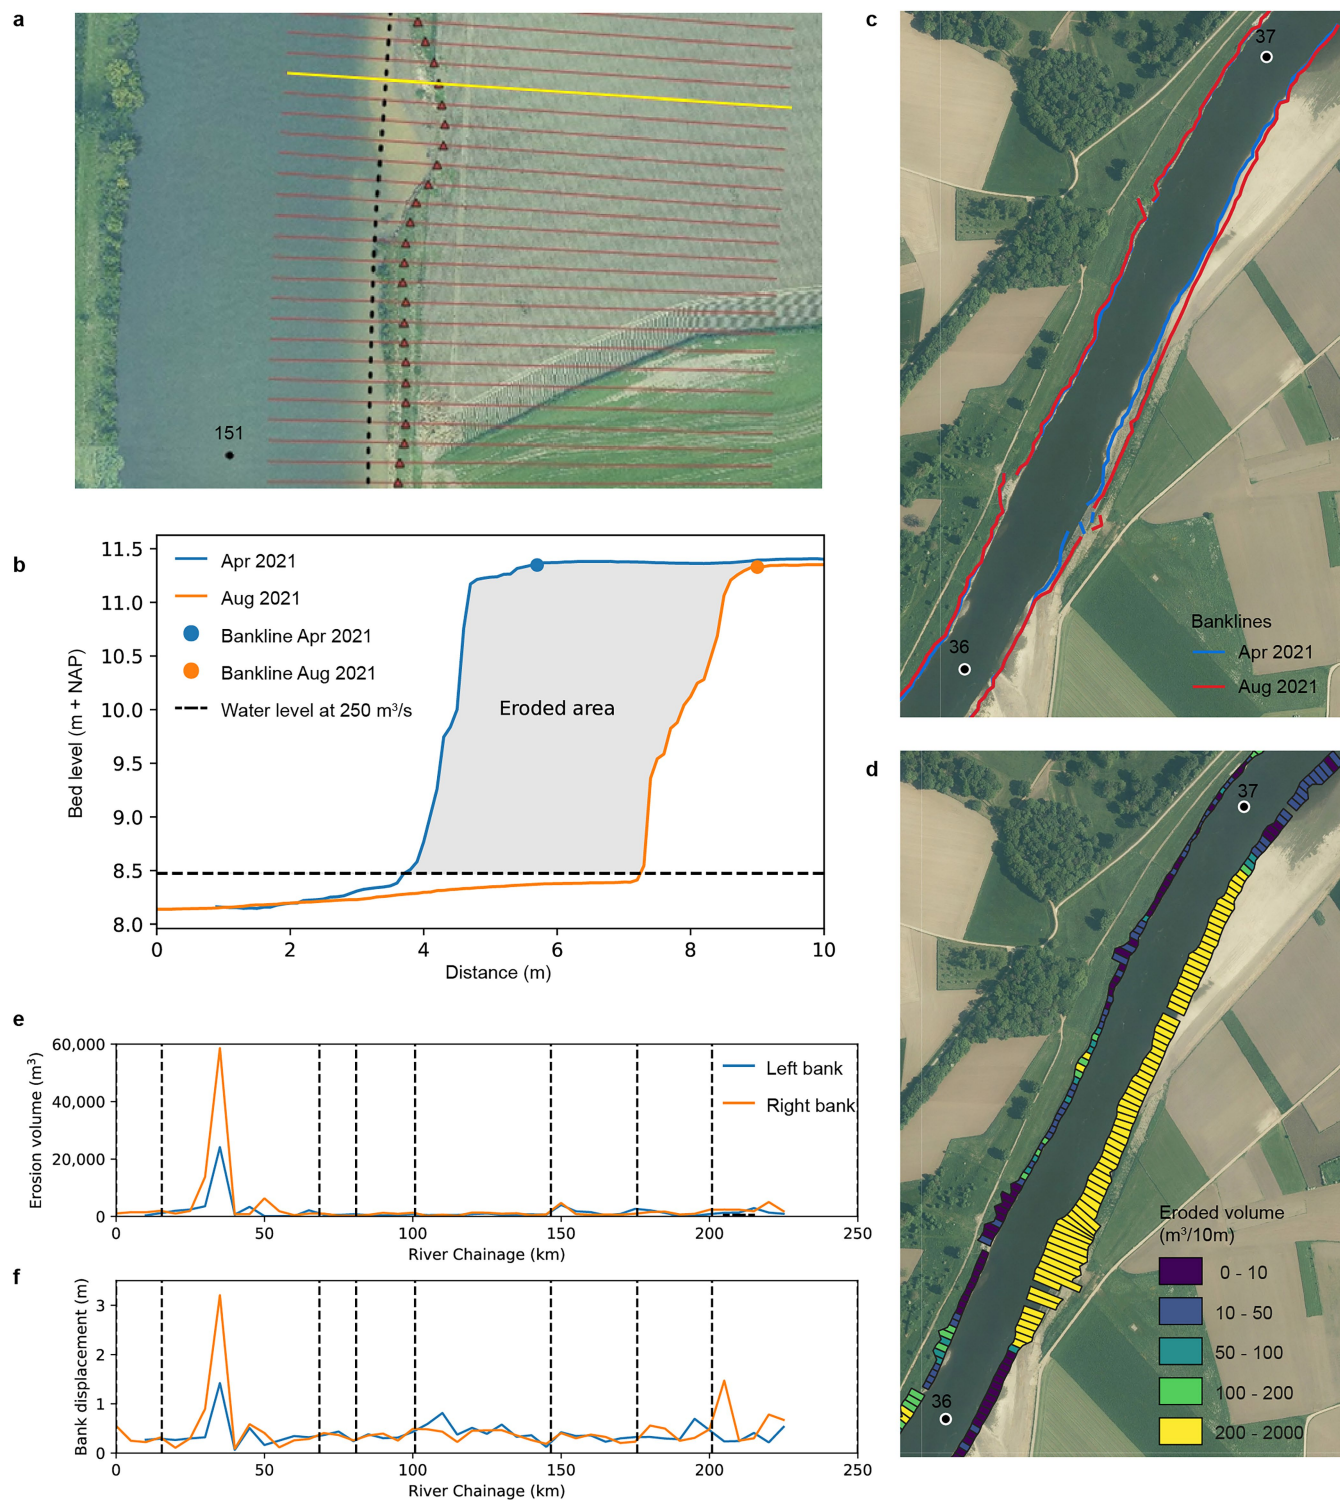
**Extended Data Fig. 8 | Bank erosion assessment.** **a**, Example cross-sections on the right bank near km 151 with estimated erosion line (red triangles). **b**, Cross-section at km 151.14 (yellow line in panel **a**) and eroded area based on cross-sectional profiles and impoundment level. **c**, Example erosion lines before (blue) and after (red) the flood. **d**, Matching erosion volumes per section of 10 m

long (distance in flow direction). **e**, Erosion volume per 5 km river length at the left and right banks. Dotted black lines show the locations of 7 barrages in the river. **f**, Average bank displacement per 5 km river length at the left and right banks.

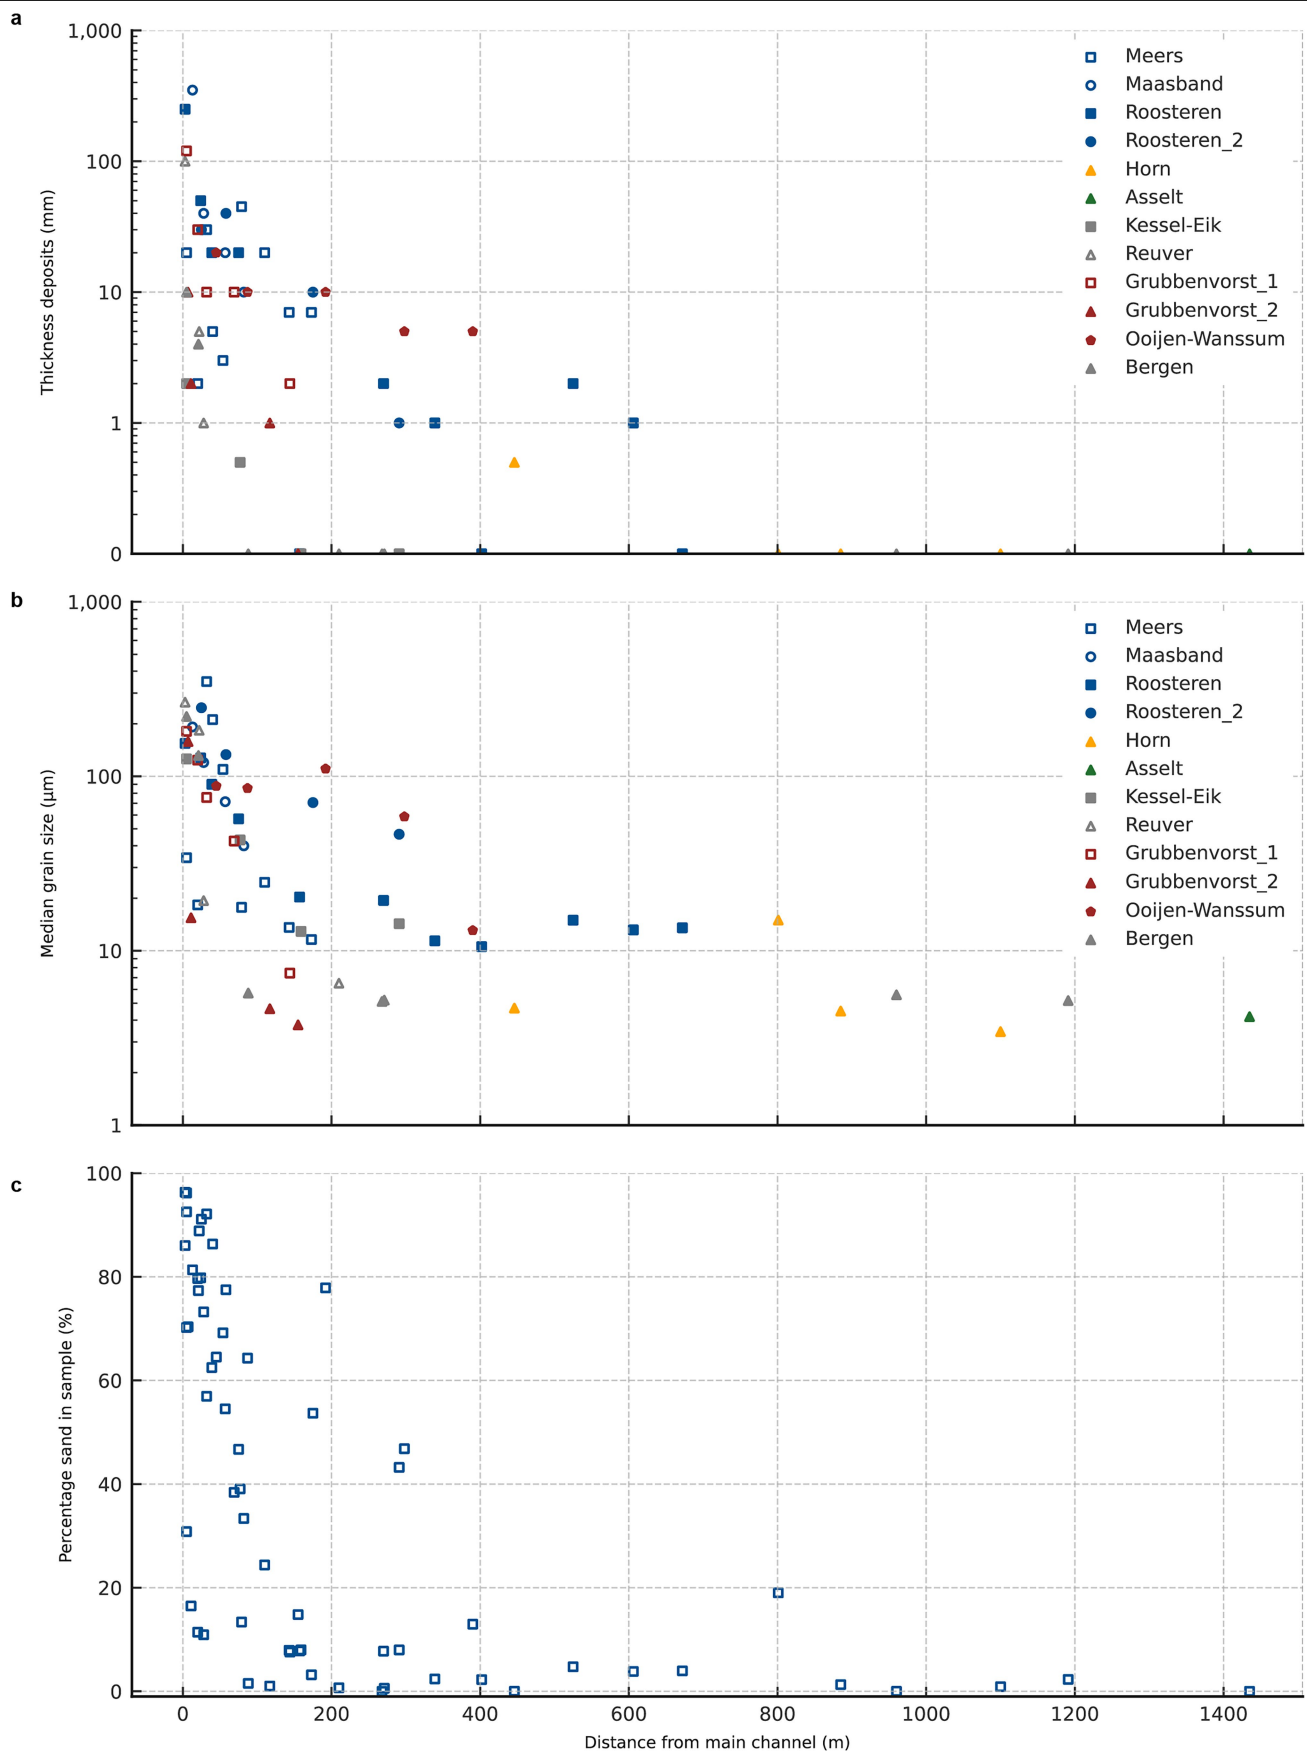
**Extended Data Fig. 9 | Composition of samples in transverse direction from the main channel at 10 locations. a.** Thickness of deposits. **b.** Median grain diameter of samples. In panels a and b, locations in the legend are sorted from

upstream to downstream. Square, circle and triangle markers indicate respectively inner bends, outer bends, and straight sections of samples.

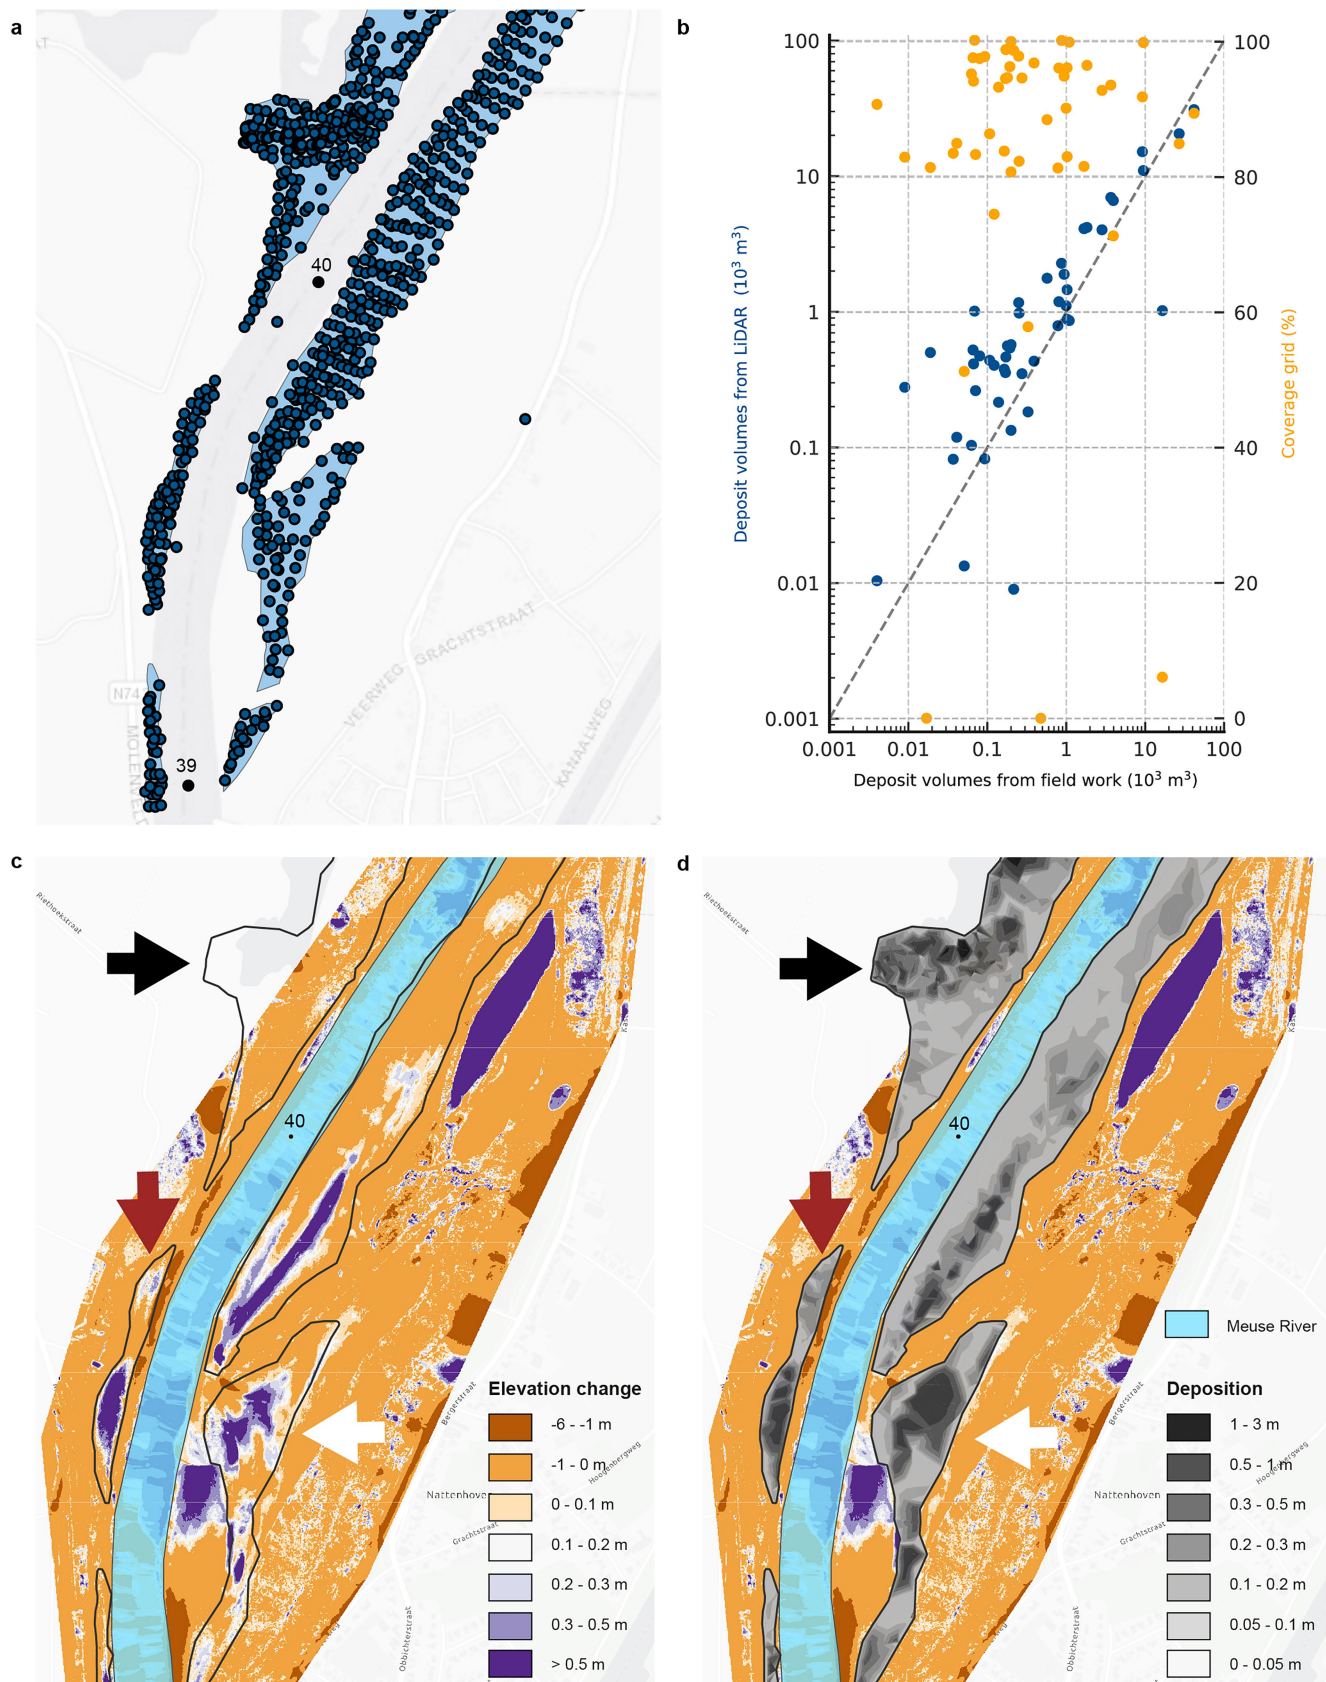
Extended Data Fig. 10 | See next page for caption.

**Extended Data Fig. 10 | Deposit volumes from field sampling and LiDAR.**
