## Study on the failure mechanism of high-temperature granite under two cooling modes

In the geothermal development of hot dry rock (HDR), both the drilling of the wellbore and the heat exchange of the heat reservoir involve the effects of different cold and hot conditions on the high-temperature rock mass. The testing machine for rock mechanics was used to conduct a uniaxial compression test and carry out micro testing on the treated samples; furthermore, with the help of scanning electron microscopy the fracture mechanism of granite subjected to different temperatures and cooling methods was studied. The results show: (1) With the gradual increase in temperature, the compressive strength of granite under the two cooling methods gradually decreases. (2) The failure modes of the samples under the two cooling methods are mainly shear failure of the "Y" type. The degree of damage of the sample under water cooling is significantly greater than that under natural cooling. Electron micrographs could confirm these results. (3) It can be obtained by testing the mineral composition and element changes of granite at different temperatures. When the temperature reaches 600°C, its change is

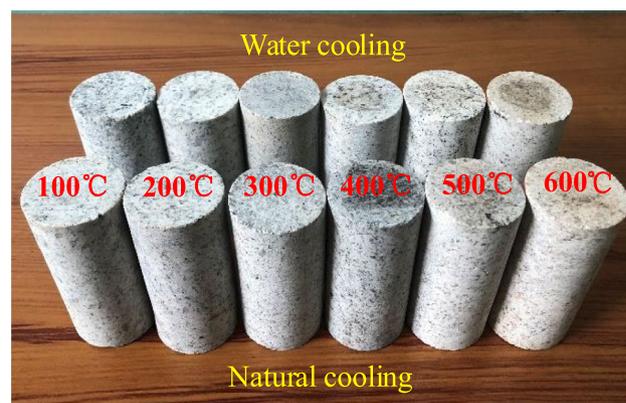
**Figure 1.** Granite specimens.

The test specimens had dimensions of  $\Phi = 50 \times 100$  mm, and they were prepared according to the standards of precision recommended by the International Society for Rock Mechanics (ISRM). The specimens are shown in Fig. 1. The test specimens were divided into seven groups to be heated to different temperatures. The heating temperatures adopted in this study were: room temperature (20 °C), 100, 200, 300, 400, 500, and 600 °C. Each group contained four specimens, yielding a total of 52 specimens. The specimens were heated to the different target temperatures at a constant rate of 4 °C/min, and the target temperature was then maintained for 8 h to ensure that the samples could be fully heated. A group of heated samples was directly taken out for water cooling and cooled to room temperature. The other group was placed in a furnace and cooled to room temperature.

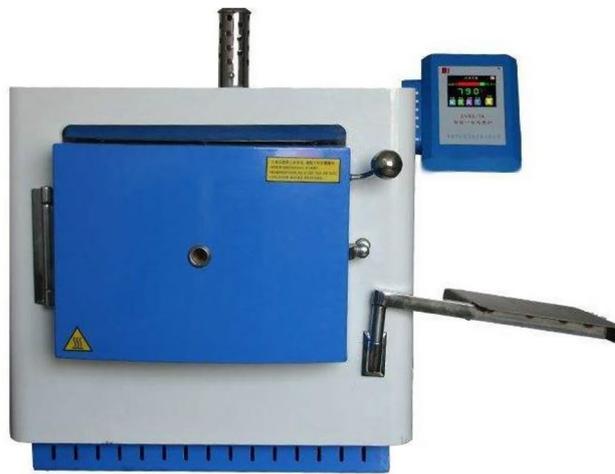
**Figure 2.** Heating equipment.

A full uniaxial stress–strain test was carried out on each test specimen using a rock testing machine. The loading mode was set to be displacement control with a loading rate of 0.02 mm/min. The test results were automatically recorded by the computer<sup>21</sup>. The cross-sectional morphology of the specimen was analyzed via SEM (model JSM-7610F). The specimens were heated up to 100 ~ 600 °C at a heating rate of 4 °C/min. The heating device was an XRMF-9X intelligent integrated muffle furnace, shown in Fig. 2. The main parameters were as follows: the heating temperature was from room temperature to 1200 °C, the resolution was 1 °C, and the temperature control accuracy was  $\pm 1$  °C.

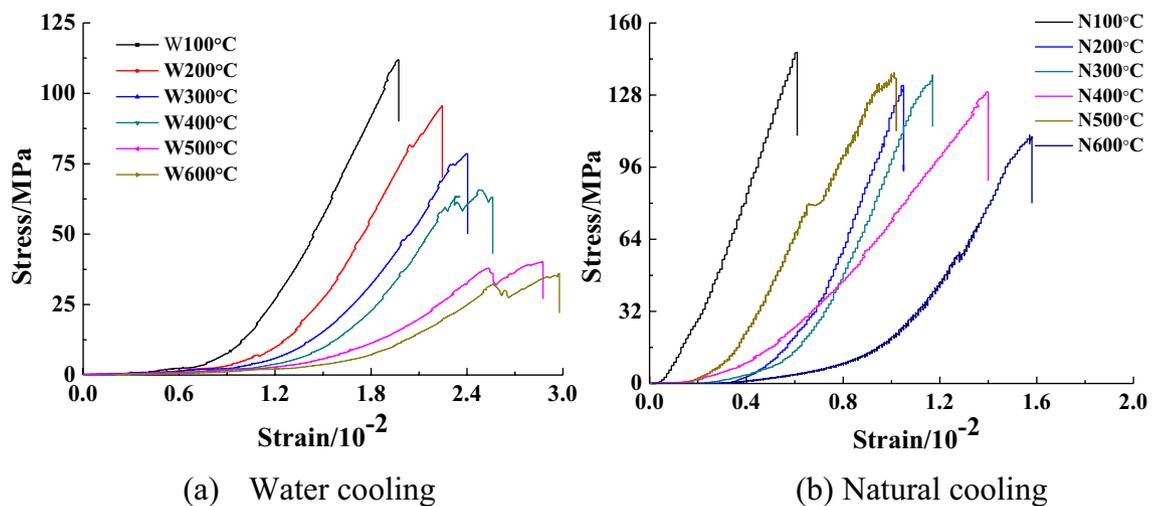
**Figure 3.** Stress–strain curves of granite under different temperatures and cooling modes<sup>22</sup>. (a) Water cooling, (b) Natural cooling.

It can be seen from Fig. 3a that the uniaxial compressive strength of the specimen under water cooling decreases with increasing temperature, while the peak strain increases with increasing temperature. The compaction phase of the specimen is also higher than that of the sample after natural cooling. In the elastic phase, it can be seen that the slope of the sample gradually decreases. When the temperature reaches 500 °C, it can be seen that the sample gradually changes from being brittle to being ductile.

It can be seen from Fig. 3b that the uniaxial compressive strength of the sample under natural cooling exhibits a downward trend with increasing temperature; however, this decrease is small, and the peak strain increases with temperature. An increasing trend can be observed, and the length of the compaction phase in the stress–strain curve of this sample is shorter than that of the sample under water cooling.

By comparing panels (a) and (b) in Fig. 3, it can be concluded that the strength of the sample under water cooling is significantly lower than that of the sample under natural cooling, and the peak strain is higher than that of the sample under natural cooling. Furthermore, the slope of the strain–stress curve for the sample under water cooling is less steep than that of the sample under natural cooling. It is especially noteworthy that the proportion

of the compaction stage is relatively high. This may be due to the fact that the sample is affected by thermal expansion and contraction during heating and cooling, which causes cracks between the internal particles; thus, the time required for the pore cracks to be gradually compacted during the uniaxial compression process is longer.

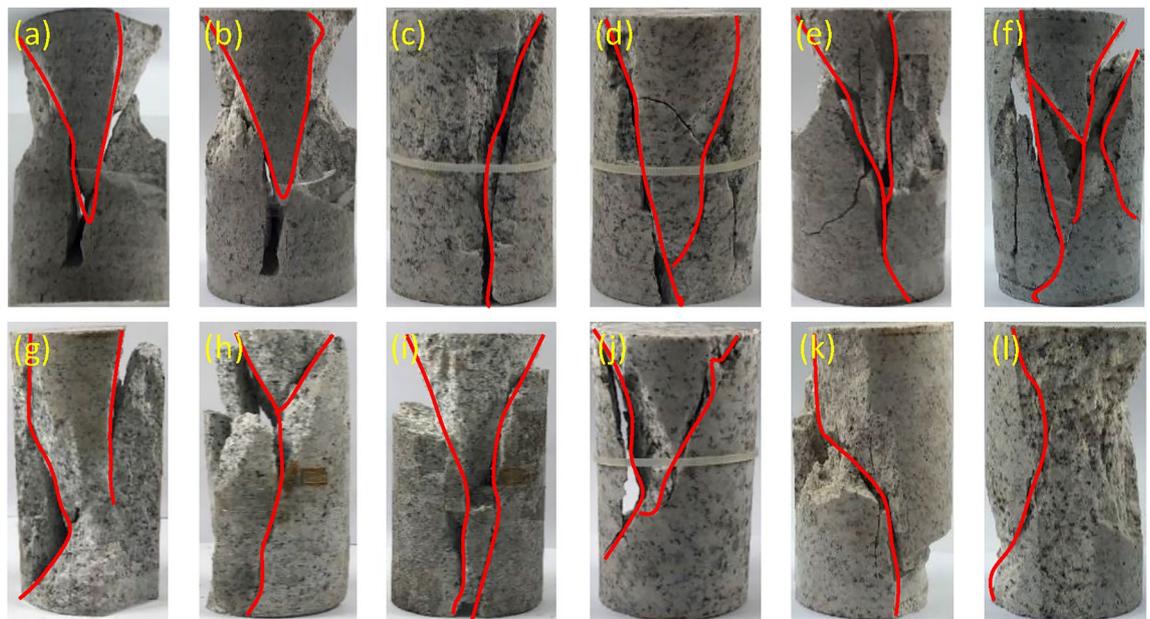
**Figure 4.** Failure modes of granite specimens with increasing temperature: (a–f) water cooling from 100 ~ 600 °C and (g–l) natural cooling from 100 ~ 600 °C.

It can be seen from Fig. 4 that there are noticeable oblique shear planes and longitudinal penetrating planes (see panels (a, c ~ e) in the failure mode of granite after water cooling, and most specimens with conical shape are destroyed. More than 90% of the sample exhibit a conical destruction at the upper end and a splitting failure at the lower end. These are clearly Y-shaped and V-shaped, respectively. The upper part has a conical shape due to the end effect, while the longitudinal end of the crack is due to the lateral tensile failure caused by the pressure; the failure mode of granite after natural cooling is mainly caused by splitting damage. With the increase in temperature, the damage becomes increasingly more complex. When the temperature is 100 °C, the fragmentation does not give rise to a macroscopic fracture surface. When the temperature is 200 °C, the macroscopic fracture surface has a conical shape. The fracture then becomes longitudinally penetrating and cracking when the temperature is 300 °C. At 400 °C the specimen exhibits a Y-type failure, while, when the temperature is 500 ~ 600 °C, the failure mode is more complex. When damage occurs, more particulate debris is produced<sup>23</sup>.

In general, the damage caused after cooling with water is mostly shear failure. The damage caused after natural cooling is mostly splitting and tensile failure. Although both are brittle modes of failure, the brittleness after cooling with water is smaller than that after natural cooling. Thus, the temperature has a significant effect on the failure mode.

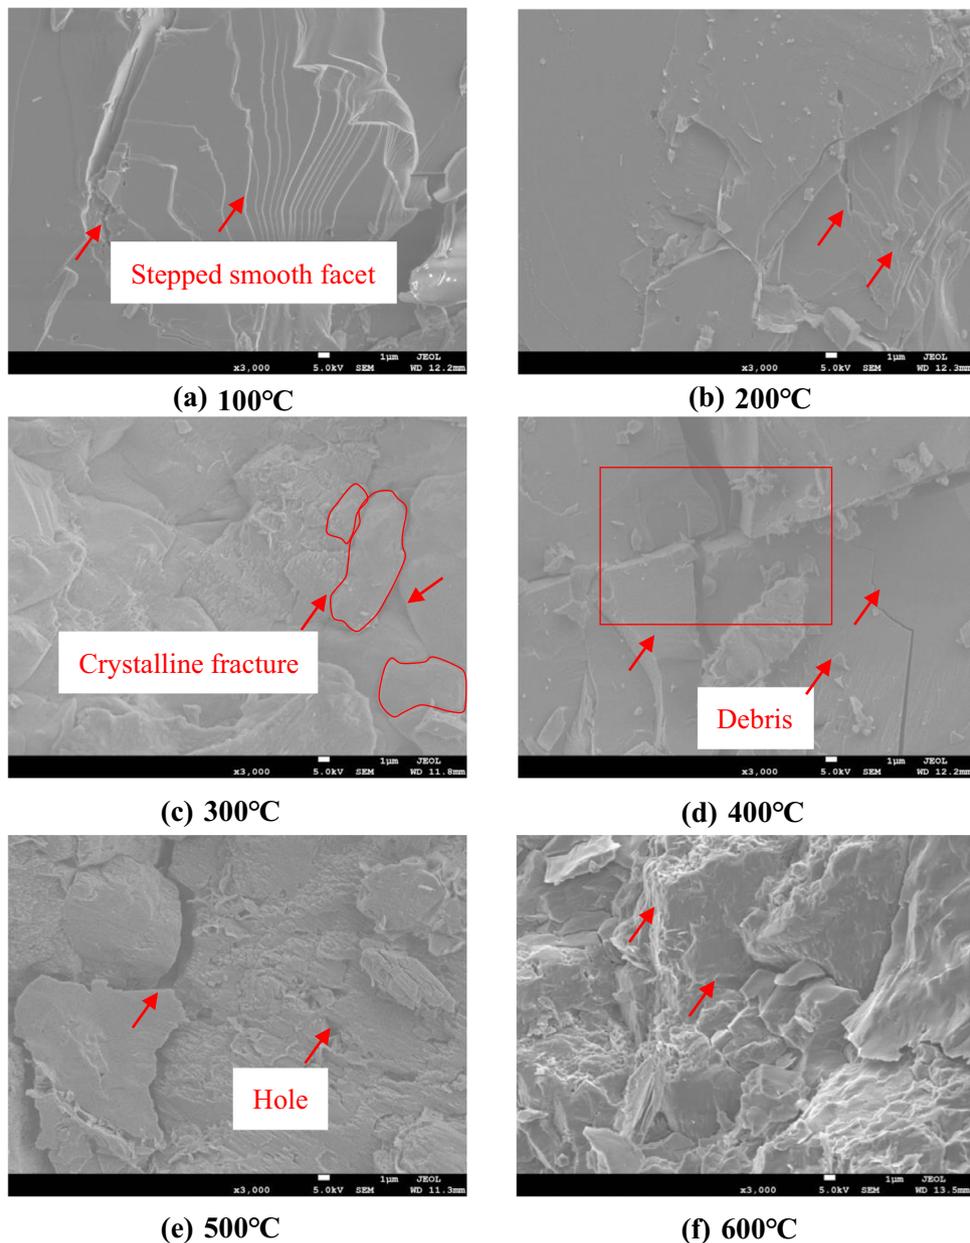
**Figure 5.** Changes in the microstructure of granite under water cooling (magnification: 3000). (a) 100 °C, (b) 200 °C, (c) 300 °C, (d) 400 °C, (e) 500 °C, (f) 600 °C.

Figure 5 shows SEM images of the fracture surfaces of granite specimens that were water-cooled after being heated to different temperatures. When the heating temperature is 100 °C (Fig. 5a), the microscopic fracture morphology of the sample is stepped, the crystal surfaces are smooth and flat, the structure is complete, and only small microscopic cracks are visible. When the heating temperature is 200 °C (Fig. 5b), the fracture morphology is smooth and flat, and one narrow unconnected transgranular microcrack can be noticed. When the heating temperature rises to 300 °C (Fig. 5c), narrow cracks and transgranular microcracks develop at grain boundaries, and micropores and a triangular micropit can be observed. When the heating temperature is 400 °C (Fig. 5d), noticeable large cracks appear on the fracture surface, which are interpenetrated. The fracture morphology is cleavage-stepped, and the main cracks meet to form a cross. Additionally, debris can be observed on the fracture surface of the sample. When the heating temperature is 500 °C (Fig. 5e), part of the crystal is destroyed, split by a large transgranular crack that communicates with an intergranular crack. The presence of fine transgranular cracks and distributed microcavities indicates that a slight plastic deformation of the fracture surface has occurred. This may be due to the fact that brightness is related to conductivity. When the heating temperature rises to 600 °C (Fig. 5f), the SEM image of the sample is brighter than at lower temperatures, indicating that rock heated to this temperature has high conductivity. Thus, heating has a pronounced effect. At this high temperature, the crystal surface is rough and broken, and the width of the crack along the grain boundary is greater than that at lower temperatures. After the thermal stress inside the sample reaches a certain level, grain boundaries and transgranular cracks will penetrate each other to form a fracture network, causing severe damage.

It can also be seen from the SEM micrograph that the number of intragranular cracks in granite is higher at 600 °C than at other temperatures, and it gradually increases with the increase in temperature. Granite is more active under high-temperature conditions, especially when the temperature reaches 600 °C. Indeed, at this temperature, the reaction is the strongest, and the main oxide inside the rock changes, which is quite different from the situation at 100 ~ 500 °C. This is mainly because, upon encountering water at high temperature, the sample is in, it generates alkaline substances, and the minerals change. Generally, MgO has a lower amount of alkaline substances, while Fe<sub>2</sub>O<sub>3</sub> has a higher one. For example, from Eqs. 2–6, it can be seen that SiO<sub>2</sub> in granite reacts with water to form H<sub>4</sub>SiO<sub>4</sub>, etc. It can be observed that the oxides in granite all react with water to form substances containing H<sup>+</sup> ionic bonds. From the SEM images and microscopic slices, it can be seen that, during the high-temperature stage (500 ~ 600 °C), the internal fracture of the sample is more severe. This may be due to the conversion between the mineral phases, or it may be because some minerals will melt, resulting in some microscopic defects in the rock. The higher the temperature of the sample, the more noticeable the defects inside the rock; as the temperature increases, the number of cracks and the crack width also gradually increase.

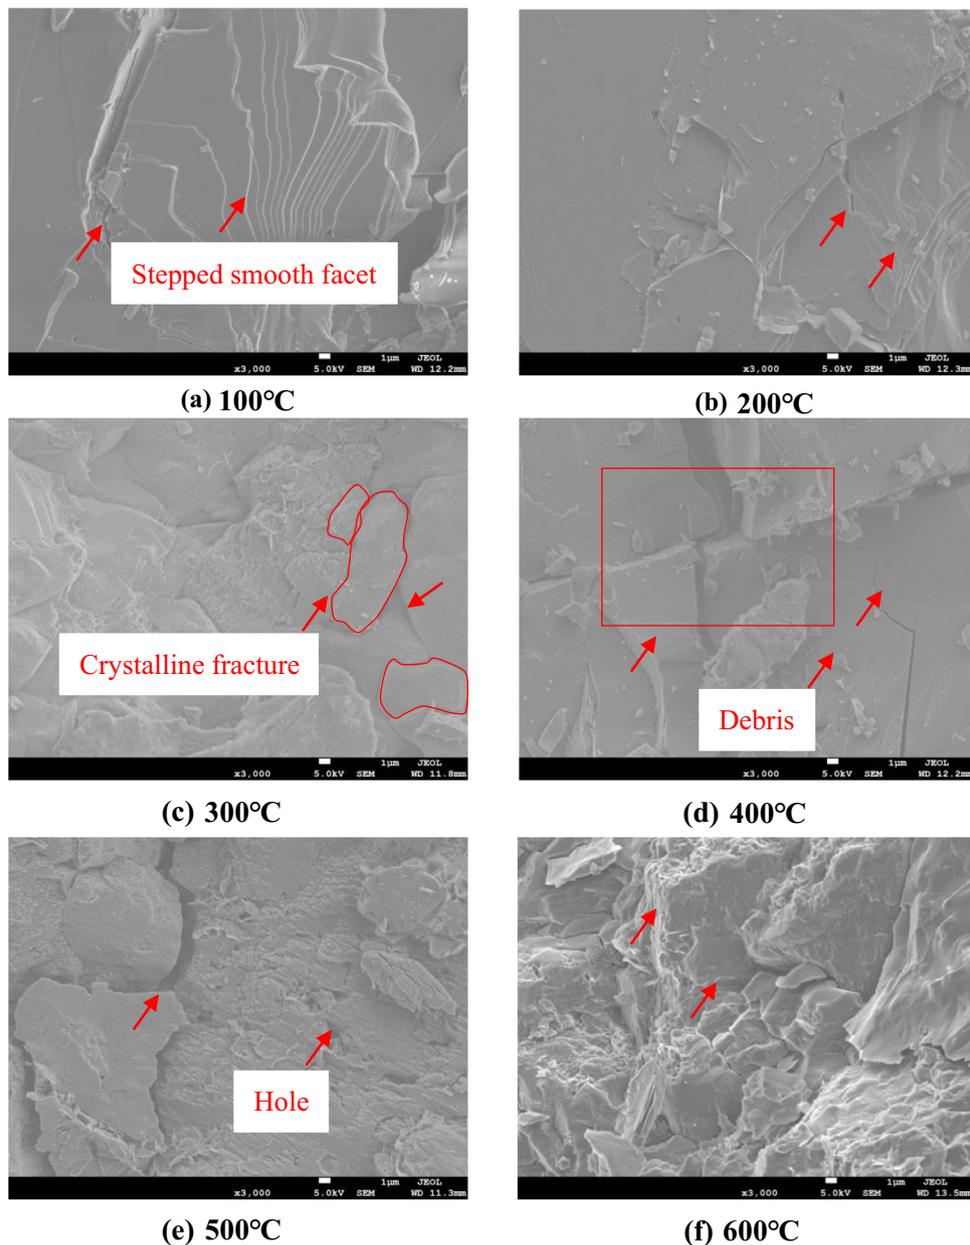
**Figure 6.** Changes in the microstructure of granite under natural cooling. (a) 100 °C, (b) 200 °C, (c) 300 °C, (d) 400 °C, (e) 500 °C, (f) 600 °C.

Figure 6 shows SEM images of the fracture surfaces of granite specimens cooled naturally after being exposed to different temperatures. Overall, the surface topography in Fig. 6a, b is smooth and flat with some minor cracks. From Fig. 6c, it can be seen that, when the heating temperature reaches 300 °C, the surface of the granite sample becomes deformed along the grain boundary, and microruptures like those seen at 100 and 200 °C have expanded and transformed to follow the grain boundary. Fig. 6d, e show that the surface is greatly damaged upon heating to 400 and 500 °C, becoming increasingly roughened and uneven, and that a small amount of debris is generated. Particles also start to peel off from the specimen. Figure 6f shows that, when the heating temperature reaches 600 °C, the surface of the sample is broken, pulverizing damage occurs, and more debris appears on the surface. These observations explain why the mechanical strength of granite decreases with increasing temperature<sup>24</sup>.

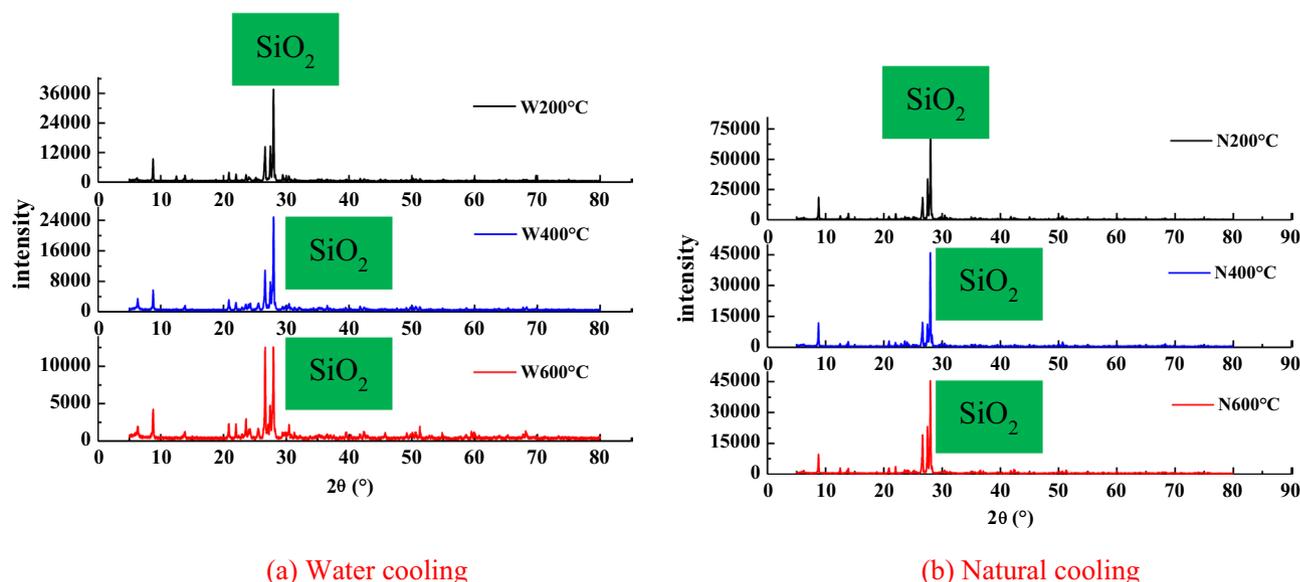
**Figure 7.** XRD patterns of granite. (a) Water cooling, (b) Natural cooling.

From the Fig. 7 seen that by comparing the XRD patterns of the granite samples under the two cooling methods, it is found that the diffraction data derived from the four main minerals in granite has not disappeared; however, their diffraction intensity has changed, which indicates that the change in the rock is mainly due a

change in the internal structure. From the changes in the diffraction angles corresponding to the maximum diffraction peaks of the four main minerals after heating to different temperatures, it can be seen that the maximum diffraction peaks under the two cooling modes decrease with the increase in temperature. The content of the mineral components will be reduced accordingly. Comparing the two cooling methods, it can be seen that the peak corresponding to the water-cooled sample is lower than that corresponding to the naturally cooled sample, which is mainly due to the physical and chemical effects of the minerals during the cooling process. During the cooling process, due to the capillary action of water, the pores and cracks inside the sample are filled and play a role during cooling. At the same time, water and minerals react chemically, and some minerals will decompose under a certain temperature. (For example, when the temperature is 200 ~ 550 °C, biotite and potassium feldspar will decompose upon getting in contact with water. See Eq. 1 for the specific expression). The naturally cooled sample is placed in the furnace for cooling; however, due to the thermal stress the sample is subjected to for a prolonged period of time, the sample is thermally expanded and is finally cooled to room temperature. The sample cooled by water is subjected to heating during the heating process. After thermal expansion, it is quickly water-cooled, which causes it to shrink rapidly. This results in the sample cracking due to the rapid change in temperature, and the damage caused to the sample mineral particles cannot be recovered.

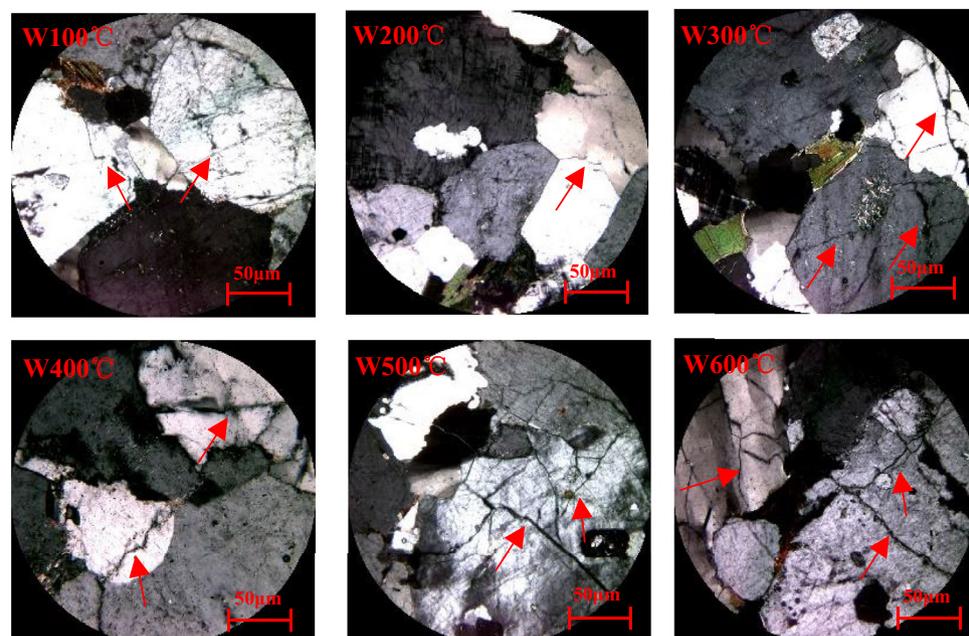
**Figure 8.** Microscopic slices of granite under water cooling (the red arrow marks the rupture line).

As can be seen from Fig. 8, When the granite temperature reaches 100 and 200 °C and water is encountered, the fast cooling rate will cause a relatively high temperature gradient between the outside and the inside of the specimen, and a relatively high cold shrinkage deformation gradient will also be present. Additionally, as the test specimen is not homogeneous, the cold shrinkage deformation will also be nonuniform, creating tensile stress between the constitutive mineral particles of the test specimen. When the tensile stress exceeds the bond strength, microcracks are generated, causing damage to the test specimen. This damage is mainly due to the cooling of granite. From the microscopic slices of granite under water cooling it can be seen that: (1) As the temperature increases, the degree of damage of the sample gradually increases, which is mainly manifested in the gradual increase in the number and width of cracks; (2) Mineral crystals gradually change from a microcrack state to a multicrack state, and the damage degree of the sample heated to temperatures higher than 400 °C becomes increasingly more severe.

When the heating temperature is higher than 300 °C, a large amount of high-temperature and high-pressure water vapor and air bubbles will be generated for the water-cooled sample<sup>27–30</sup>. When these invade the rock, they will have a “wedging” effect on the test specimen, which will cause the pores in the specimen to expand further and evolve. At the same time, due to chemical reactions of the minerals inside the rock under the action of water, the internal components will be transformed. SiO<sub>2</sub> and CaO react to form CaSiO<sub>3</sub>, CaO and Fe<sub>2</sub>O react to form ferrite, and CaO and CO<sub>2</sub> react to form CaCO<sub>3</sub>. In addition, since biotite, which has the chemical formula K(Mg,Fe)<sub>3</sub>AlSi<sub>3</sub>O<sub>10</sub>(OH)<sub>2</sub>, contains (OH)<sup>-</sup>, it tends to thermally decompose from a temperature of 200 °C. When the temperature is higher than 450 °C, biotite begins to thermally decompose, and the thermal decomposition becomes more severe when the temperature reaches 600 °C. When the temperature is between 200 and 550 °C, K-feldspar will degrade into kaolinite or mica due to the phase equilibrium of the K<sub>2</sub>O–Al<sub>2</sub>O<sub>3</sub>–SiO<sub>2</sub>–H<sub>2</sub>O system. Equation 1 is the most relevant chemical equation in this work, while Eqs. 2–6 are other major chemical equations.

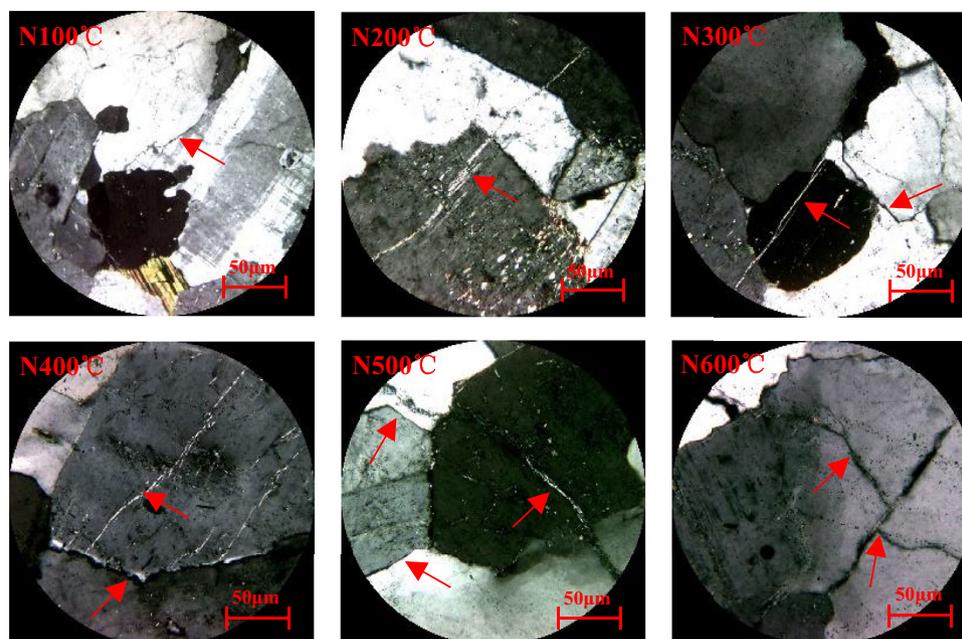
**Figure 9.** Microscopic slices of the sample under natural cooling (the red arrow marks the rupture line).

As can be seen from Fig. 9, When the temperature is lower than 200 °C, the mineral particles inside the specimens expand during the heating process, and a small number of microcracks are generated due to the uneven thermal expansion deformation, while the primary microcracks remain closed. Small amounts of gas and/or liquid are heated and become volatilized<sup>32</sup>, for example, as water vapor; the loss of this gas and/or liquid improves the contact between the mineral particles, thereby increasing friction. In the natural cooling process, the cooling rate is very slow compared with that under water cooling. The temperature gradient generated inside the specimen is very small. During the natural cooling process, the shrinkage deformation is relatively uniform, and the probability of creating new cracks is very small<sup>33</sup>. From the SEM image in Fig. 6, it can be seen that, after heating the sample to 100 °C, the number of cracks is limited, and they are located mostly along the grain boundaries; thus, when the heating temperature is less than 200 °C, natural cooling can be considered a slow process. Almost no new cracks are generated in the test specimens, but the shapes of the cracks may change, such as when an originally closed crack opens during the shrinking process, or the width of an original crack increases.

When the temperature is greater than or equal to 200 °C, thermal cracking will occur in the test specimen, and the higher the temperature is, the more noticeable the thermal cracking effect will be. This is again caused by chemical effects, but the chemical action during the natural cooling process will cause a very small amount of damage because hydration reactions will be limited. This is the most relevant difference between water cooling and natural cooling. This leads to the damage to naturally cooled granite being less than that in water-cooled granite.
