Stability study of complex caves: a case study of Yuanjue Cave in the Dazu Rock Carvings

A refined 3D numerical model was constructed to reflect the intricate topography, geological structures, and support conditions of the Yuanjue Cave in the Dazu Rock Carvings. The study identifies the main factors influencing the stability of the roof, the deformation and failure modes and key areas, and the current stage of the cave's stability was determined. The results show that the development of cavity depth acts as the trigger for roof deformation and failure, while the breakage of strip stones is the primary controlling factor. The overall deformation and failure mode of the roof is a combination of bending and torsion, with the key failure area located at the left front of the cave entrance. The current state of deformation in the cave's roof indicates it is in the mid-term accelerated change stage. These findings offer a reference for the stability analysis of other similarly complex caves.

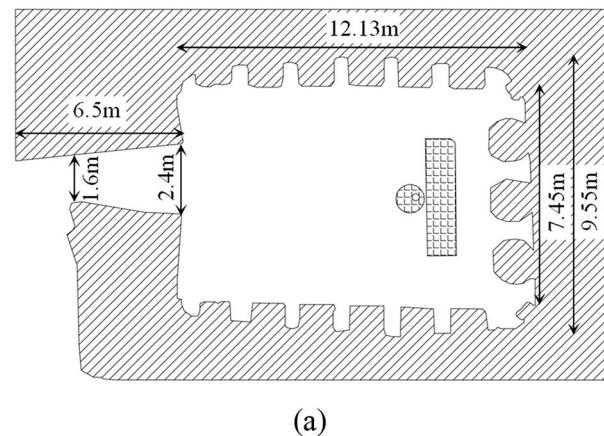
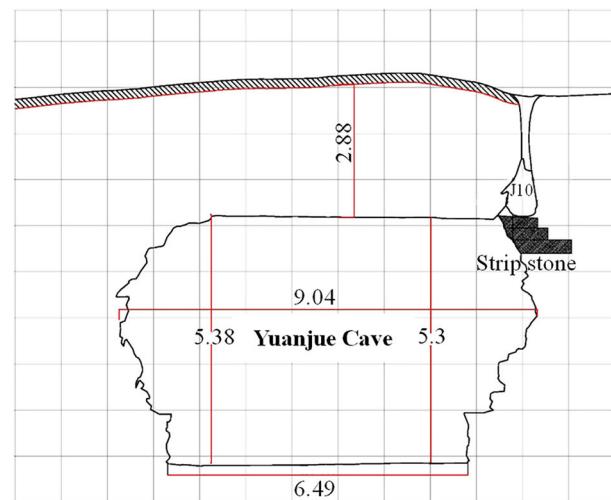
Fig. 2 | The profile of the dimensions inside Yuanjue Cave. **a** Transverse section; **b** Longitudinal section. The selected cross-section within the cave is not necessarily the one with the largest dimensions.

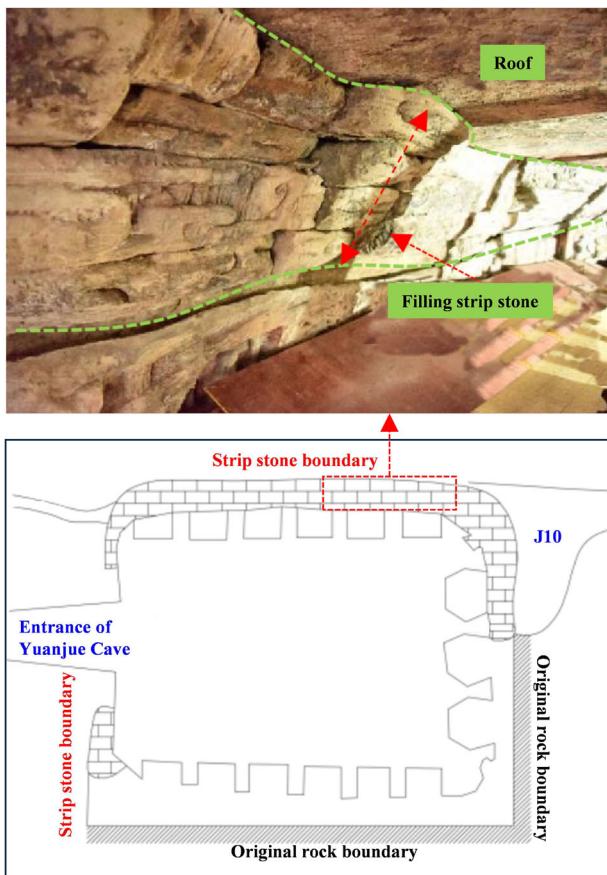
and the original rock mass. The roof boundary is divided into the “original rock boundary” formed by the original rock mass and the “strip stone boundary” formed by the supporting stones. The “original rock boundary” is consolidated with the surrounding rock of the same strata, occupying about half of the roof's boundary. The “strip stone boundary” consists of intact load-bearing stones and fractured broken stones, which occupy the other half of the roof's boundary, as shown in Fig. 3.

Fig. 3 | Schematic diagram of the roof support boundaries in Yuanjue Cave.

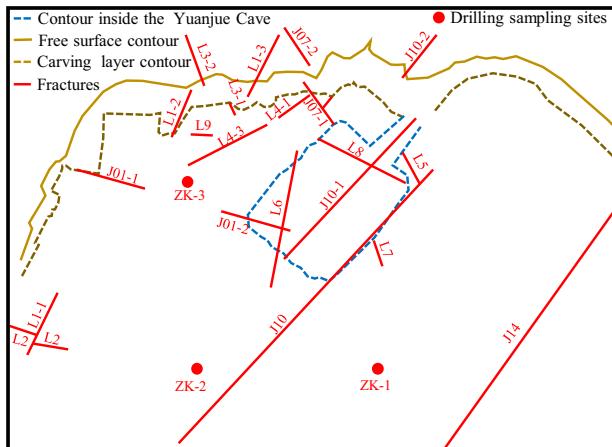
Fig. 4 | Fracture distribution surrounding Yuanjue Cave.

the spatial positions and orientations of the fractures, a total of 13 fractures were identified around Yuanjue Cave, labeled as J-01, J-07, J-10, J-14, L1, L2, L3, L4, L5, L6, L7, L8, and L9. Most of these fractures are primarily distributed within the sculpture strata, with only the L6 fracture located in the roof strata, cutting through the southwestern corner of the entire roof of Yuanjue Cave. The planar distribution of the fractures is shown in Fig. 4.

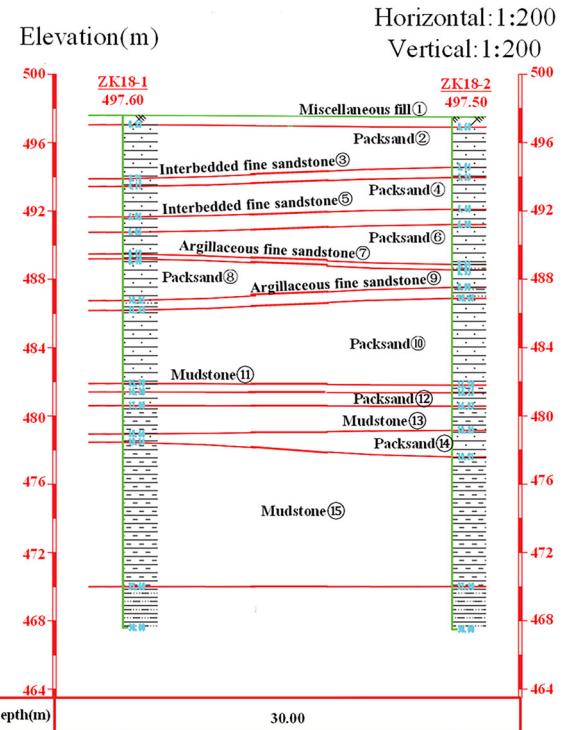
Fig. 5 | Geological profile of Yuanjue Cave in Dazu Rock Carvings.

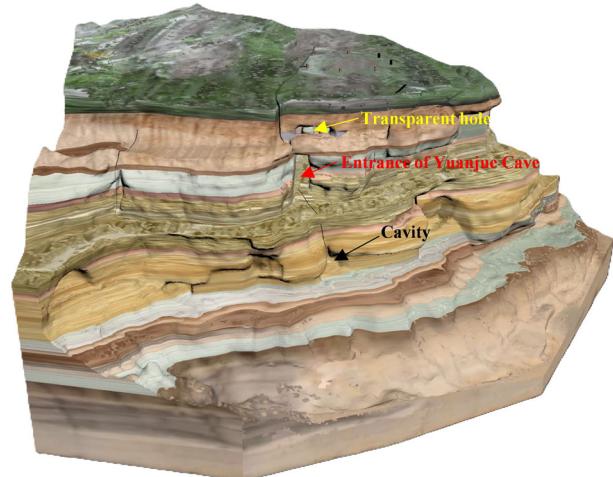
Fig. 6 | Schematic diagram of the cavity below the cave entrance.

layer of lower strength stratum beneath the entrance of the cave. After long-term differential weathering, this layer has weathered and eroded at a faster rate than the layers above and below it. As a result, a cavity with a certain depth has formed at this layer, as shown in Fig. 6.

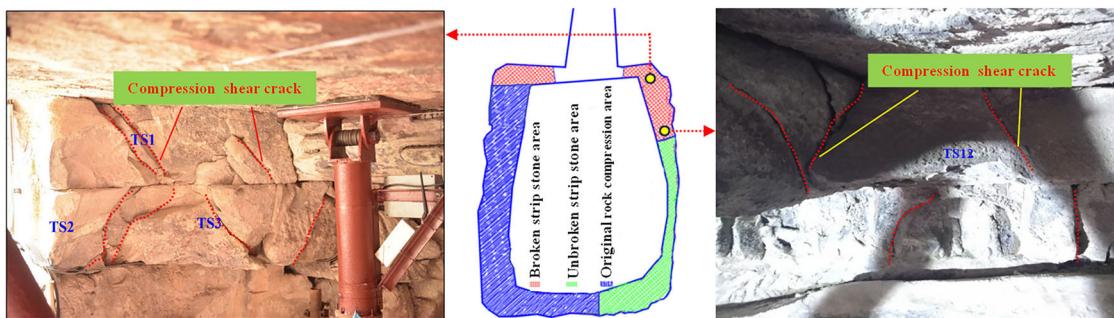
Over the centuries, under the continuous influence of natural forces and various deterioration factors, the strip stones beneath the roof of Yuanjue Cave have gradually broken down, and the rock mass at the bottom of the roof has experienced ongoing peeling. This has posed a significant threat to the safety and stability of Yuanjue Cave. Field inspections of the strip stones beneath the roof of Yuanjue Cave revealed that some of the strip stones have developed compressive fractures. These fractured strip stones are mainly concentrated in the front section of the cave chamber, with a trend of further development towards the rear. The characteristics and distribution of the fractured strip stones are shown in Fig. 7. After the

Fig. 7 | Distribution characteristics of crushed supporting strip stones in the front section of Yuanjue Cave.

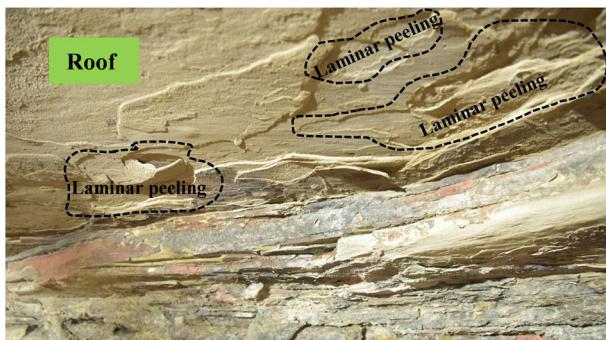
Fig. 8 | Laminar peeling on the roof inside Yuanjue Cave.

excavation of Yuanjue Cave, stress redistribution occurred within the rock mass. Under the influence of additional loading and long-term weathering, varying degrees of peeling damage have developed at the bottom of the roof, as shown in Fig. 8.

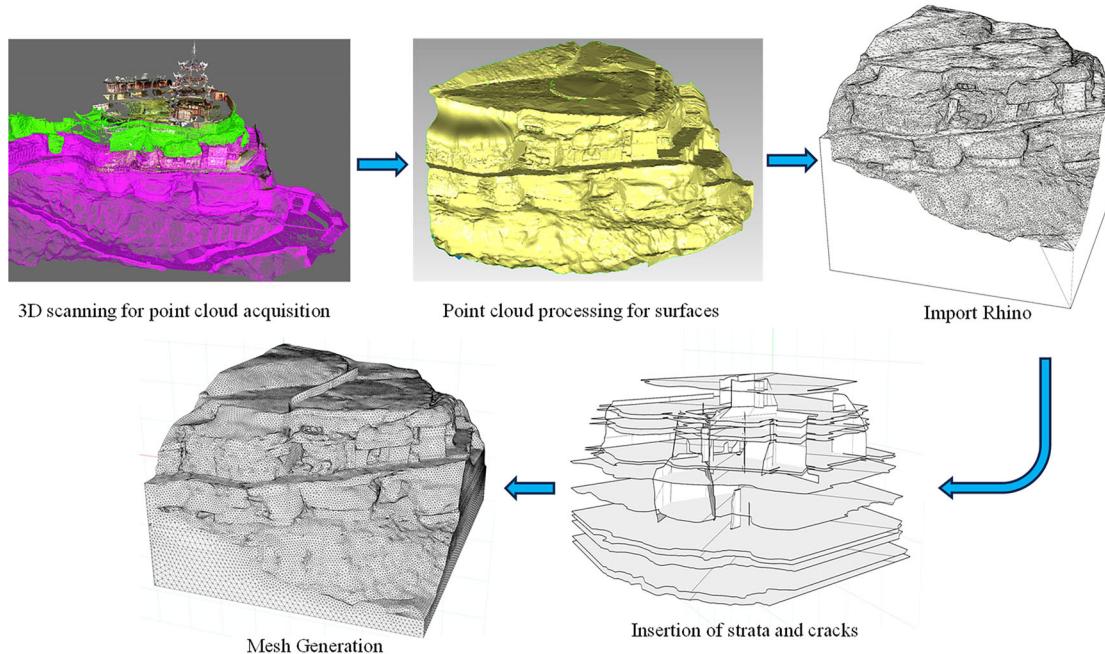
(2) Given the complex stratigraphy of Yuanjue Cave and the highly developed surrounding fractures, the model stratigraphy was divided into groups in Rhino software based on the elevation of each layer, following preliminary stratigraphic surveys and fracture investigations. The fractures were then segmented in Rhino according to their planar positions and stratigraphic locations. The specific modeling process is shown in Fig. 9.

Fig. 9 | Flowchart of modeling through point cloud.

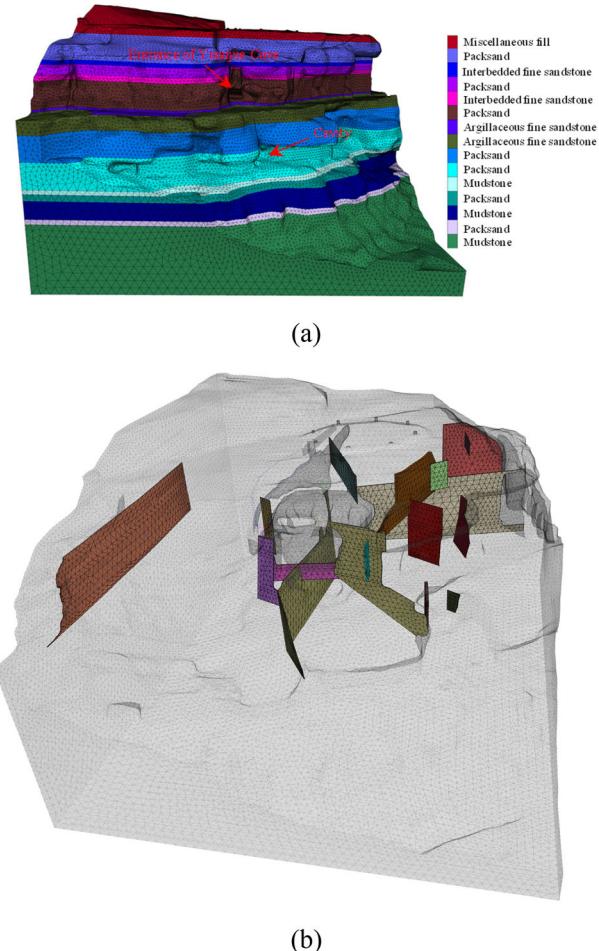
Using the above 3D modeling scheme, a refined 3D geological model of Yuanjue Cave was constructed, incorporating the complex stratigraphy and fracture distribution, as shown in Fig. 10. Based on this model, a refined 3D geological model including the strip stone blocks and cavity was constructed according to the grouping scheme of the strip stones and cavity. The grouping of the cavity and strip stones is illustrated in Fig. 11. The overall model dimensions are 58.05 m × 47.33 m × 31.51 m, with a total of 1,719,093 elements. The model contains five artificially cut boundaries, with the bottom boundary subjected to fixed constraints and the side boundaries subjected to normal constraints. After the constraint boundary of the model is established, the linear elastic model is firstly adopted to carry out self-balancing under the gravity field condition. Then, the calculation is carried out in the elastoplastic phase of the Mohr-Coulomb model.

Fig. 10 | 3D Geological model of Yuanjue Cave. **a** Stratigraphic distribution map; **b** Fractures distribution map. The different colors in the image represent different strata or fractures.

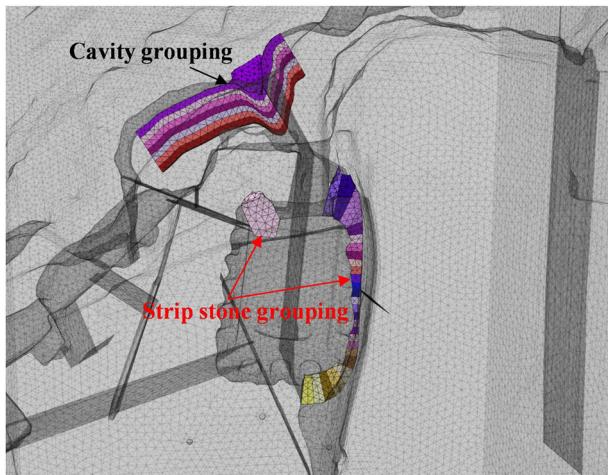
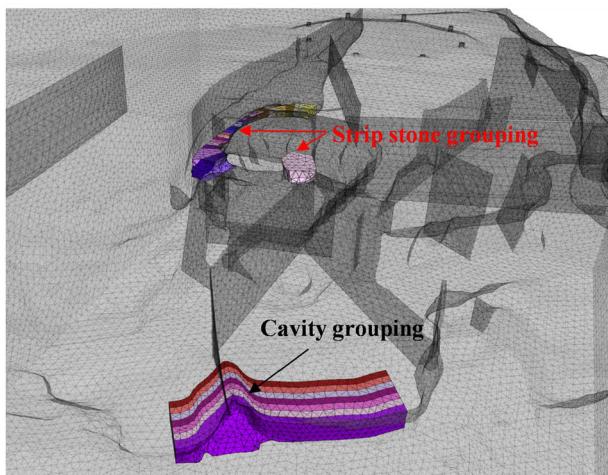
Fig. 11 | Schematic diagram of cavity and strip stone grouping. **a** Top view; **b** Elevation view. Different colors in the figure represent different groups of strip stone or cavity.

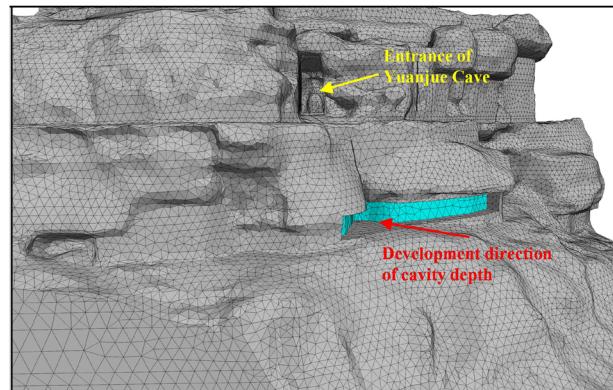
Fig. 12 | Schematic diagram of cavity depth development direction.

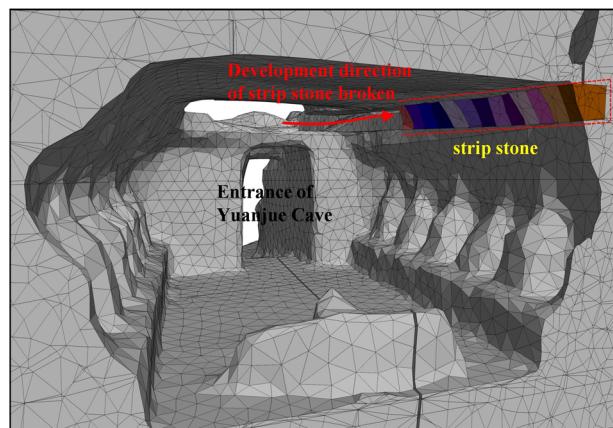
Previous research has shown that the surrounding rock mass of Yuanjue Cave is generally stable, and the stability of the cave mainly depends on the stability of its roof^{24,25}. The strip stones as a support structure for the roof has an important influence on the stability of the roof²⁶. Additionally, based on field investigations, the cavity beneath the entrance of Yuanjue Cave may also affect the stability of the roof. Therefore, considering the local fractures in the supporting strip stones of the roof and the gradual development of the cavity beneath the cave, the bearing and failure conditions of the strip stones were generalized into two forms: intact load-bearing strip stones and broken strip stones that no longer provide support. The null model in the FLAC3D numerical analysis software was used to simulate the state of broken strip stones and cavity depth development. For the simulation of cavity depth development, the cavity is gradually set as a null model from the inside out to simulate the increasing depth of the cavity. Since each group of cavities is 0.5 m, the depth of the cavity increases by 0.5 m with each simulation. The development of the cavity is illustrated in Fig. 12. For the simulation of broken strip stones: The broken strip stones are set as void models to simulate the gradual development of the broken strip stone length. Since each group of strip stones is 0.5 m, the broken strip stone length extends by 0.5 m with each simulation. The development of broken strip stones is illustrated in Fig. 13.

Fig. 13 | Schematic diagram of broken strip stone development direction.

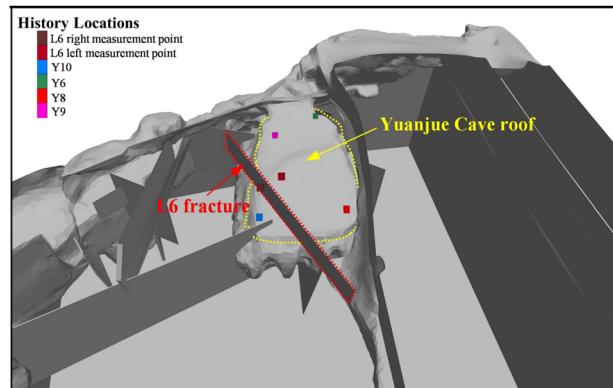
During the numerical simulation process, vertical displacements at four corner measurement points above the roof of Yuanjue Cave, as well as the distribution of maximum principal stress in the roof, were monitored. Two additional measurement points were set on either side of the L6 fracture to monitor the trend in the width of the fracture. The locations of all monitoring points are shown in Fig. 14.

Fig. 14 | Schematic diagram of measurement point positions in numerical simulation.

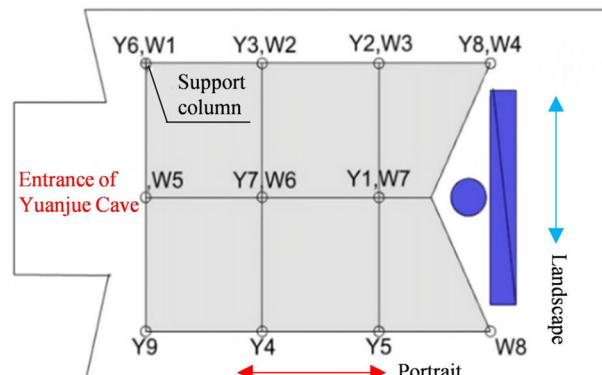
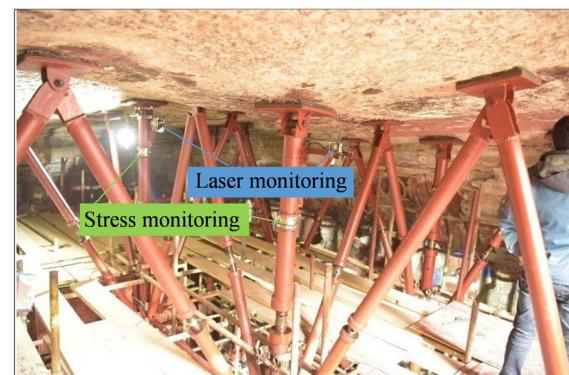
Fig. 15 | Field monitoring of roof support force and peeling in Yuanjue Cave. a Schematic diagram of support force and peeling measurement points; b Field layout of support force and peeling monitoring. Support force and peeling measurement points are positioned at varying heights on the support columns.

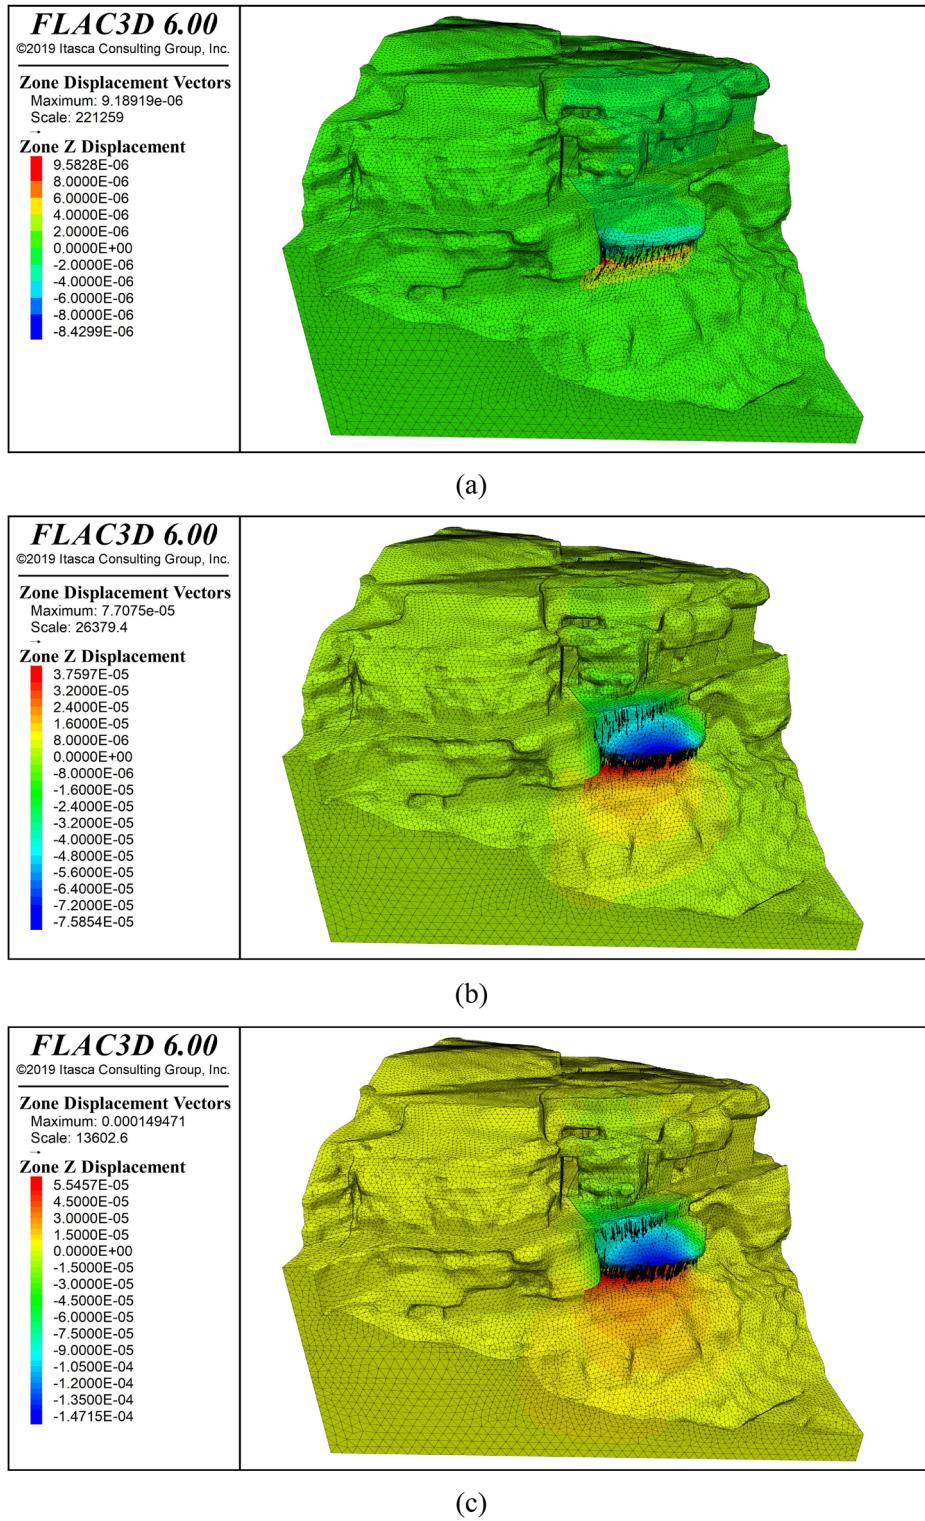
The cloud and vector diagrams of vertical displacement in the rock mass at the entrance area of Yuanjue Cave under different cavity depths are shown in Fig. 16. Based on the numerical simulation results, the displacement curves of roof measurement points Y6 and Y9 at the front side of the roof as a

Fig. 16 | Cloud and vector diagrams of vertical displacement in the rock mass at the entrance of Yuanjue Cave under different cavity depths.
 a Cavity depth 0.5 m; b Cavity depth 2.5 m; c Cavity depth 3.5 m. Negative values in the figure represent settlement.

central, and front-right sections of the roof. This finding is consistent with the numerical simulation results in Figs. 16 and 19, which show that the roof of Yuanjue Cave bends towards the front entrance under the influence of the cavity, while also tilting towards the left front side under the condition of broken strip stones.

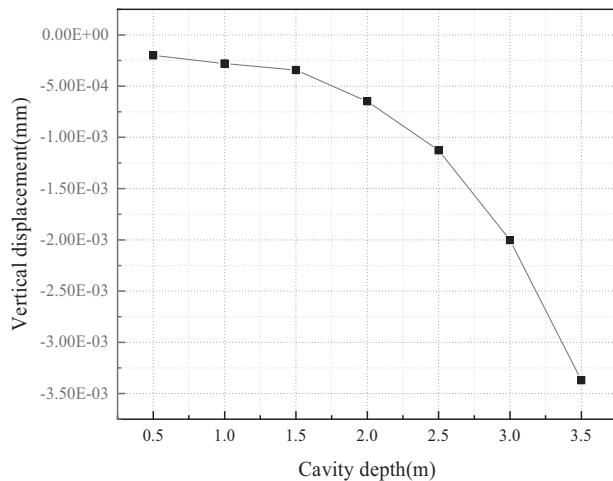
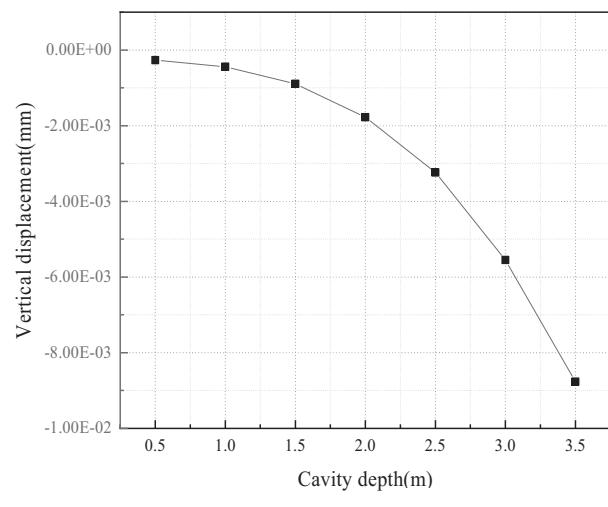
Fig. 17 | Variation of the vertical displacement of front roof measurement points with the cavity depth. a Measurement point Y6; **b** Measurement point Y9. Vertical is the z-axis direction in the cloud map.

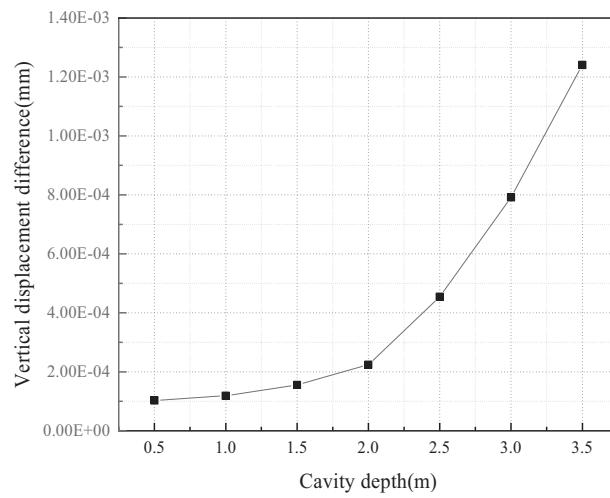
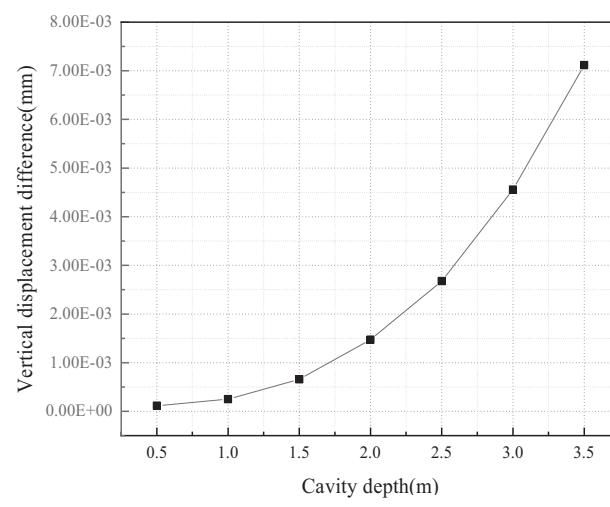
Fig. 18 | Variation of vertical displacement difference between front and rear roof measurement points with the cavity depth. a Y6-Y8; **b** Y9-Y10. “-” represents a minus sign.

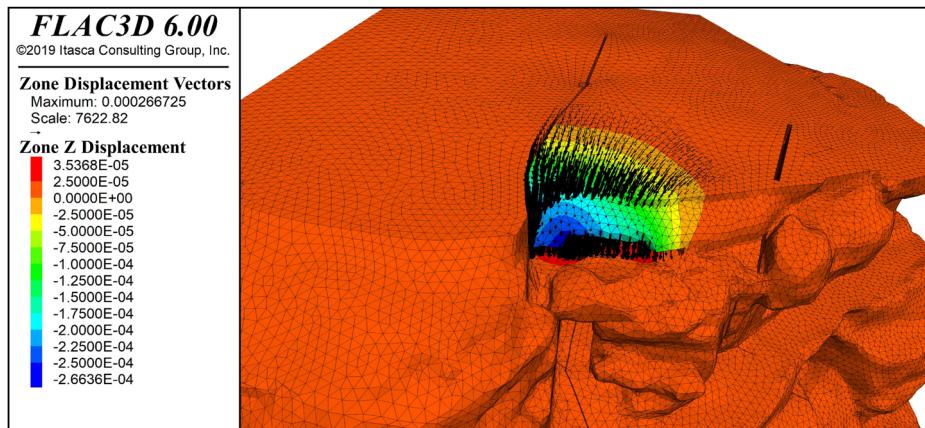
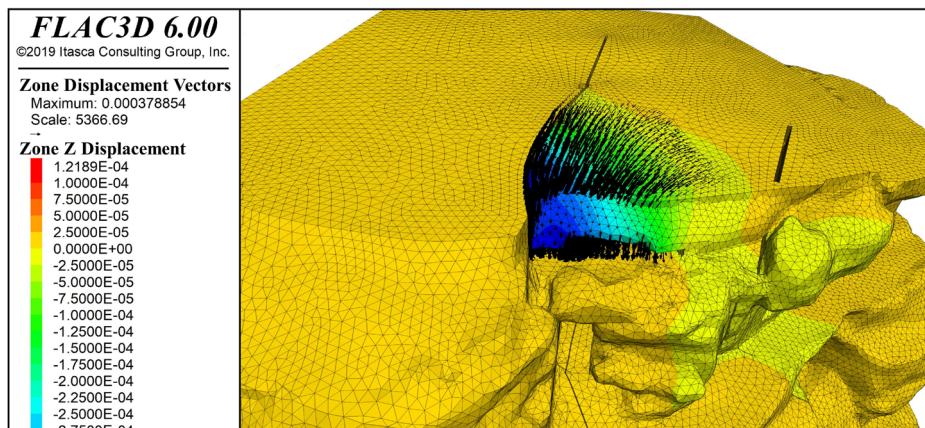
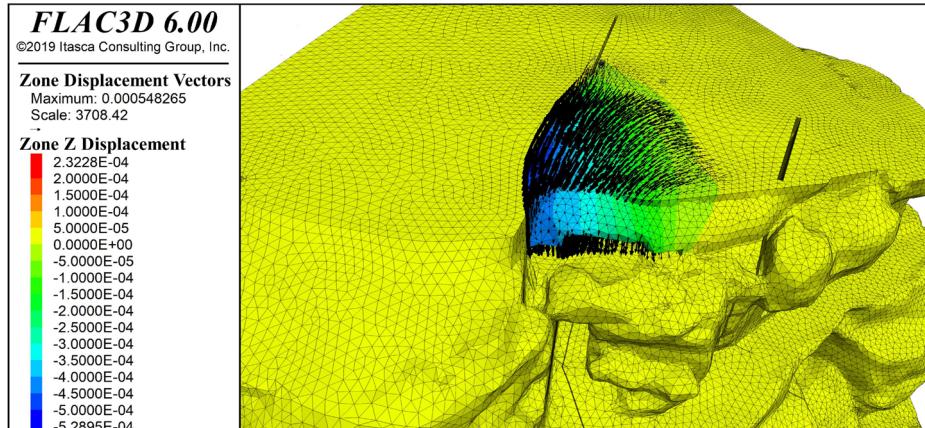
(1) As shown in Fig. 19, as the length of the broken strip stones increases, the vertical displacement of the roof in Yuanjue Cave continues to increase, and the uneven settlement becomes progressively more severe. The inclined and bent area in the left front part of the roof expands, and the roof shows a tendency to tilt and overturn towards the left front side of the cave entrance.

Fig. 19 | Cloud and vector diagrams of vertical displacement in the roof under different broken strip stone lengths. **a** Broken strip stone length 5 m; **b** Broken strip stone length 9 m; **c** Broken strip stone length 14 m. Negative values in the figure represent settlement.

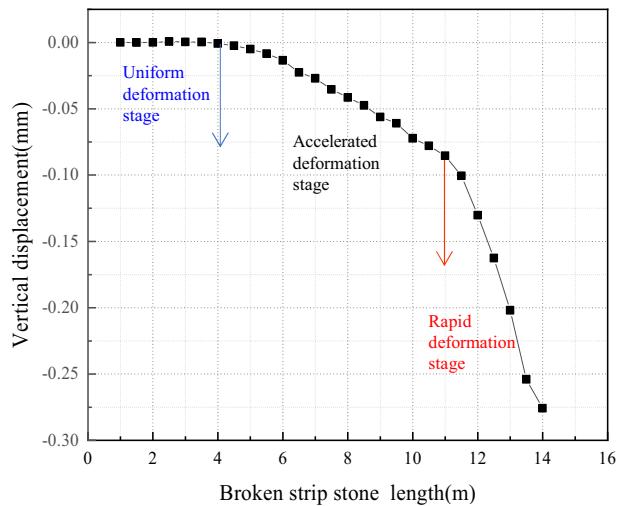
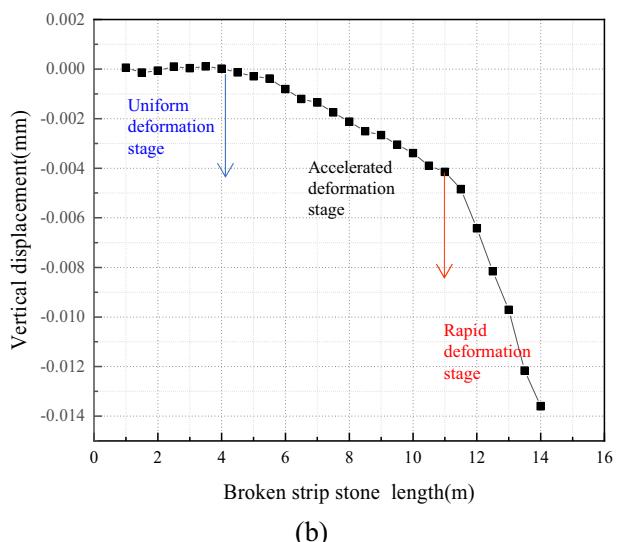
(2) Figs. 20 and 21 indicate that as the length of the broken strip stones increases, the vertical displacement at the various roof measurement points and the width of the L6 fracture both increase. The increase process can be roughly divided into three stages: an initial steady change stage when the broken strip stone length is less than 4 m, a mid-term accelerated change stage when the length is between 4 m and 11 m, and a late rapid change stage when the length exceeds 11 m.

Fig. 20 | Variation of vertical displacement of roof measurement points with the broken strip stone length. **a** Measurement Point Y8; **b** Measurement Point Y10. Three colors represent three stages.

The study found that the stability of the roof in Yuanjue Cave is primarily controlled by the breakage of the supporting strip stones. The development of vertical settlement of the roof and the width of the L6 fracture can be roughly divided into three stages as the length of the broken strip stones increases (Figs. 20 and 21):

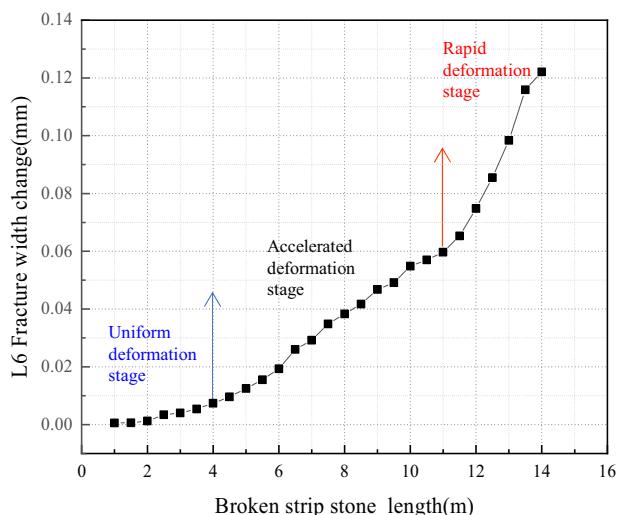
Fig. 21 | Variation of L6 fracture width increment with the broken strip stone length.

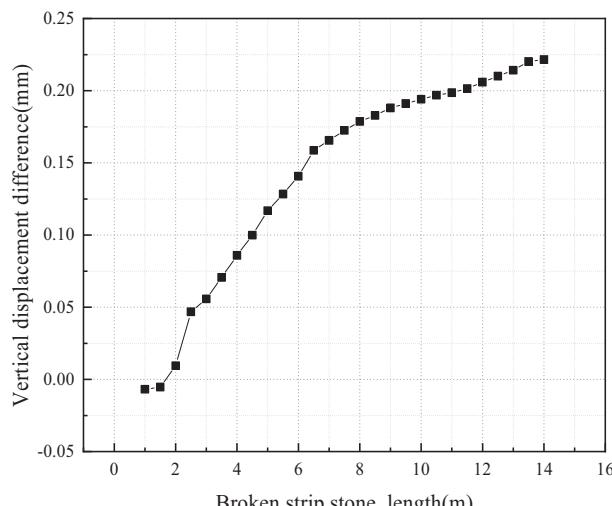
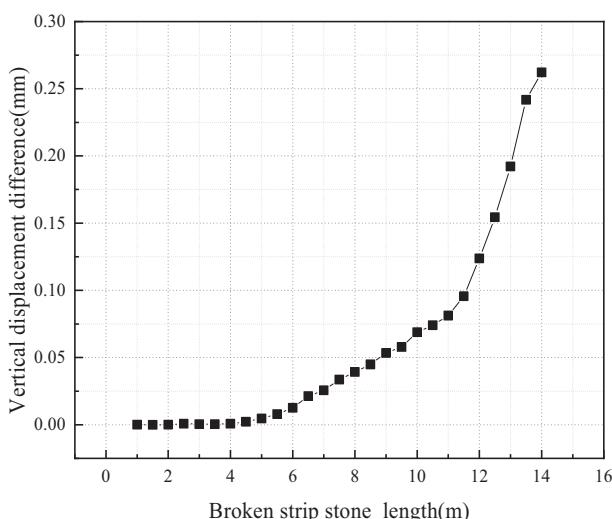
To determine the trend of uneven deformation in the roof as a function of the length of the broken strip stones, the vertical settlement differences between the left measurement points (Y6, Y8) and the right measurement points (Y9, Y10) were plotted as a function of broken strip stone length, as shown in Fig. 22.

(1) The settlement values at the left roof measurement points Y6 and Y8 are greater than those at the right points Y9 and Y10, indicating that the roof is tilting towards the left side of Yuanjue Cave (the side with the infilled strip stones). As the length of the broken strip stones increases, the settlement difference between the left and right measurement points continues to grow, and the degree of tilting intensifies.

(2) During the initial stage of strip stone breakage, the front part of the roof tilts more rapidly than the rear part. However, as the length of the broken strip stones continues to increase, the forward tilting gradually slows, while the rear tilting begins to accelerate significantly. In the early stage of strip stone breakage, the settlement difference between the left and right measurement points at the front is significantly greater than that between the rear measurement points.

Fig. 22 | Variation of vertical displacement difference between measurement points with the broken strip stone length. **a** Y6-Y9; **b** Y8-Y10. “-” represents a minus sign.

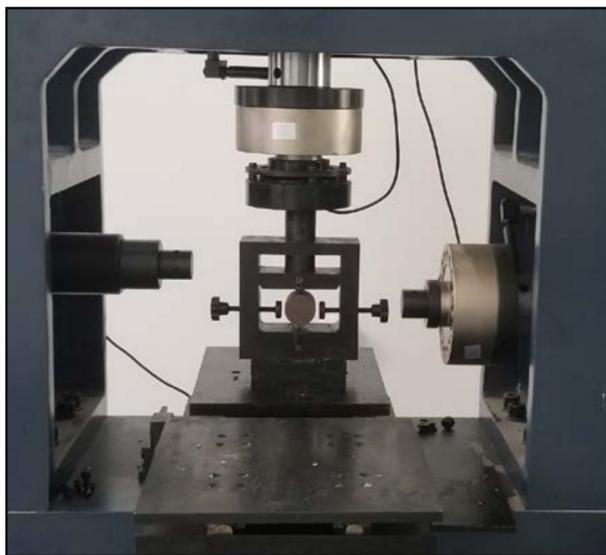
The samples obtained from the three drilling locations were subjected to Brazilian splitting tests under both dry and saturated conditions, as shown in Fig. 23. Figure 24 shows the tensile strength of the rock mass at different depths in the Yuanjue Cave area under dry and saturated conditions (averaged from the three sampling points). To show the tensile regions and the magnitude of tensile stress at the bottom of the roof, Fig. 25 displays the distribution of maximum principal stress in the roof of Yuanjue Cave under varying lengths of broken strip stones. The negative region is caused by compression due to the contact between the roof and the strip stones, and is unrelated to the tensile region at the roof.

**Fig. 23 |** The Brazilian splitting experiment.

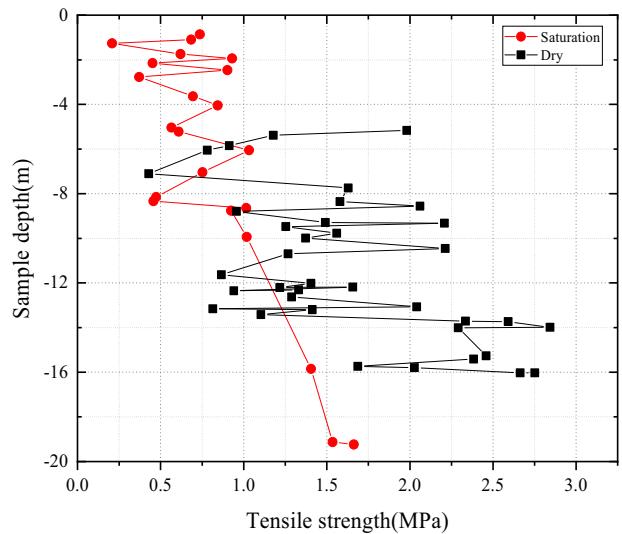
(1) As shown in Fig. 24, changes in moisture content significantly affect the tensile strength of the rock. The tensile strength in saturated conditions is markedly lower than that in dry conditions, and the closer the rock is to the

surface, the lower the tensile strength, with the lowest value being less than 0.25 MPa.

**Fig. 24 |** Tensile strength of rock mass at different depths in dry and saturated conditions.

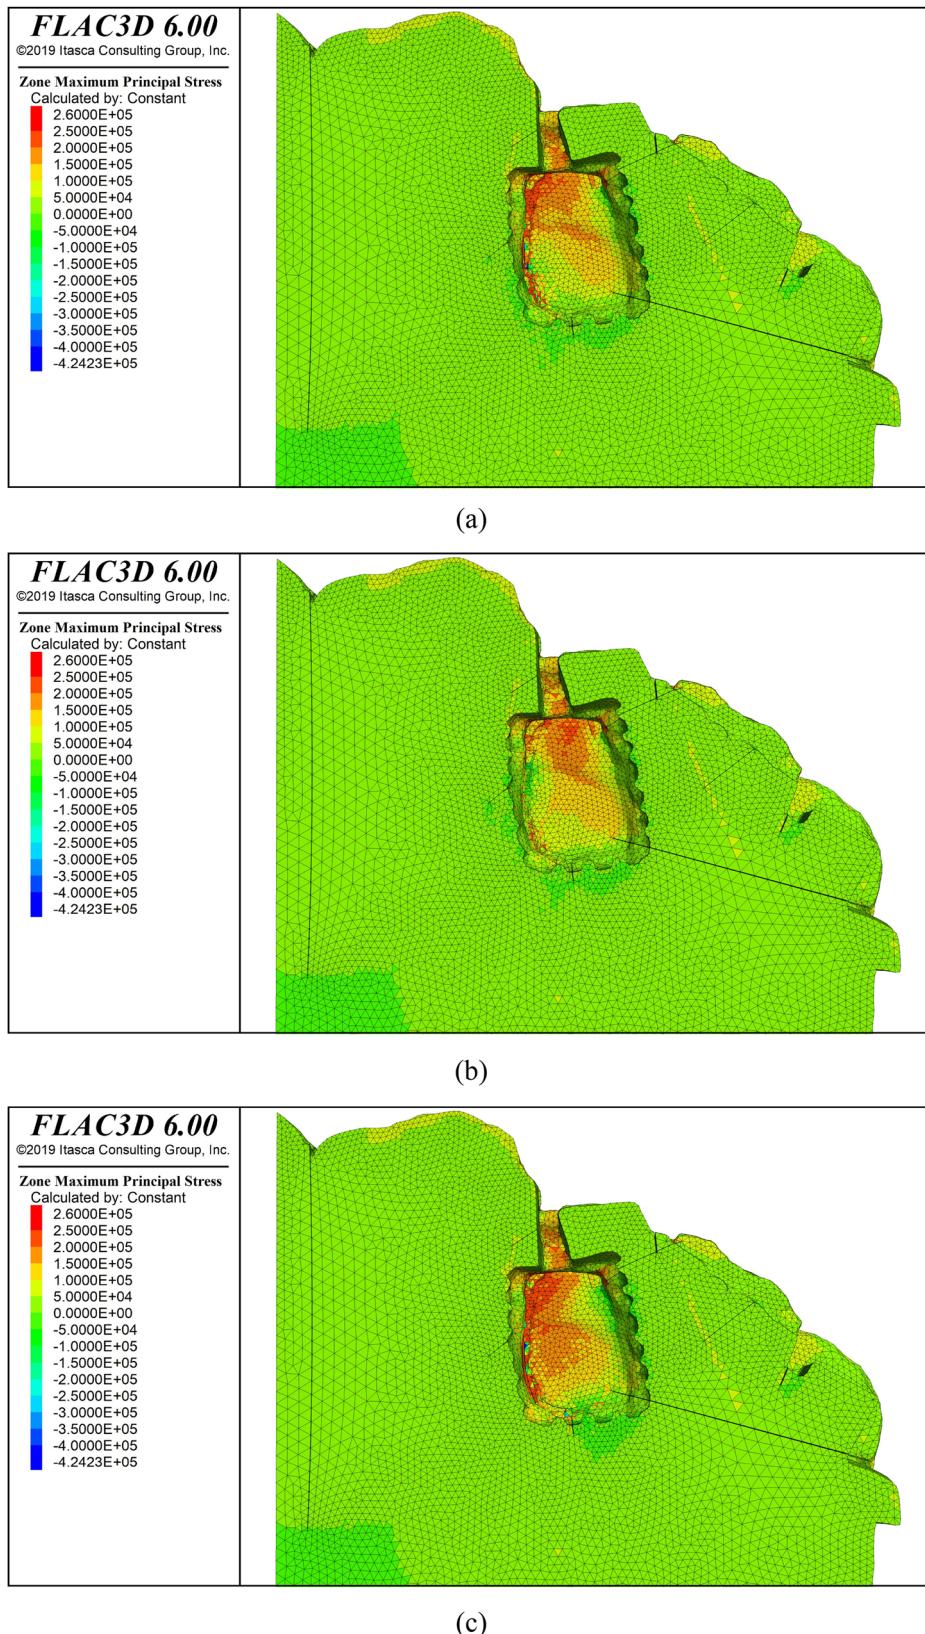
(2) Fig. 25 shows that the bottom surface of the roof in Yuanjue Cave is under tensile stress, and as the length of the broken strip stones increases, the maximum principal stress (tensile stress) at the bottom surface of the roof also gradually increases. The maximum value has already exceeded the tensile strength of the surface rock in saturated conditions (0.25 MPa), and the region of concentrated tensile stress shifts from initially being above the cave entrance to progressively moving towards the left front side of the cave entrance.

Fig. 25 | Cloud diagrams of maximum principal stress on the roof under different broken strip stone lengths. **a** Broken strip stone length 5 m; **b** Broken strip stone length 9 m; **c** Broken strip stone length 14 m. Regions with deeper red coloration indicate higher principal stress values.

infiltrates from outside the cave or condensation occurs inside, the moisture content of the surface rock of the roof increases, further reducing its mechanical properties. As the bottom surface of the roof is under tensile stress (Fig. 25), when the tensile stress in certain areas exceeds the tensile strength of the surface rock, laminar peeling occurs under its own weight (Fig. 8). Therefore, under identical rock properties and environmental conditions, the uneven stress deformation at the bottom of the roof can reflect the area of uneven peeling. It can be concluded that as the length of the broken strip stones increases, the area prone to peeling on the roof gradually shifts from above the entrance to the left front side of the cave entrance.

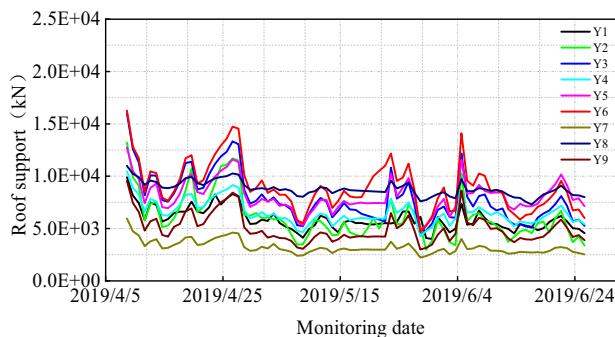
As shown in Fig. 26, the monitored support force values for the roof of Yuanjue Cave exhibit relatively small overall variations. Based on the roof area and thickness combined with the average density of the rock, the total

weight of the roof is estimated to be approximately 570 tons. The sum of the maximum support forces at all measurement points is about 7.7 tons, which is less than 2% of the total weight of the roof. This indicates that the roof of Yuanjue Cave remains stable overall and that the primary support force is provided by the existing boundary conditions.

Fig. 26 | Monitoring data of roof support force in Yuanjue Cave.

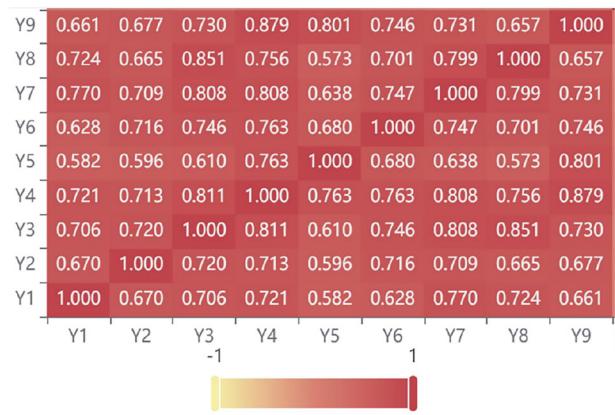
Fig. 27 | Correlation heatmap between the support force measurement points on the roof of Yuanjue Cave.

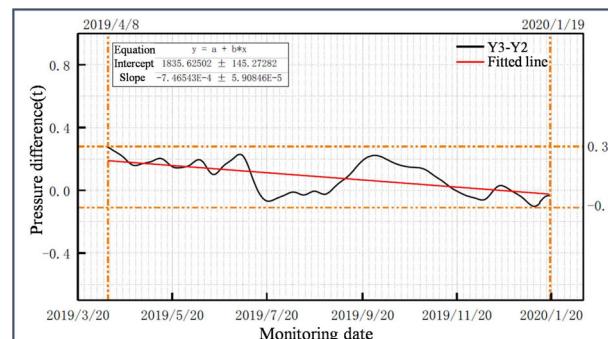
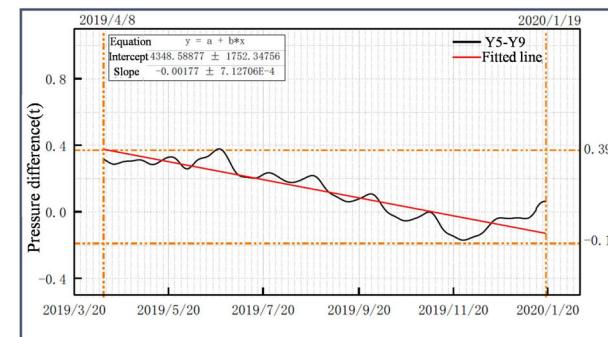
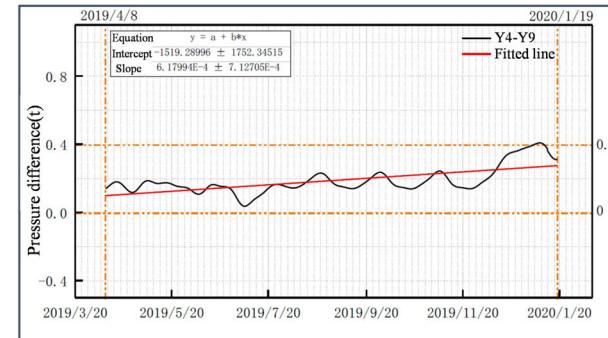
As shown in Fig. 28, the variation curves of the differences in support force at each measurement point on the roof of Yuanjue Cave are relatively small and overall stable. However, based on the fitted lines, it can be observed that the difference curves exhibit a certain trend of development, and the slopes of the fitted lines for different measurement points vary, indicating that uneven deformation has occurred in the roof of Yuanjue Cave. The remaining support force measurement points were analyzed in

Fig. 28 | Difference and linear fitting results between the support force at roof measurement points. a Y3-Y2; b Y5-Y9; c Y4-Y9. “-” represents a minus sign.

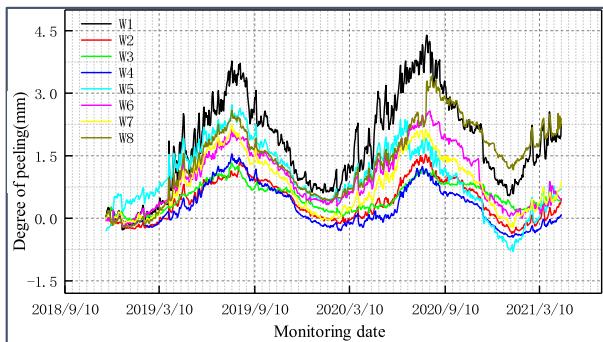
Fig. 29 | Peeling monitoring data of Yuanjue Cave roof.

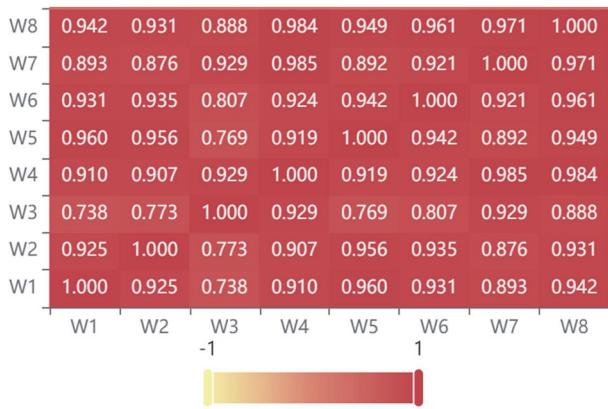
Fig. 29. To explore the correlations between changes in peeling at different roof measurement points and assess the uneven stress distribution at the bottom of the roof, a correlation heatmap was generated for the peeling measurement points using the same analysis method as for the support force measurements. The resulting heatmap is presented in Fig. 30.

(3) Among the measurement points on the left side of the roof, the correlation between W1 and W2, as well as between W3 and W4, is relatively high, while the correlation between W2 and W3 is lower. This is consistent with the field observation that the length of the broken strip stones extends to between W2 and W3. This suggests that the breakage of the supporting strip stones has caused uneven stress on the left side of the roof, resulting in a lower correlation between the peeling in the front and rear regions.

Fig. 30 | Correlation heatmap between the peeling measurement points on Yuanjue Cave roof.

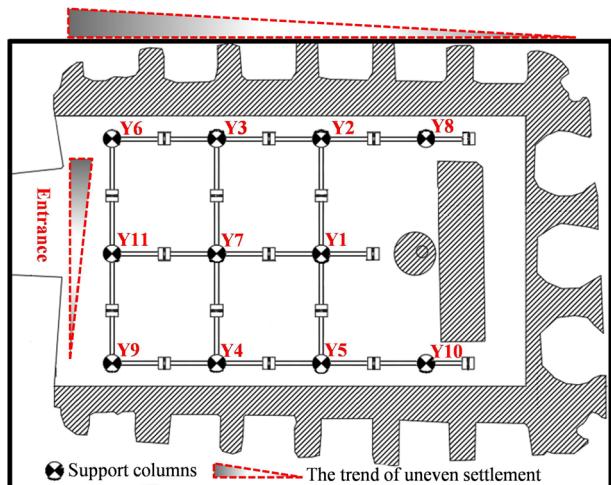
Fig. 32 | Uneven settlement development trend derived from support force monitoring.

The development trend of uneven settlement in the roof of Yuanjue Cave can be derived from the changes in the temporary support forces over time, as shown in Fig. 32. Compared to field monitoring, the mechanical state in numerical simulations reflects more extreme conditions. However, both exhibit the same deformation development trend under the condition of strip stones broken. Therefore, the verification of field monitoring results against numerical simulation results focuses not on absolute values but primarily on comparing deformation development trends. It can be observed that the trend of uneven settlement derived from field temporary support force monitoring data is consistent with the uneven deformation trend obtained from numerical simulations in Fig. 19, with both indicating a tilting and settlement towards the left front side of the cave entrance. The

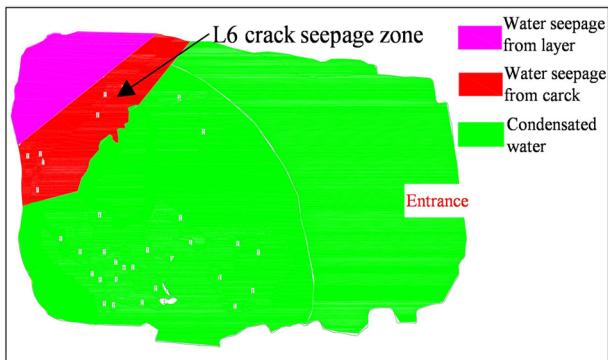
Based on the overall seepage condition of Yuanjue Cave's roof observed during the field survey (Fig. 31), the reason for the severe peeling at measurement point W8 is primarily that it is located within the seepage zone of fracture L6, where rainwater infiltration has accelerated the peeling process. Since the roof seepage is mainly concentrated in the right rear (southwest

Fig. 31 | Seepage condition of Yuanjue Cave roof.

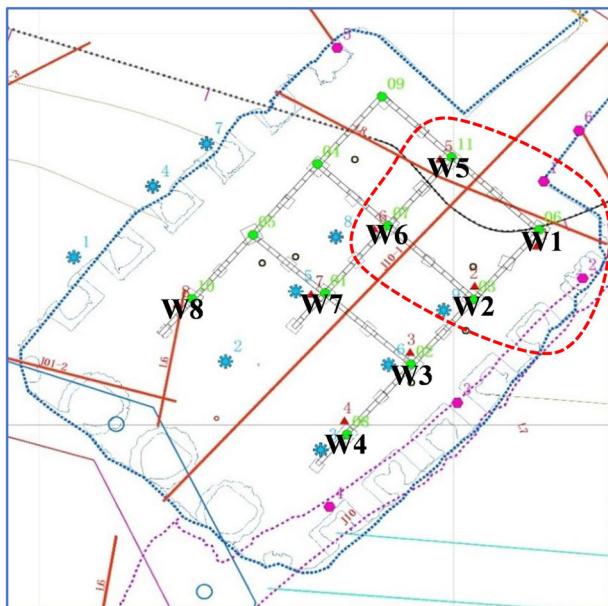
and laterally. This indicates that the region enclosed by points W1, W2, W5, and W6 experiences the most intense differential peeling development, both in the longitudinal and lateral directions.

**Fig. 33 | Region of most intense uneven stress development derived from peeling monitoring.**

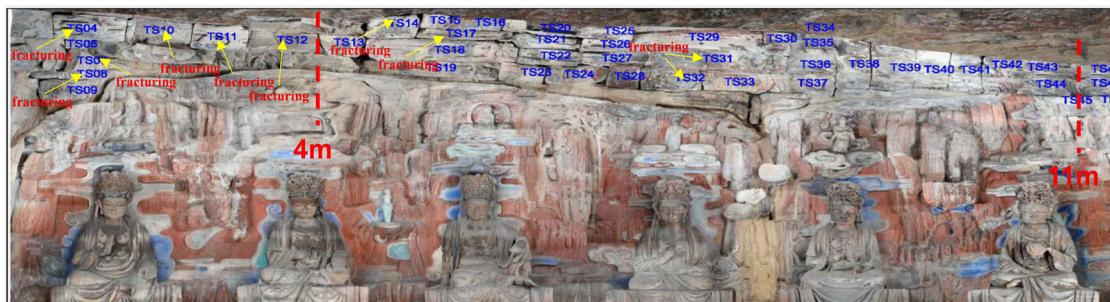
Fig. 34 | Schematic diagram of the current condition of crushed strip stones in Yuanjue Cave.

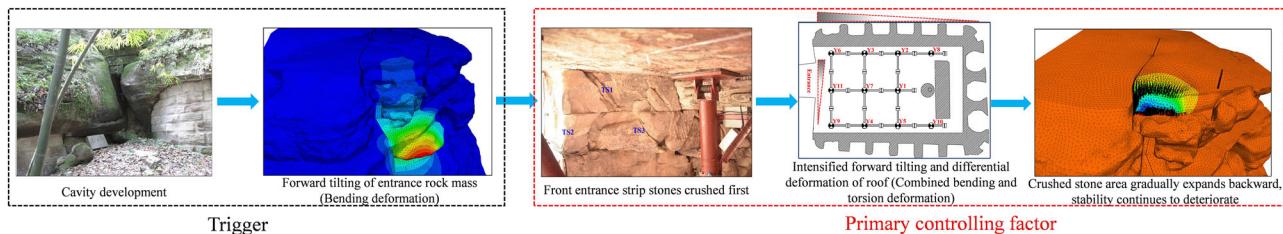
Combining the results from numerical simulations and field monitoring analyses, the deformation and failure development process of Yuanjue Cave's roof is as follows: First, the development of cavity depth causes the rock mass near the cave entrance to tilt forward, resulting in differential deformation between the front and rear parts of the roof (bending deformation). Subsequently, the differential deformation between the front and rear parts of the roof increases the pressure on the strip stones at the front of the cave entrance, leading to their initial failure. As the supporting capacity of the crushed strip stones at the front entrance declines significantly, the forward tilting and differential

Fig. 35 | Development process of instability and failure of Yuanjue Cave roof.
