An application of AHP-based fire vulnerability assessment for 20th century mountainous built heritage

This study applies the Analytic Hierarchy Process (AHP) framework to evaluate fire safety risks in 36 historic buildings in Nan'an District, Chongqing, a mountainous urban area with complex geographical and environmental challenges. The research highlights the interplay between geographical clustering, environmental factors and fire safety infrastructure, revealing the tension between preserving the authenticity of heritage buildings and implementing modern fire safety measures. By integrating with field surveys, the study identifies and prioritises critical vulnerability factors. The findings demonstrate the effectiveness of the AHP framework in systematically quantifying fire risks and providing actionable insights for decision-making. Recommendations are proposed to enhance fire safety, including tailored infrastructure improvements, strengthened management practices, and the integration of unobtrusive fire suppression technologies. This research contributes to the advancement of risk assessment methodologies in heritage conservation and offers a foundation for extending the AH

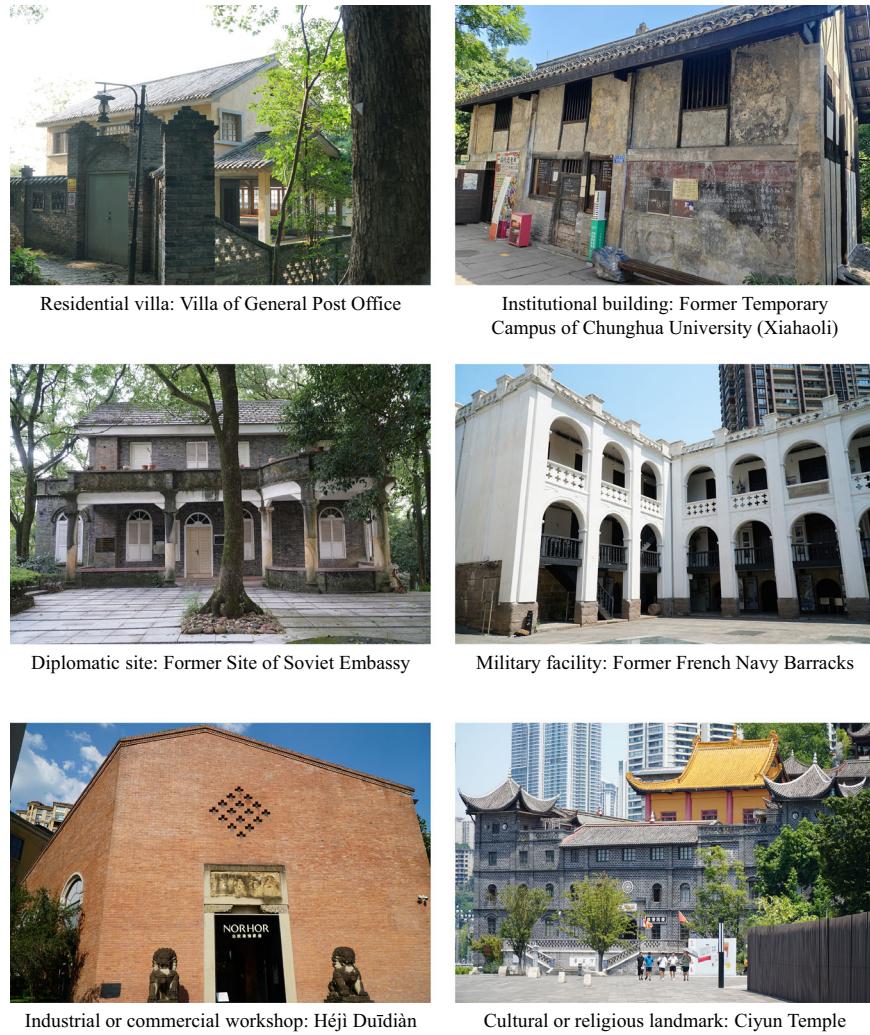
Fig. 1 | Example of surveyed heritage buildings.

The heritage buildings surveyed in this study encompass a diverse range of uses, including residential villas (Villa of General Post Office), institutional buildings (Former Temporary Campus of Chunghua University), diplomatic sites (Former Site of Soviet Embassy), military facilities (Former French Navy Barracks), industrial or commercial workshops (Héji Duidiàn) and cultural or religious landmarks (Ciyun Temple).

Functionally, the heritage buildings encompass a diverse range of uses (Fig. 1), including residential villas (e.g., the Villa of General Post Office), institutional buildings (e.g., the former campus of Chunghua University), diplomatic sites (e.g., former embassies), military facilities (e.g., Former French Navy Barracks), industrial or commercial workshops (e.g., Héjì Duidiàn) and cultural or religious landmarks (e.g., temples like Ciyun Temple). This functional diversity underscores the historical significance of the district while adding complexity to preservation and fire vulnerability assessment, as each building type presents distinct vulnerabilities based on its original purpose and materials. By understanding the specific characteristics of each building type, conservation strategies can be tailored to address the unique vulnerabilities associated with each structure.

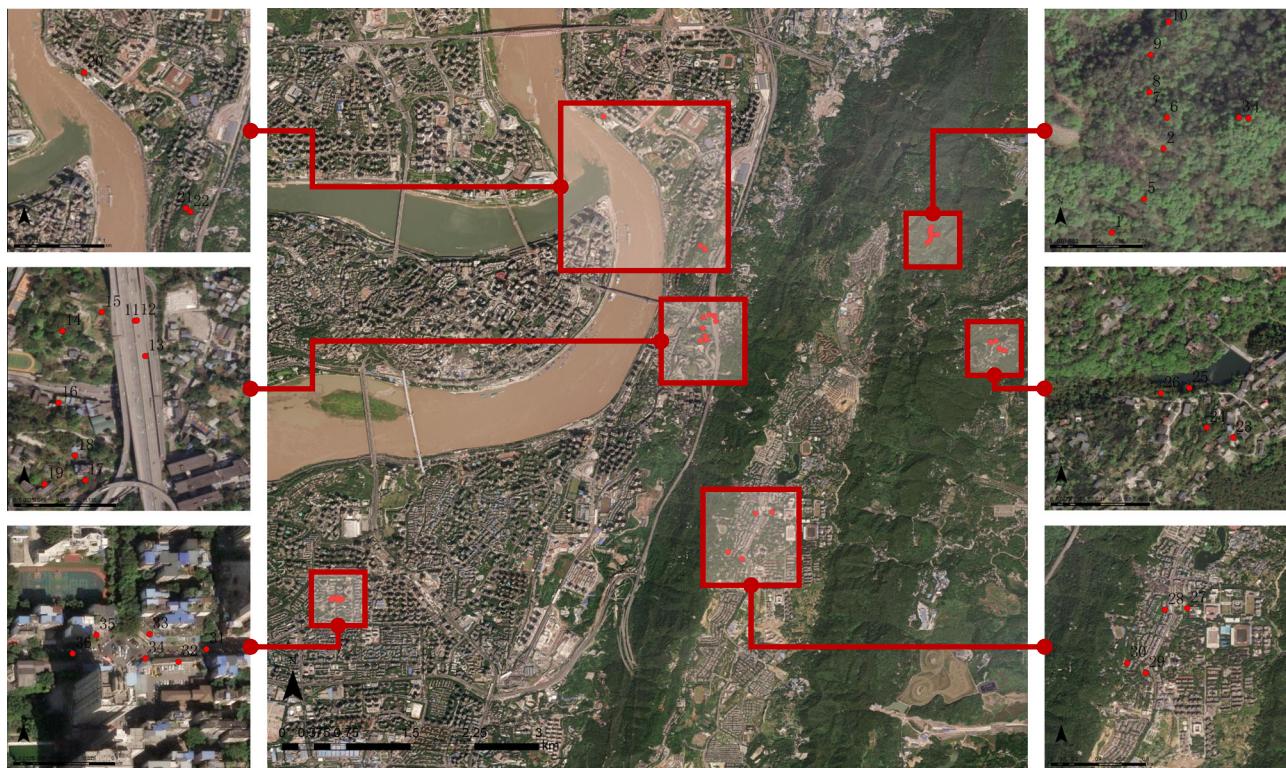
Fig. 2 | Location of case studies (developed by author based on the aerial images acquired from the National Platform for Common GeoSpatial Information Services of China (Tianditu), www.tianditu.gov.cn). The central panel shows the general distribution of the surveyed heritage sites, and the panels on the both sides

shows the distribution of the sites in the clusters. Upper left: Danzishi and Ciyun Temple; upper right: CHSMRJ; middle left: Mishi Jie and Longmenhao; middle right: Nanshan Botanic Garden; lower left: Chongqing Image; lower right: Huangjiaoya.

The location of these historic buildings is distributed across distinct terrain-based clusters (Fig. 2), each with unique environmental conditions that influence their preservation needs. The riverfront plain clusters, such as Longmenhao, Mishi Jie, Danzishi and Cuiyun Temple, are situated on flat terrain along the Yangtze River. These areas historically benefited from easy trade access. The mountain slope clusters, including Chongqing Historic Sites Museum of Resistance against Japan (CHSMRJ) and Nanshan Botanic Garden, are located on steep, forested slopes. Buildings here are adapted to rugged terrain, offering strategic views but dealing with significant accessibility challenges and heightened maintenance demands due to the steep, natural landscape. Lastly, the hillside terrace clusters, located in areas like Huangjiaoya and Chongqing Image, are positioned on moderate slopes that allow for terraced architecture, balancing scenic views with manageable elevation. However, hillside clusters still encounter issues related to soil stability and erosion. These classifications—riverfront plains, mountain slopes and hillside terraces—highlight the diverse environmental factors impacting Nan'an's heritage sites, each requiring tailored conservation and fire safety strategies to address their specific challenges.

Among the 36 heritage buildings analysed in this study, their geographical distribution demonstrates a clear clustering pattern, as shown in Fig. 2. This clustering is not only evident in the physical distribution of the buildings but also reflected in their calculated fire safety scores. The fire

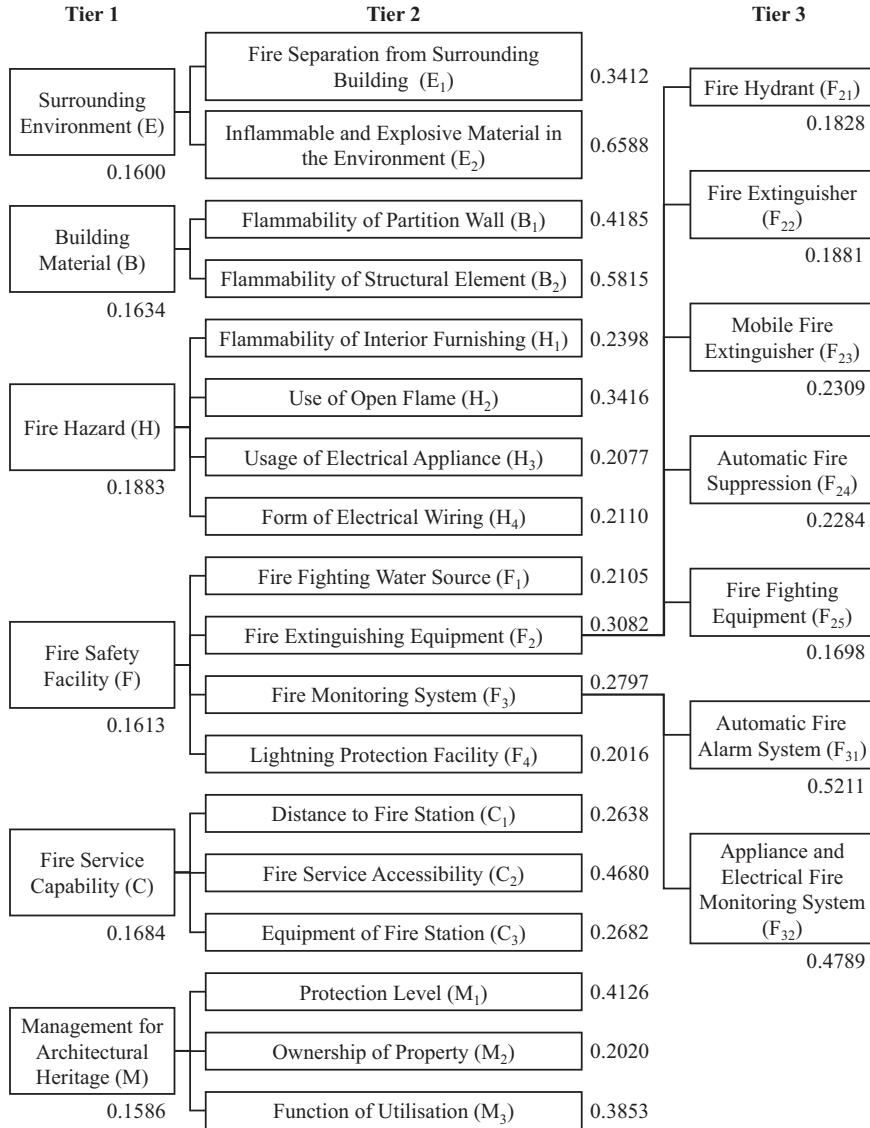
Fig. 3 | Fire safety factor framework for built heritages in Nan'an District with weights for fire safety factors. This framework contains 23 items and is categorised into 3 tiers. Each item is marked with a code in the brackets, and the weights of each item are on the right or bottom side of the box.

Regarding to the realistic condition of the built heritages in Nan'an District and previous relevant studies, a purposed fire safety factor framework for AHP assessment is formulated as Fig. 3, which contains 23 items and is categorised into 3 tiers. This comprehensive approach ensures that the diverse factors influencing fire safety in heritage contexts are adequately addressed, with particular attention to the unique challenges presented by Nan'an District's mountainous geography. The weights for each factor is acquired from an expert survey, and will be explained in later sections.

By using the same approach, the weights for the remaining Tier 2 and 3 factors can be calculated, as the numbers shown next to the factors in Fig. 3, and the normalised weight coefficient values of all factors are obtained, as shown in Fig. 4.

Among the Tier 1 factors (Fig. 3), Fire Hazard (0.1883) is significantly at the top of the experts' priorities due to its direct influence on fire ignition and spread. The use of open flames, electrical appliances, and flammable material inside the building are seen as critical contributors to fire vulnerability. The following is Fire Service Capability (0.1684), which reflects the importance of timely and effective emergency responses. The accessibility to fire stations and the adequacy of firefighting equipment as essential for controlling fire incidents, especially in the challenging terrain of mountainous areas where logistical delays can have severe consequences (Figs. 5, 6). Building Material (0.1634) is also regarded as highly critical, as it directly relevant to the flammability of the structure (Fig. 7). The significance of using fire-resistant materials to mitigate the flammability of structural elements, partition walls, and interior furnishings is noted. Fire Safety Facility (0.1613) is another key consideration, as it encompasses the presence of automatic fire alarms, extinguishing systems, and other essential equipment. Effective safety facilities enable early detection and response, particularly in remote areas where delays in firefighting accessibility are common (Fig. 8). This is particularly crucial in densely built heritage clusters, which are typical of mountainous urban areas. While still important, Surrounding Environment (0.1600) directly affects the potential for fire spread. It is necessary to manage external hazards, such as the presence of flammable materials and the adequacy of fire separation between buildings. Finally, Management for Architectural Heritage (0.1586) is slightly less critical compared to the factors above. Nevertheless, robust management strategies, including effective governance, property protection levels, and appropriate building utilisation, can balance fire safety with the conservation of cultural and historical values. In summary, among the Tier 1 factors experts prioritise the ones that directly influence fire ignition, spread and response

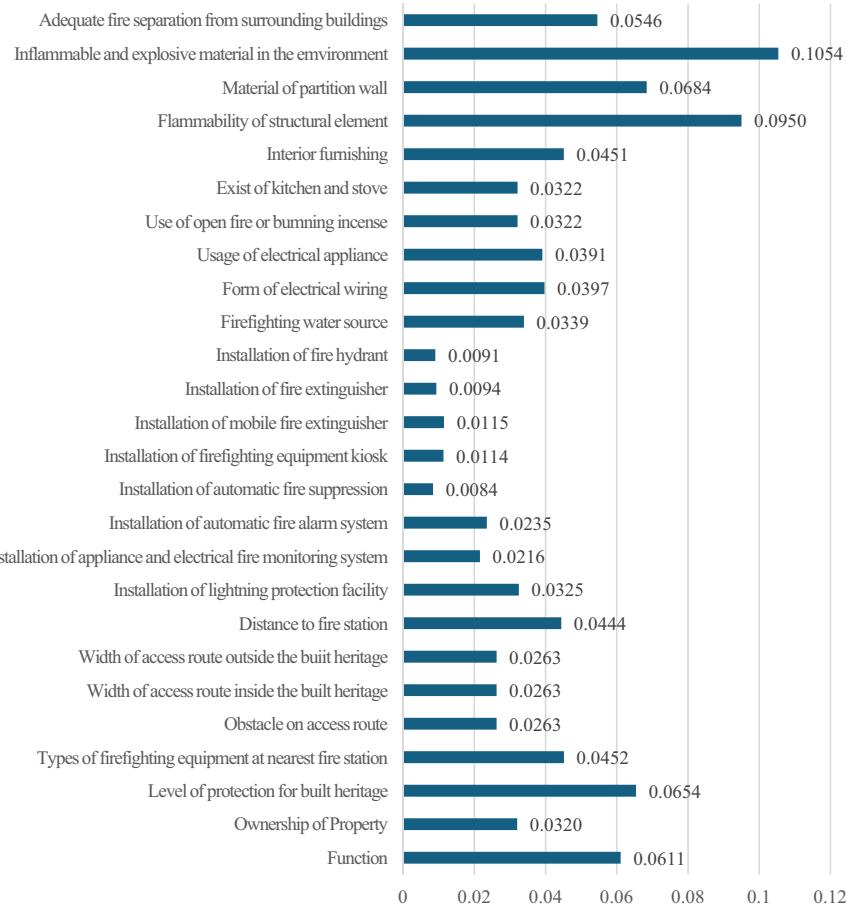
Fig. 4 | Normalised weight coefficient values for all fire safety factors. This normalised weight coefficient values are calculated by multiplying the weights of the Tier 1, 2 (and 3, where applicable) items in the fire safety factor framework.

While comparing the subdivided factors using the homogenised weight coefficients (Fig. 4), the results indicate that experts prioritise factors related to environmental hazards and structural vulnerabilities. Inflammable and explosive materials in the environment (0.1054) and flammability of structural elements (0.0950) are ranked as the most critical. These

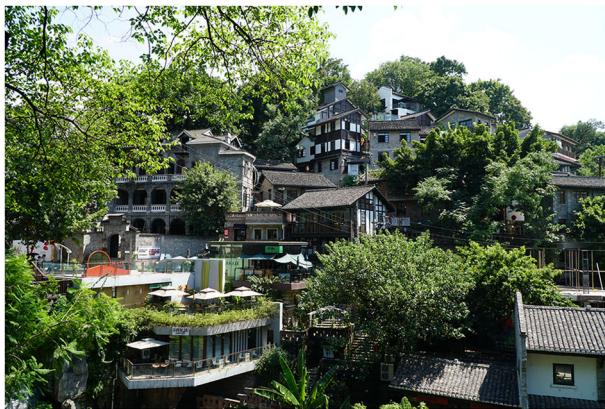
Fig. 5 | The mountainous landscape at Mishi Jie. This landscape especially essences the accessibility to fire stations and the adequacy of firefighting equipment for controlling fire incidents.

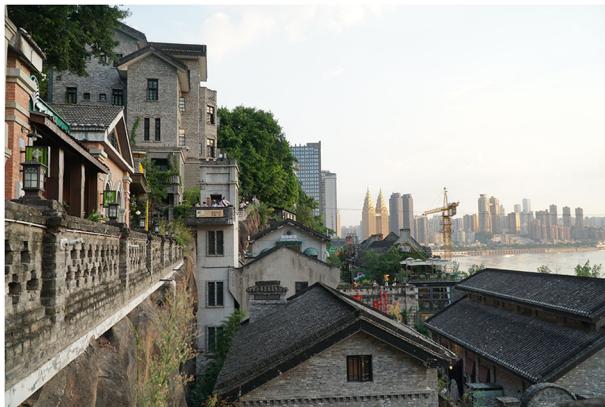
Fig. 6 | The mountainous landscape at Longmenhao. This landscape especially essences the accessibility to fire stations and the adequacy of firefighting equipment for controlling fire incidents.

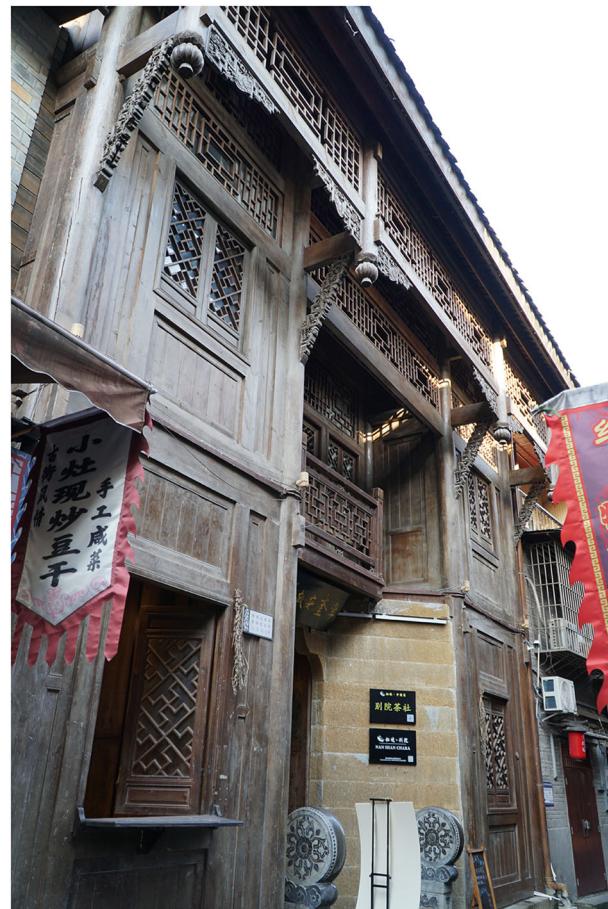
Fig. 7 | The Flammable main façade of the Former Residence of Li Kui'an. The use of flammable material aggravates the fire vulnerability of the historic building.

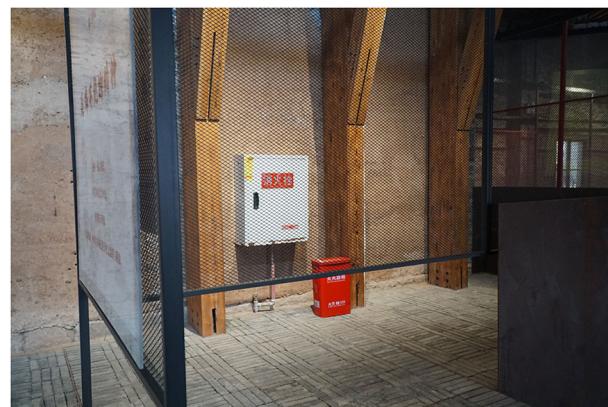
Fig. 8 | Fire safety facilities at Former Site of Anderson & Co. Company. This safety facilities enable early detection and response to control the fire at its beginning and to minimise the damage.

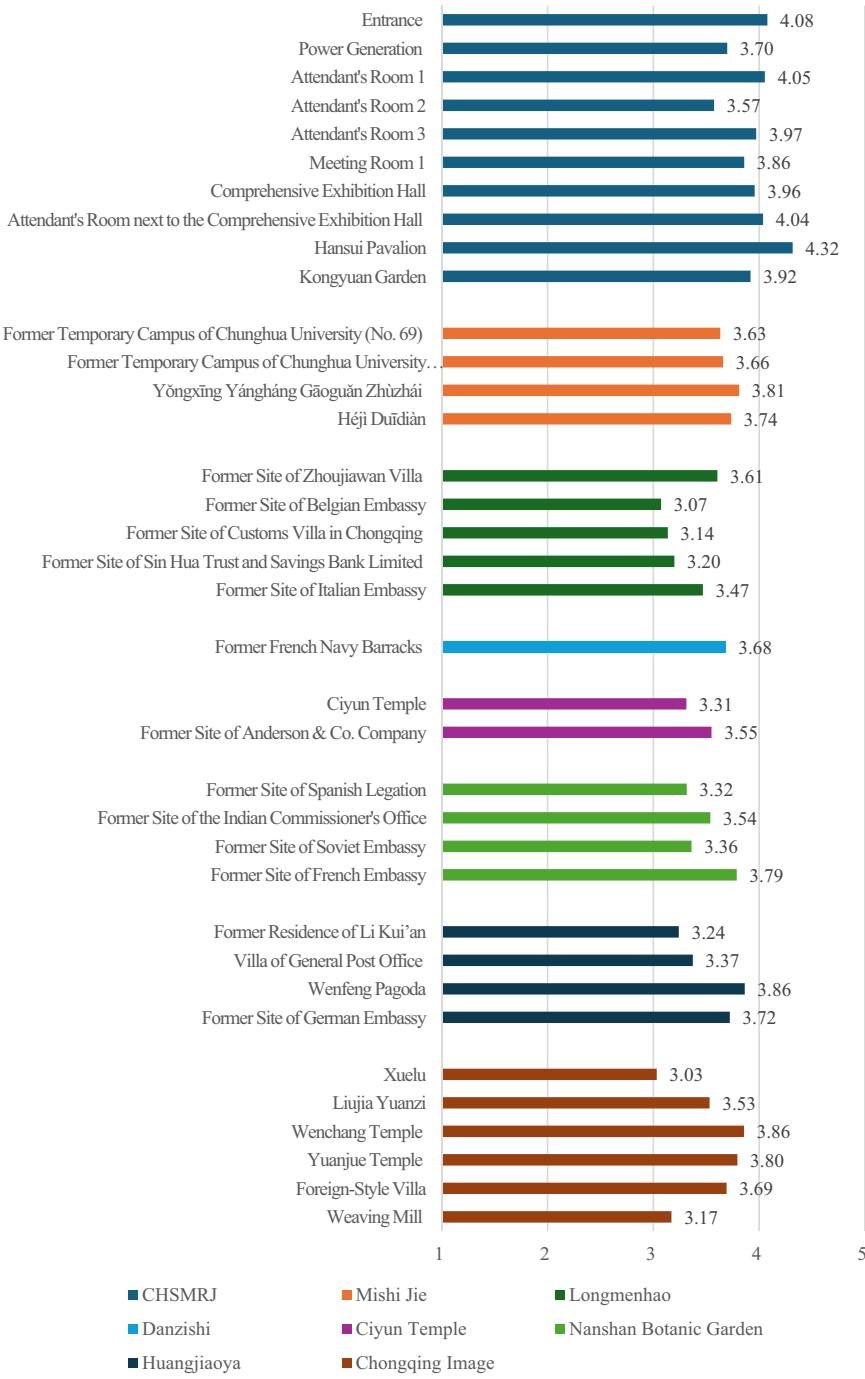
Fig. 9 | Score of fire safety for the surveyed 36 heritage buildings with group by eight clusters.
Each cluster is grouped and marked with a colour.

safety scores, derived using the evaluation method employed in this research, exhibit a notable tendency to cluster geographically (Fig. 9). This correlation between fire safety scores and geographical groupings is likely influenced by shared conditions within the same cluster, such as similar firefighting accessibility, rescue capabilities and management practices. For example, buildings with higher fire safety scores (indicating lower fire vulnerability levels) are primarily found within the CHSMRJ cluster. Among

these, the Hansui Pavilion achieves the highest score, representing the lowest fire vulnerability. This favourable score is not only a reflection of the broader advantages provided by the cluster but is also linked to the specific architectural and structural characteristics of the Hansui Pavilion itself.

Conversely, buildings with lower fire safety scores (indicating higher fire vulnerability levels) are concentrated within the Longmenhao and Chongqing Image clusters. Notable examples include the Former Site of the Belgian Embassy and Xuelu, both of which exhibit the lowest scores among the assessed heritage buildings. This concentration of higher fire vulnerability within these clusters suggests that certain shared challenges, such as limited firefighting infrastructure, less effective management practices, or higher density of combustible materials, may contribute to the increased vulnerability of buildings in this area.

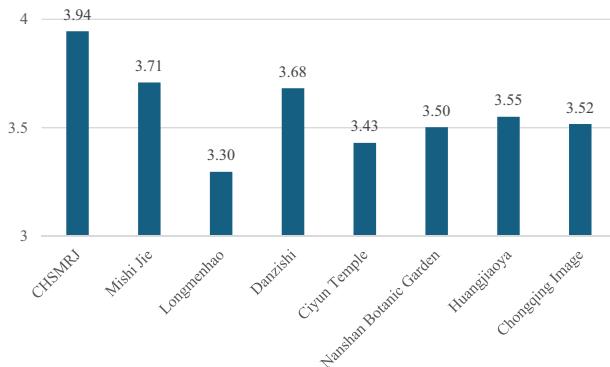
Fig. 10 | Score of fire safety for the eight clusters. This score is the average score of the heritage sites in each cluster.

To further understand the vulnerability distribution, the average fire safety scores for each geographic cluster were calculated. This analysis highlights the overall fire safety conditions of the clusters and allows for comparisons between them (Fig. 10). The CHSMRJ cluster has the highest average vulnerability score of 3.94, indicating the lowest vulnerability among the clusters. This reflects the presence of favourable conditions such as well-maintained fire safety infrastructure, effective management practices, and architectural features that mitigate fire hazards. The Mishi Jie and Danshizi clusters follow closely with a score of 3.71 and 3.68, also suggesting a strong emphasis on fire safety measures within this area. Clusters such as Huangjiaoya (3.55), Chongqing Image (3.52), Nanshan Botanic Garden (3.50), and Ciyun Temple (3.43) exhibit moderate fire safety scores. These clusters are

characterised by reasonably effective fire safety measures, although there may be some areas requiring improvement. The Longmenhao cluster has the lowest average score of 3.30, indicating the highest vulnerability among the clusters. This score suggests challenges such as

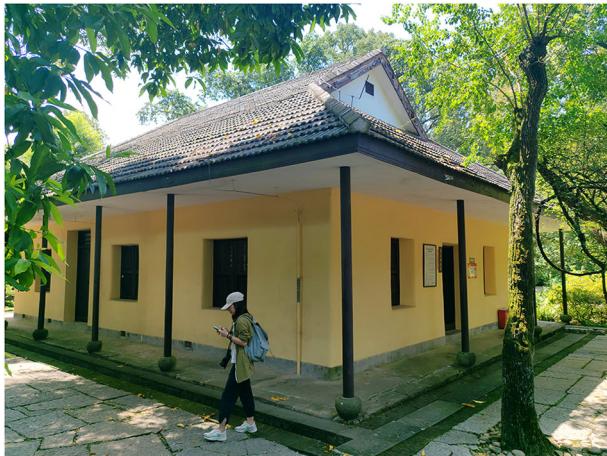
Fig. 11 | Recent restored the Attendant's Room 1 at CHSMRJ. This shows that the anti-war heritage sites have gained increasing prominence in recent years as key elements of Chongqing's urban heritage conservation efforts.

of Chongqing's urban heritage conservation efforts. Many of these sites are currently undergoing or have recently undergone restoration, and visitor numbers have been steadily rising (Fig. 11). To mitigate fire vulnerabilities associated with increased usage, measures such as the installation of fire extinguishers and fire alarm systems could be implemented. In contrast, the Nanshan Botanic Garden remains largely unopened, with most buildings, such as the Former Site of the Spanish Legation (Fig. 12), still in a closed-off state and concealed within the forested area. While the electrical load is minimal in these buildings, their fire safety management is notably weaker.

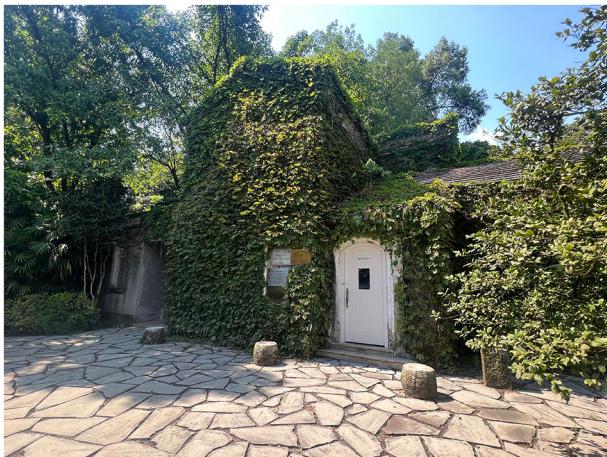
Fig. 12 | Closed Former Site of the Spanish Legation at Nanshan Botanic Garden. The unopening of the heritage sites indicates their weaker fire safety management, although the electrical load is minimal.

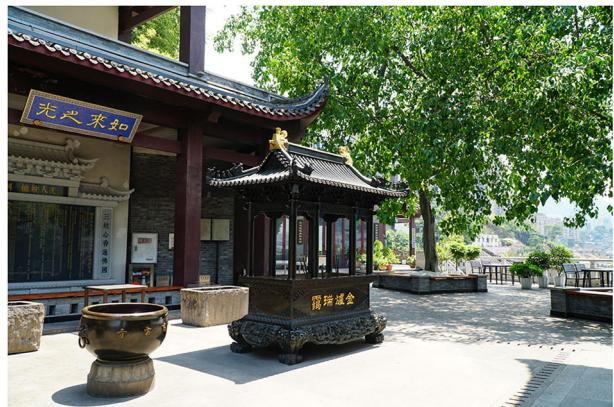
Fig. 13 | Burning incense for prayer at Ciyun Temple. This religion activities lead to higher fire loads to the site.

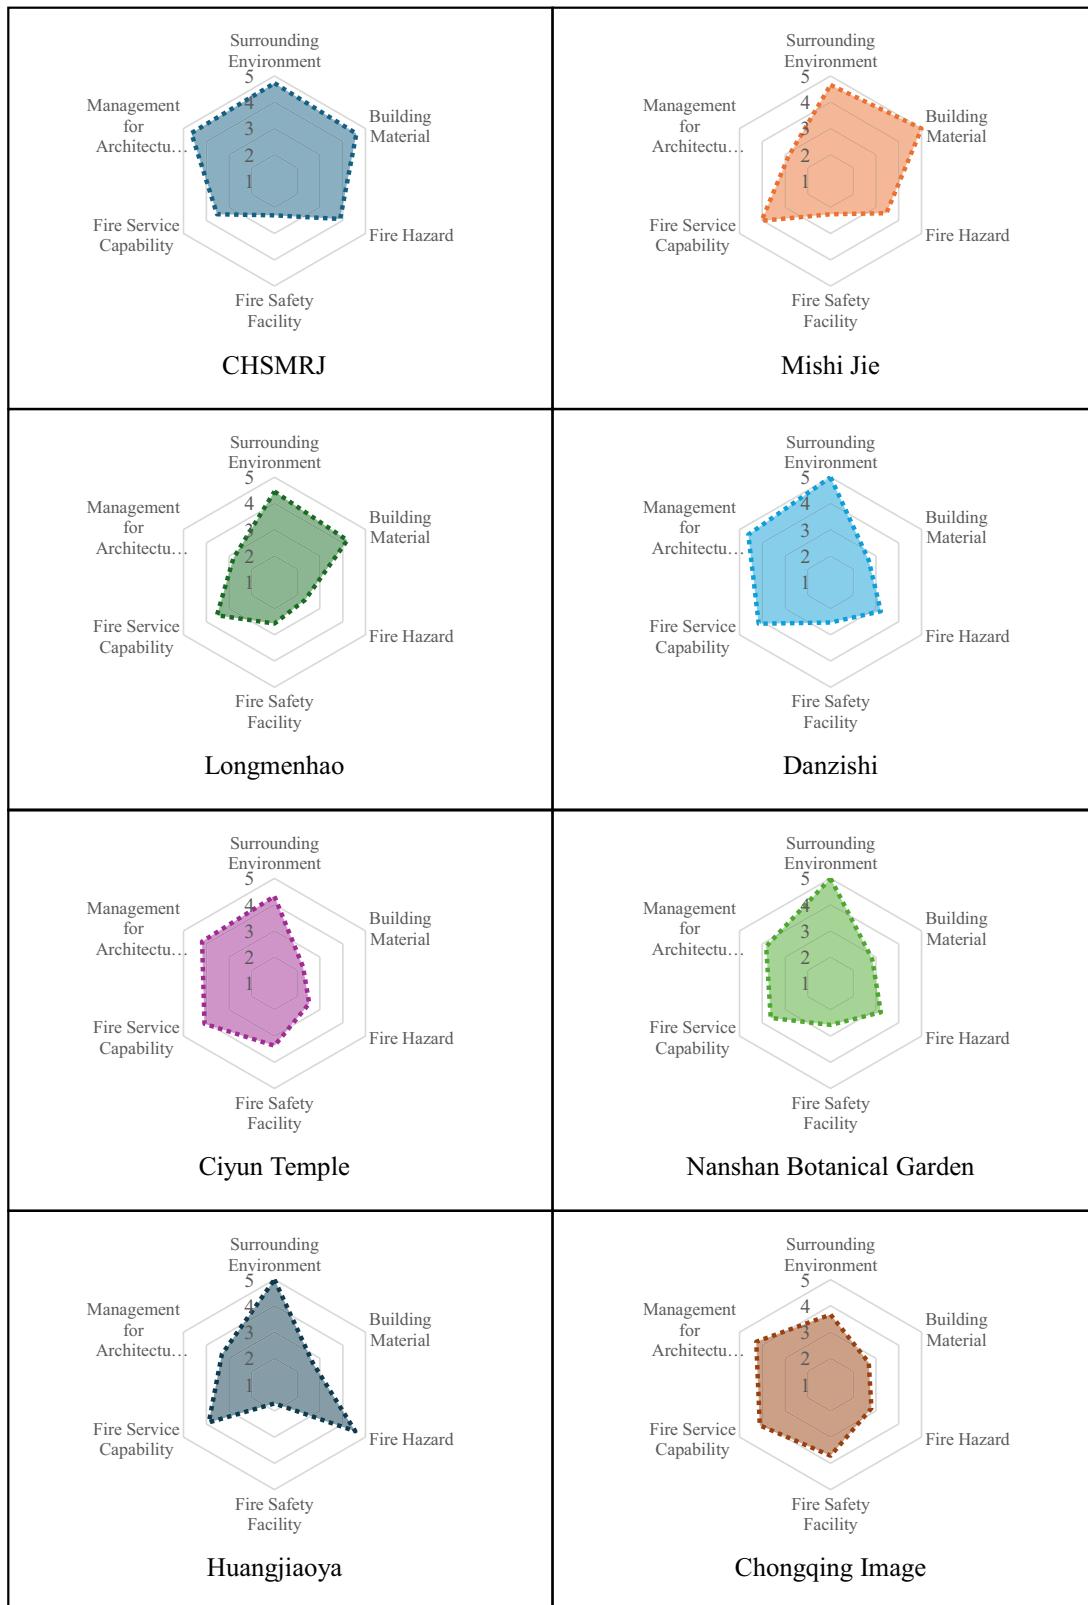
Fig. 14 | Subdivided fire safety score according to the six Tier 1 factors for the eight clusters. The scores are the average scores of the six Tier 1 factors of the heritage sites in the corresponding cluster.

It is important to highlight that, even when two clusters exhibit similar overall fire safety scores, their specific conditions and contributing factors can differ significantly (Fig. 14). For example, the clusters of Chongqing Image and Nanshan Botanic Garden have very close overall scores, with a difference of only 0.02, the smallest margin observed among all pairwise

comparisons in this study. Despite this similarity in their aggregated scores, the underlying factors driving their performance reveal stark contrasts. Nanshan Botanic Garden performs well in Surrounding Environment, benefiting from low-density development, natural separation between buildings, and minimal human activity, which reduce ignition vulnerabilities. However, it performs poorly in the Fire Safety Facility category, indicating potential deficiencies in critical systems such as fire extinguishing equipment, alarm systems, or fire suppression mechanisms. These weaknesses highlight the need for targeted improvements to strengthen its fire safety infrastructure. Conversely, Chongqing Image exhibits an entirely different profile. This cluster is satisfactory in the Fire Safety Facility category, which suggests the presence of adequate firefighting systems and routine-maintained fire safety equipment. However, it underperforms in the Surrounding Environment category, potentially due to challenges such as inadequate fire separation distances, clustering of buildings, or the presence of inflammable materials in the immediate vicinity (Figs. 15, 16). Such environmental vulnerabilities may offset the advantages provided by its strong fire safety infrastructure, emphasising the need for a holistic approach to fire vulnerability mitigation that considers both structural preparedness and external hazard reduction.

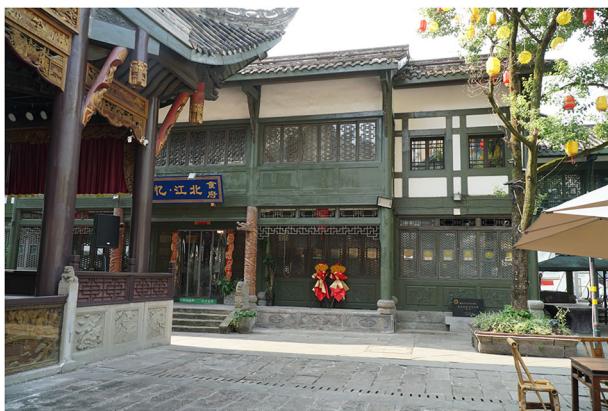
Fig. 15 | Timber framed Xuelu at Chongqing Image, with closely surrounded by timber structures. The inadequate fire separation distances, clustering of buildings and the presence of inflammable materials in the immediate vicinity leads underperformace of the site in the Surrounding Environment category.

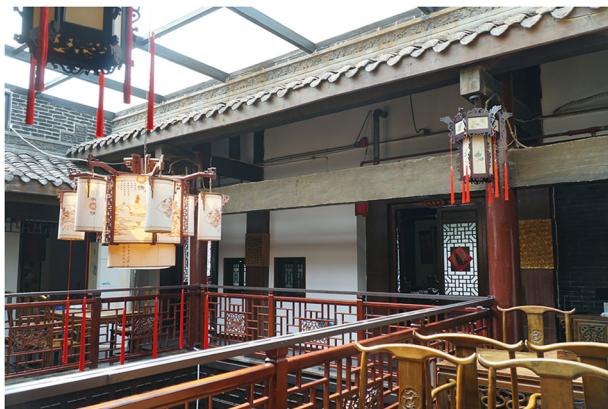
Fig. 16 | Interior of Xuelu at Chongqing Image, revitalised as a restaurant introducing vulnerability of setting up of kitchen and use of open fire. The inadequate fire separation distances, clustering of buildings and the presence of inflammable materials in the immediate vicinity leads underperformace of the site in the Surrounding Environment category.

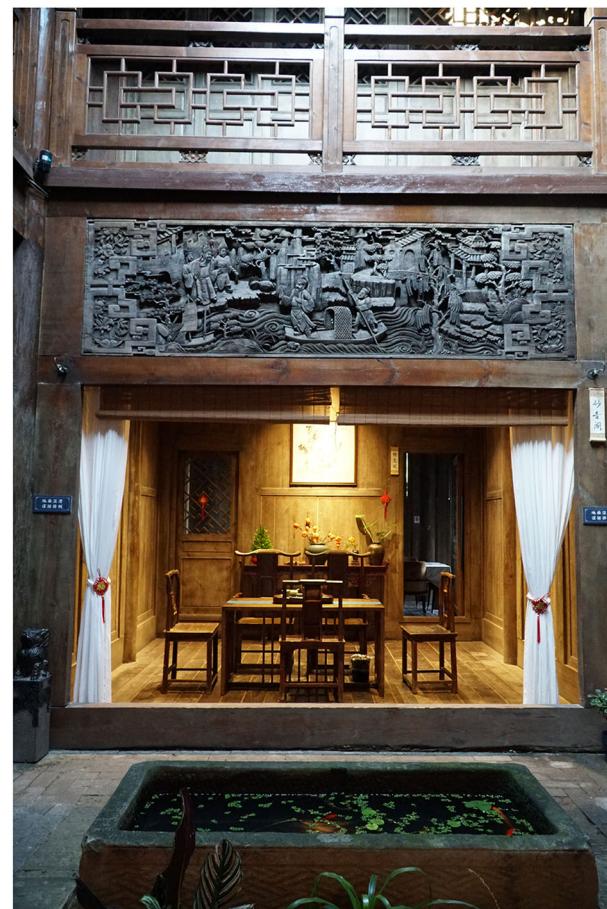
Fig. 17 | Water tank at the Former Residence of Li Kui'an. This is a simple and feasible approach to enhance fire safety of the site. It is also well-fitted with the traditional design of the building.
