Crack propagation risk threshold of classical garden rockeries based on LEFM

Traditional Chinese garden rockeries, exposed to long-term weathering and human activities, often suffer structural deterioration. However, crack propagation risks in these heritage structures have not been numerically analyzed. This study investigates the structural crack propagation risk threshold of rockeries using numerical simulation. A damage survey and data collection were conducted on the Small-rock Mountain Adobe of He Garden in Yangzhou, resulting in a structural crack database and finite element model. Static analysis assessed crack damage and identified primary deterioration causes. Linear elastic fracture mechanics (LEFM) was then used to predict crack initiation and propagation in intact rocks, with outcomes cross-validated against observed damage. Critical propagation paths of major cracks were forecasted at different stages. Finally, crack risk levels were determined using the stress intensity factor, and thresholds for crack growth were obtained, including the corresponding critical crack size and vertical displacement, providing a basis for conservation strategies.

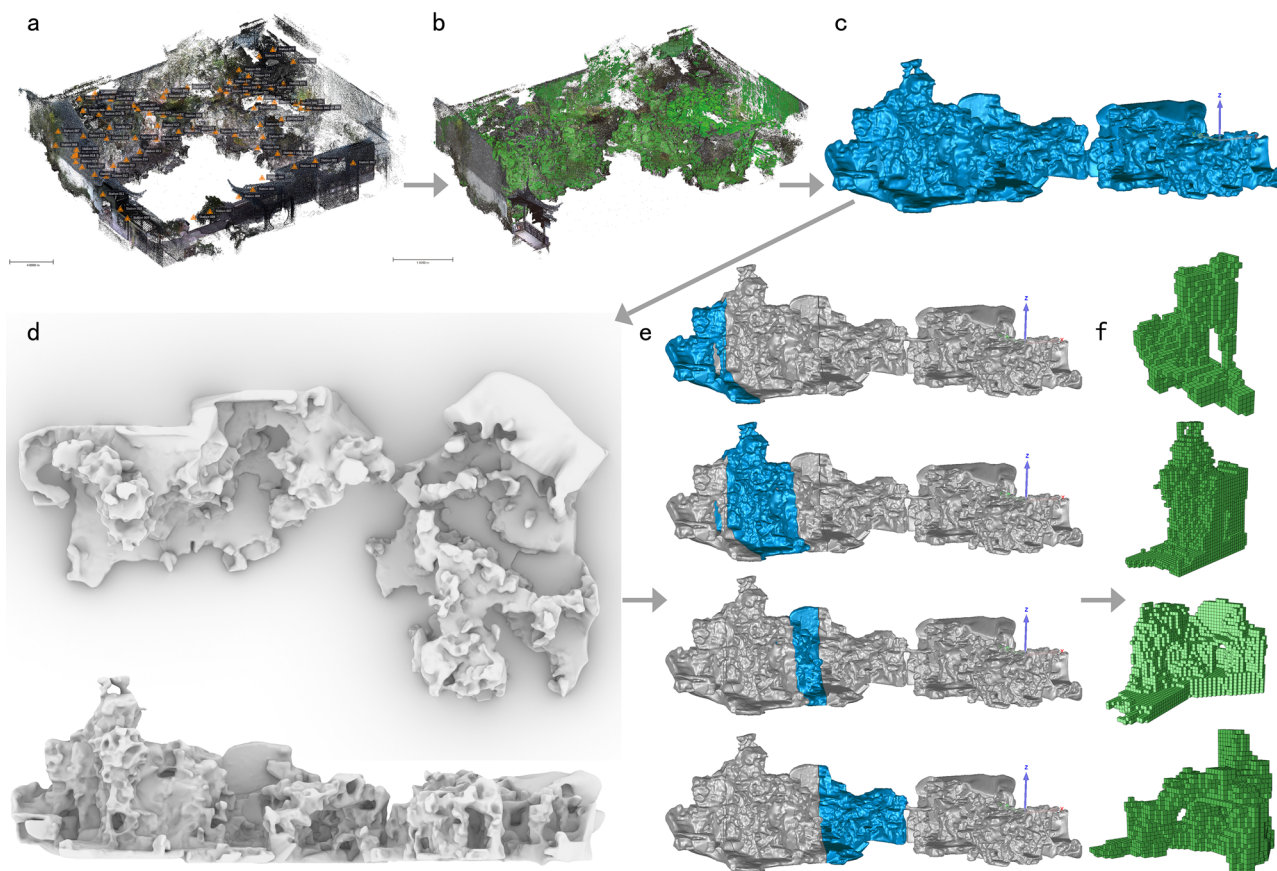
Fig. 5 | Workflow for generating the finite element model of the small-rock mountain adobe. a point cloud data collection, **b** triangular mesh pre-processing, **c** mesh doctor repair, **d** topological simplification model, **e** rock model partitioning, **f** voxel finite element model.

Figure 5 shows an example of the model generation of small-rock mountain adobe (SRMA) from the point cloud to numerical modeling, including triangulation mesh fitting, triangular mesh modeling, and a topological simplification model to voxel model generation⁴⁴. Specifically, the point cloud of the SRMA was first collected using Terrestrial LiDAR Scanning (Fig. 5a). Trimble RealWorks-Geomagic Wrap was used to perform triangular mesh pre-processing (Fig. 5b), mesh doctor repair (Fig. 5c), topological simplification model (Fig. 5d), and rock model partitioning (Fig. 5e). Finally, the “voxel model” of the west side cavern, the west main peak, the main peak east to central area, and the central cavern was obtained by using a $0.2 \times 0.2 \times 0.2$ (m) voxel model (Fig. 5f).

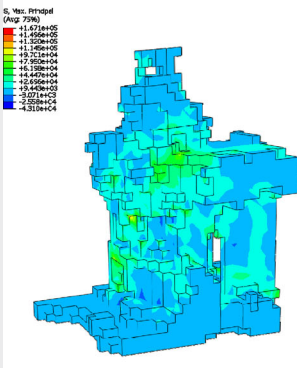
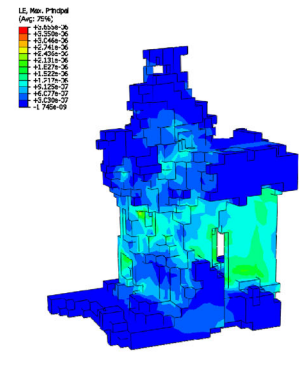
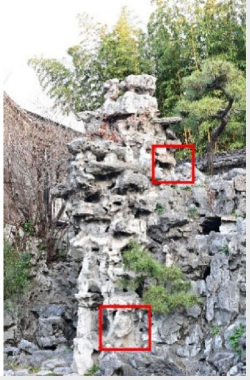
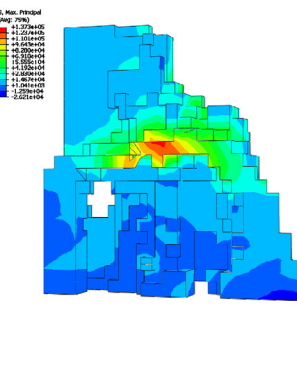
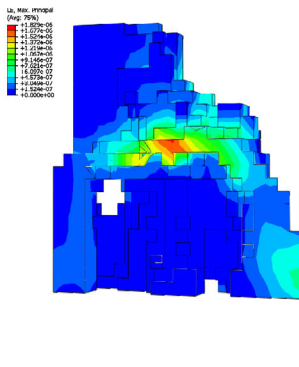
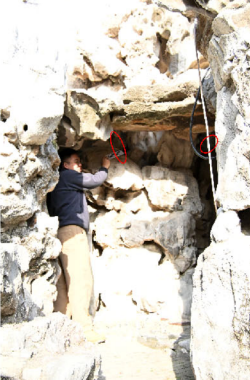
Crack number	Principal stress	Principal strain	Current crack trend
3.11, 3.14

Central cavern			
3.4, 3.13

The static simulation results for each area of the SRMA rockery were compared with the structural crack trend obtained from the on-site damage survey. The results are summarized in Table 5, including the crack number, maximum principal stress diagram, maximum principal strain diagram, and current crack trend diagram.

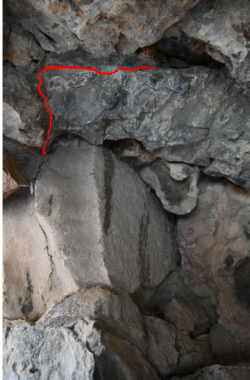
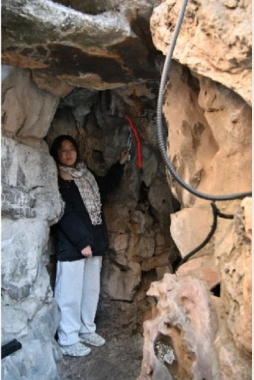
3.5

Crack number	Principal stress	Principal strain	Current crack trend
3.6

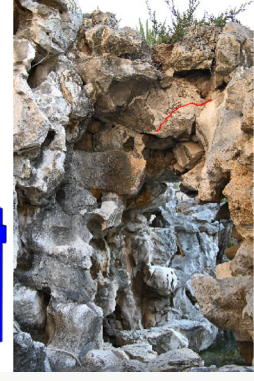
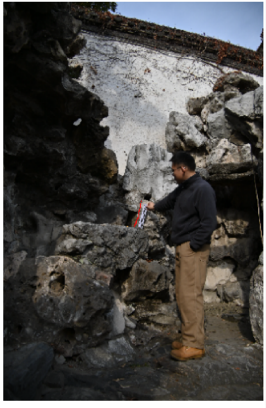
3.9

Main peak east to central area			
3.12

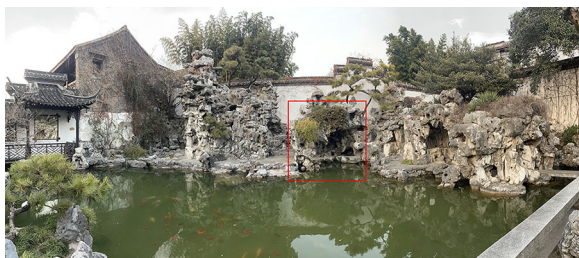
Fig. 16 | 3D scanning position. The red square area represents the region where the two scans conducted in 2021 and 2025 are compared.
