Baroque stucco techniques of Baldassarre Fontana at Kroměříž Château

This study investigates the materials and construction techniques employed in the Baroque stucco decorations of the ground-floor halls at Kroměříž Château, executed by Baldassarre Fontana and his workshop. The material composition of sixteen samples was analysed using optical microscopy, SEM-EDS, XRD, thermal analysis, and acid dissolution. The results revealed the deliberate use of high-purity calcitic lime, sourced from Devonian limestone near Přerov and gypsum from the Ketř-Opava basin. Two mortar types were identified: a lime-gypsum-sand core modelling mortar and a lime-rich finishing stucco mortar, reflecting layered application techniques. The presence of crushed marble in certain decorations suggests recipe changes and indicates a multi-phase construction process possibly extending beyond Fontana's supervision. Surface finishes were initially limited to white limewash, later overpainted with layers containing zinc white pigments. The findings highlight 17th-century stucco practices, provide a foundation for further conservation and historical research, and establish a benchmark for Central-European Baroque

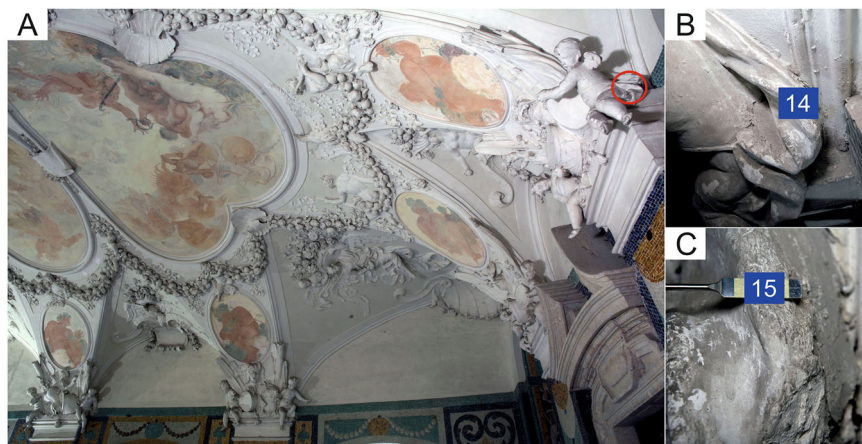
Fig. 2 | South hall stuccoes. Location of samples at the back of the putto (A). Sample STK 14 of a core modelling mortar (B), and sample STK 15 of a stucco finishing layer (C) from a relief sculpture.

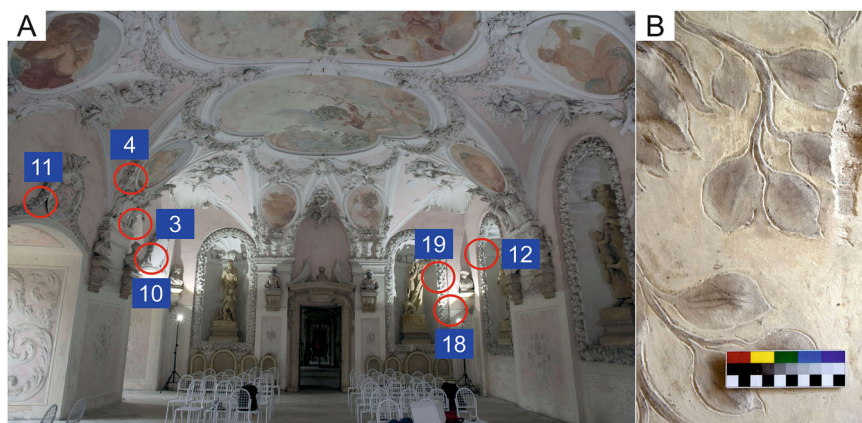
Fig. 4 | North hall stuccoes. Sample STK 3 from a relief sculpture, putto's forearm; sample STK 4—low relief behind the putto; samples STK 10, 11—garlands above the entrances; samples STK 12, 18, 19—niche frames decorations; STK 13, 20—wall decoration frames **(A)**. Detail of the decoration panel, sample STK 20, on the side wall of one of the three entrances to the hall from the park **(B)**.

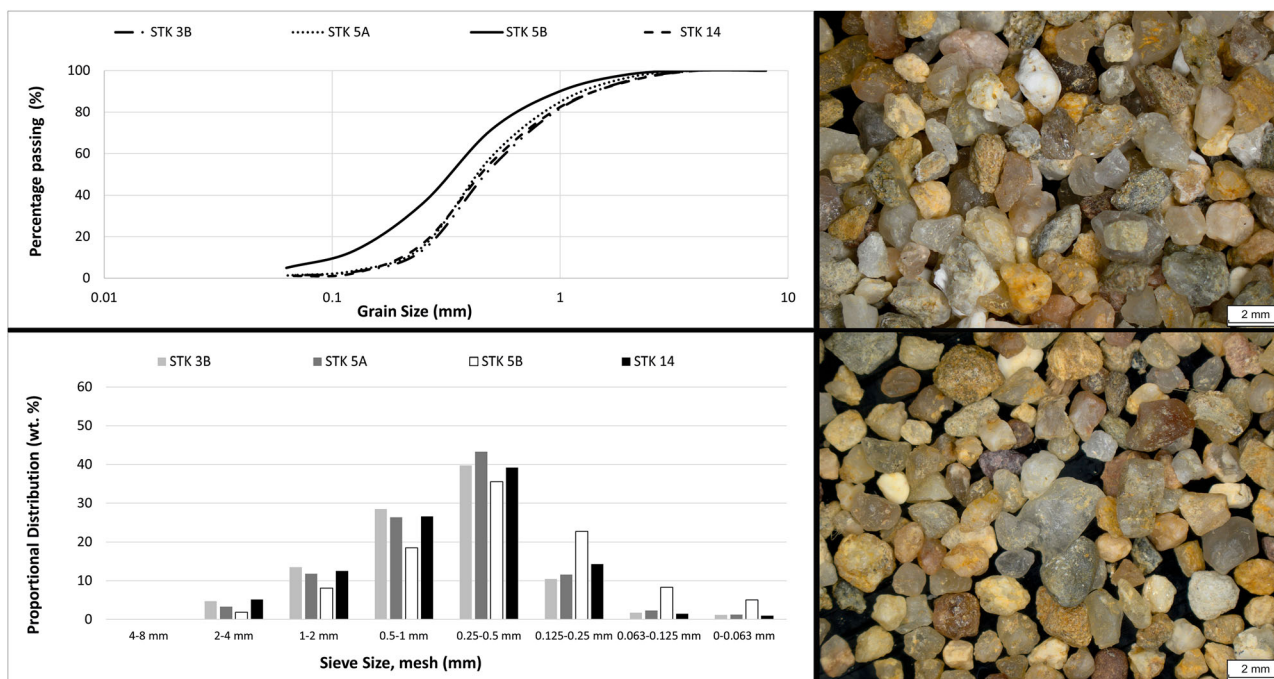
Fig. 11 | Particle size distribution of the aggregate and the 1–2 mm fractions of sand after the dissolution of the mortars with 8% HCl, samples STK 5 A (upper) and STK 5 B (lower). The white particles in sample STK 5 A are gypsum.
