OPEN Research on the salt disease and deterioration simulation of hui-zhou corridor bridge(an-fu bridge) in China

Keywords An-fu bridge, Deterioration simulation, Salt disease

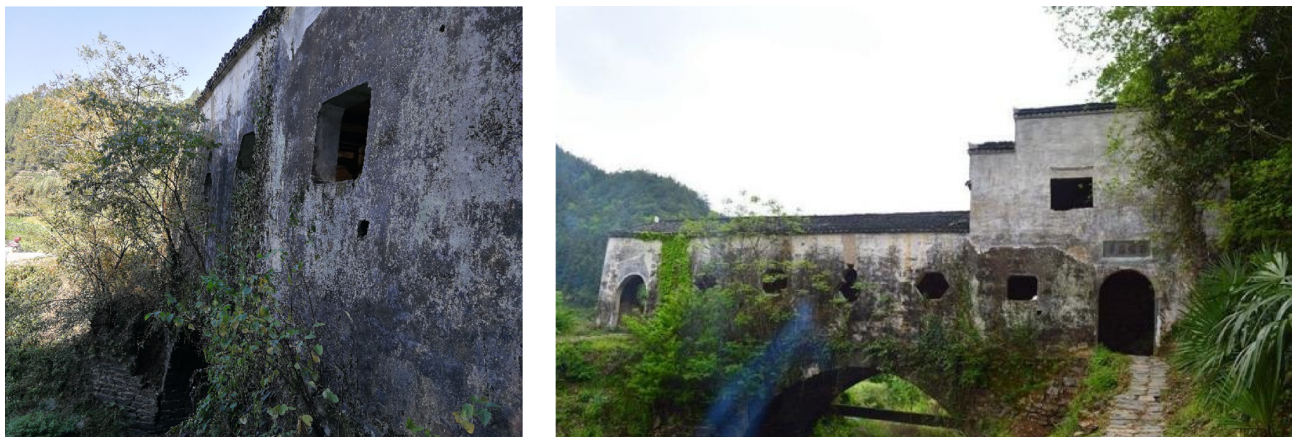
Fig. 2. (a) Current situation of weathering of Anfu Bridge wall; (b) Current situation of weathering on the facade of Anfu Bridge.

The Anfu Bridge stands out among the existing Huizhou corridor bridges due to its unique official bridge functional attributes and distinctive architectural forms as cultural relics (Fig. 2). The protection of corridor bridges not only aligns with the “Three-Year Action Plan for Corridor Bridge Protection (2023–2025)” but also offers a more systematic enhancement for the preservation of corridor bridge cultural relics that embody traditional Chinese characteristics⁴.

The Anfu Bridge, situated in Qimen County, Huangshan City, Anhui Province, boasts a unique design that distinguishes it from other existing Huizhou covered bridges. Constructed during the Jiaping era of the Ming Dynasty, the bridge's walls have exhibited significant weathering⁵.

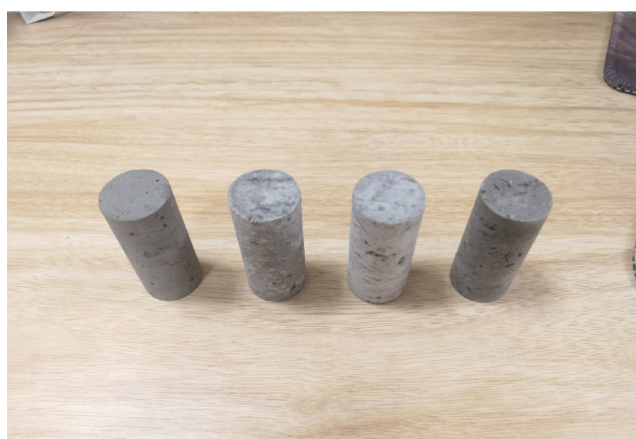
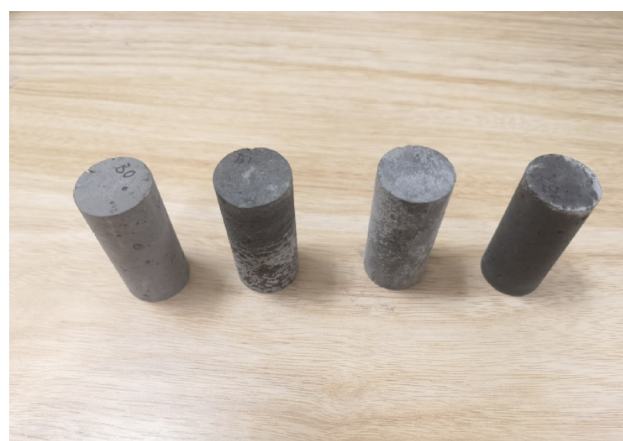
Fig. 6. (a) KNO_3 : Analysis of apparent characteristics of the sample; (b) Na_2SO_4 :Analysis of apparent characteristics of the sample.

There are a total of 10 cycles, and during the fourth cycle, the edges and corners start to become granular. As the cycle continues, the top and bottom begin to crumble, and the pulverization phenomenon intensifies. By the end of the 10 cycles, the bottom of the stone sample was fragile and exhibited partial detachment(Fig. 6).

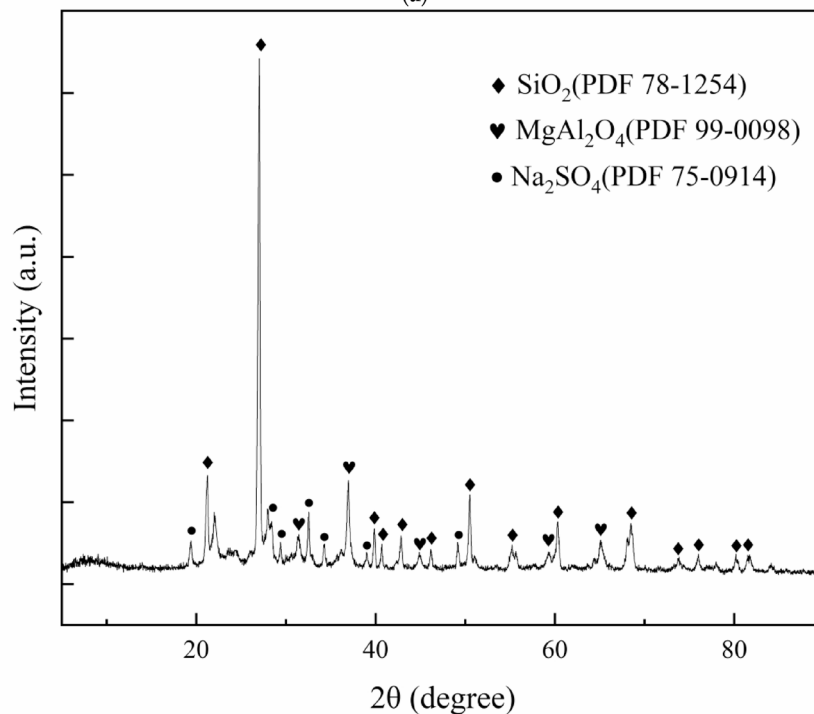
Fig. 8. XRD detection of fresh stone samples after cyclic experiments.

Through XRD detection, it was found that fresh stone samples exhibited salt enrichment internally following cycling experiments. This confirms that the crystals present within the pores of the stone sample are indeed Na_2SO_4 and KNO_3 crystals(Fig. 8、Figure 9).
