# Study on the grouting repair performance of shield tunnel segments based on high-fluidity slurry

**Keywords** Shield tunnel segmental lining, Drilling and grouting reinforcement, Load-bearing capacity, Full-scale experiment, Elastoplastic behavior, Structural rehabilitation

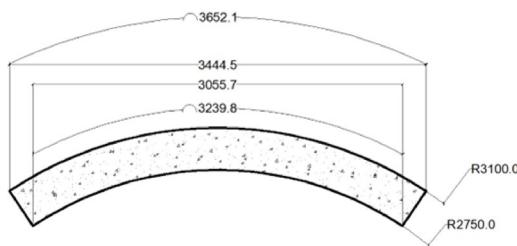
**Fig. 1.** Dimensions of standard block.

The test specimens were obtained from shield tunnel segments used in a metro project, and were composed of C50 precast concrete. Two standard segments, designated  $M_0$  and  $M_1$ , were selected for bending load tests in this study. Segment  $M_0$  was used to determine the ultimate load-bearing capacity through a monotonic loading test. Segment  $M_1$  was subjected to a distributed loading test. It was first loaded to a damaged state (80% of its ultimate capacity), then reinforced via grouting, and finally loaded to failure. Figure 1 illustrates the position of the standard segment within the segmental ring. As shown in Fig. 2, the standard segment has an outer diameter of 6200 mm, an inner diameter of 5500 mm, a central angle of 67.5°, a thickness of 350 mm, and a ring width of 1200 mm.

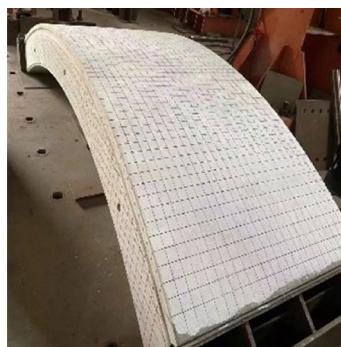
**Fig. 2.** Standard block diagram of a metro shield tunnel segment.

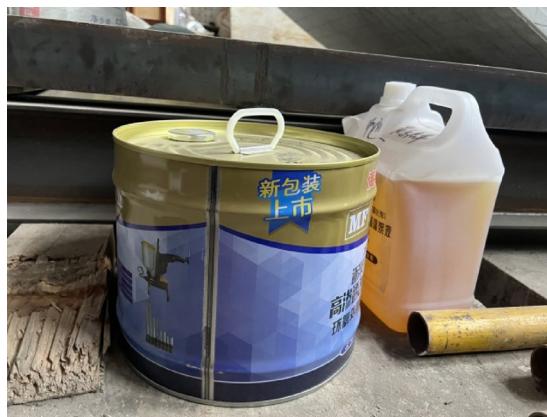
**Fig. 3.** Grouting material.

As shown in Fig. 3, a modified high-fluidity epoxy resin was used as the grouting material, and its properties are listed in Table 1.

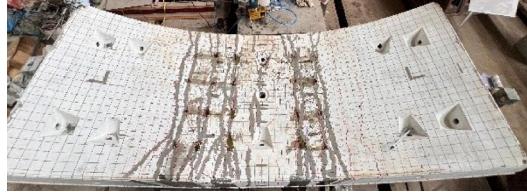
**Fig. 4.** Inner arc grouting diagram.

Based on the extent and characteristics of damage in the deteriorated segment, pressure grouting was applied to reinforce cracks with widths between 0.1 and 0.2 mm. Along the direction of each of the four cracks, 12 mm diameter and 150 mm deep grouting holes were drilled at 250 mm intervals. Prior to grouting, an air compressor was used to clean dust and debris from the grouting holes and cracks. During grouting, a trial injection was first conducted at a pressure of 0.2–0.3 MPa. Once grout leakage was ruled out, the remaining grouting holes were injected. Grouting was performed continuously until grout overflowed from each hole. For cracks narrower than 0.1 mm, the surface was first polished with sandpaper, then cleaned with an air compressor, and finally wiped with alcohol. Finally, the surface was sealed by brushing on modified epoxy resin. After grouting, the specimens were cured at room temperature for 7 days. Figure 4 shows the inner arc surface after grouting reinforcement, while Fig. 5 presents the segment's side view.

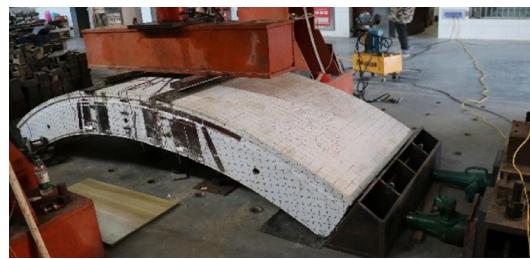
**Fig. 5.** Lateral grouting diagram.

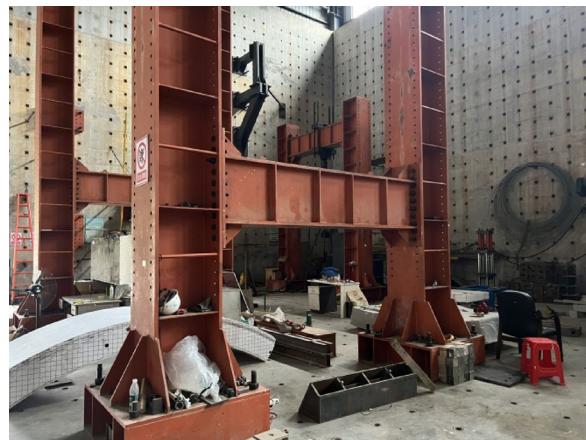
**Fig. 6.** Test loading system.

The experimental loading system, illustrated in Fig. 6, comprises a fixed-end constraint, a free end, a distribution beam, rigid shims, an electro-hydraulic servo actuator, and a load cell. A simply supported beam configuration was adopted, with the specimen placed horizontally on a dual-support boundary system. The fixed end restrained

translational movements along the X, Y, and Z axes and rotational movements about the X- and Y-axes, whereas the free end was restrained only in the Z-direction.

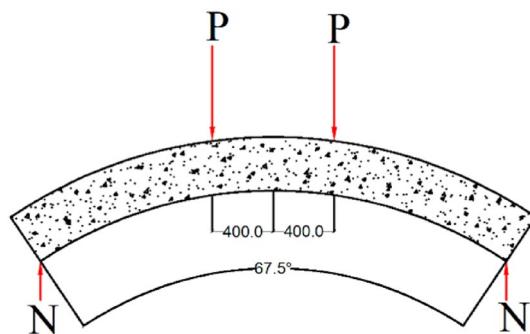
**Fig. 7.** Schematic of force application on the segment.

A vertical load  $F$  was applied using the electro-hydraulic servo actuator and transferred as a uniformly distributed load through the distribution beam. Due to the cantilever beam effect, a bending neutral axis developed at the fixed end, while the free end exhibited a controllable deflection. The Z-direction displacement constraint effectively suppressed rigid-body motion while allowing translational movement in the X and Y directions. Strain monitoring indicated that the maximum bending strain was concentrated at the upper edge of the cross-section near the fixed end.

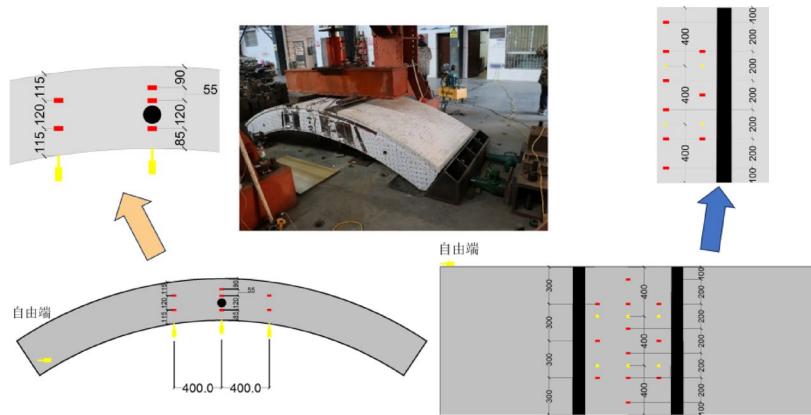
**Fig. 8.** Layout of test monitoring points.

A multi-parameter coordinated monitoring system was established for this experiment. A symmetrical sensor layout was adopted, with displacement gauges installed at the segment mid-span, beneath the loading beam, and at the free end to monitor vertical deflection and capture horizontal displacement. Additionally, arrays of circumferential electrical resistance strain gauges were installed on the intrados, extrados, and lateral surfaces to reconstruct the concrete strain field. The specific layout of measurement points on the segment is illustrated in Fig. 8.

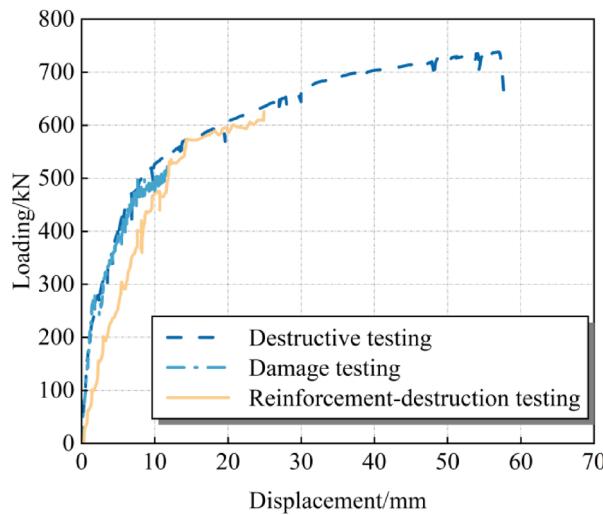
**Fig. 9.** Vertical displacement at the mid-span of the segment.

Figures 9, 10 and 11 presents the vertical displacements at the segment mid-span and loading points, alongside the horizontal displacement at the free end. As shown in Fig. 9, the failure test involved loading the specimen until failure. In the original (unreinforced) segment, stiffness was highest during the elastic stage, exhibiting a linear load–displacement relationship with minimal displacement. Upon entering the plastic stage, the specimen displayed brittle failure characteristics, rapidly failing after reaching a peak load of 738.7 kN due to the absence of reinforcement.

In the damage test, the specimen was preloaded to 525 kN to induce initial damage, followed by repair using grouting reinforcement, establishing a reinforcement–failure test. After reinforcement, the specimen's stiffness partially recovered during the elastic stage, and displacement under identical loads was reduced compared to the damage test. In the plastic stage, reinforcement improved both load-bearing capacity and ductility. Consequently, the peak load increased significantly; the rate of load decrease slowed down, and displacement grew more gradually. The load–displacement curve showed a more gradual decline, indicating that the reinforcement effectively delayed failure.

In the 525–625 kN range, segment displacement growth rate in  $M_1$  (repaired) was reduced by approximately 17–23% compared with  $M_0$ . Indicate an effective increase in strength through grouting, as shown in Fig. 9, Table 3.

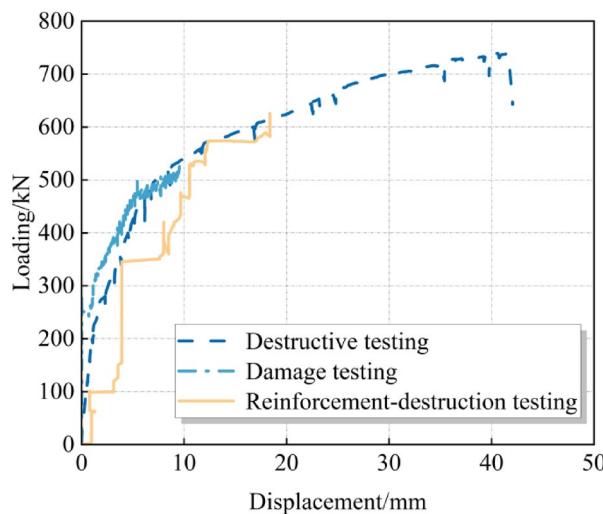
**Fig. 10.** Horizontal displacement at the free end of the segment.

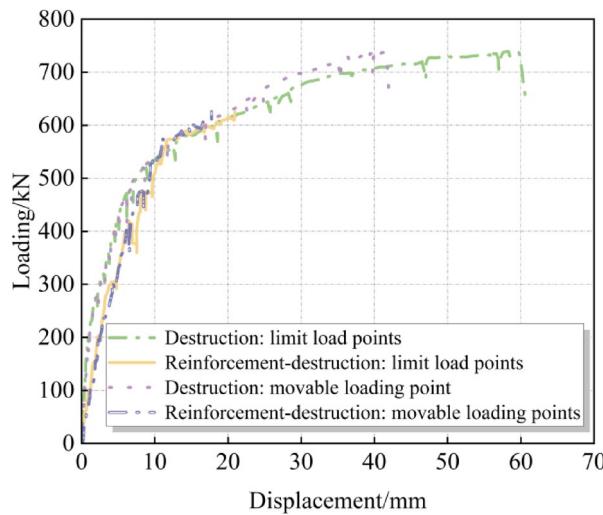
**Fig. 11.** Vertical displacement at the loading points on the segment.

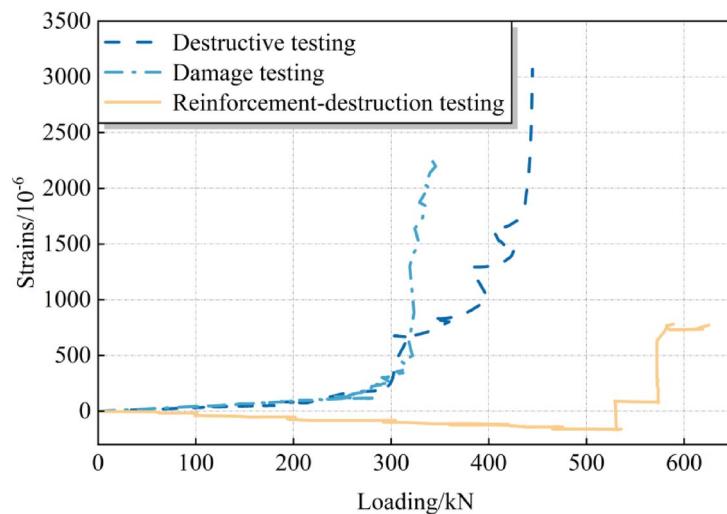
**Fig. 12.** Strain values at the monitoring points on the inner arc of the segment.

Figures 12, 13 and 14 illustrates the variations in concrete strain on the intrados, extrados, and side surfaces at the mid-span of segments  $M_0$  and  $M_1$  as the load increases. After preloading to 525 kN, the elastic modulus

decreased from  $30.2 \text{ kN}/\mu\epsilon$  (original structure) to  $16.8 \text{ kN}/\mu\epsilon$ , representing a reduction of 44%, while the peak load dropped by 14%. Between 450 and 525 kN, the rate of strain accumulation accelerated during the plastic stage, indicating significant degradation in material stiffness and load-bearing capacity due to pre-damage.

Following reinforcement, the elastic modulus recovered to  $19.7 \text{ kN}/\mu\epsilon$ , approximately 65% of the original value. The peak load increased by 9.4% to 580 kN. At failure, the strain reached  $-4200 \mu\epsilon$ , a 68% increase compared to the original specimen ( $-2500 \mu\epsilon$ ). The load-strain curve displayed a broad plateau, indicating that reinforcement effectively enhanced structural load capacity, ductility, and strain distribution uniformity.

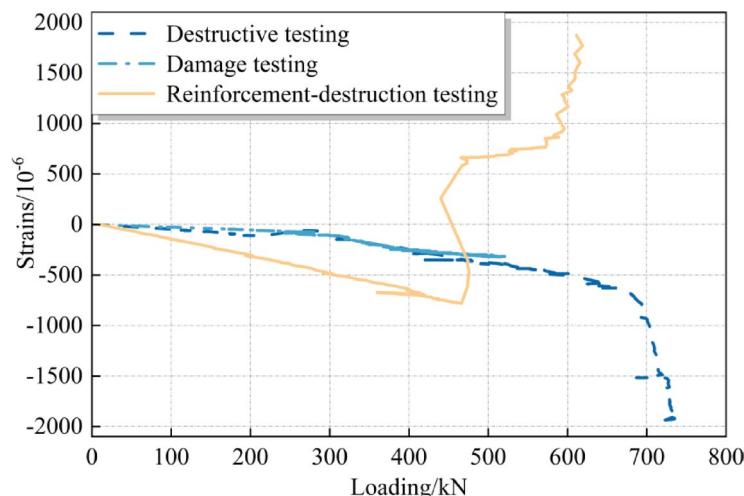
**Fig. 13.** Strain values at the monitoring points on the outer arc of the segment.

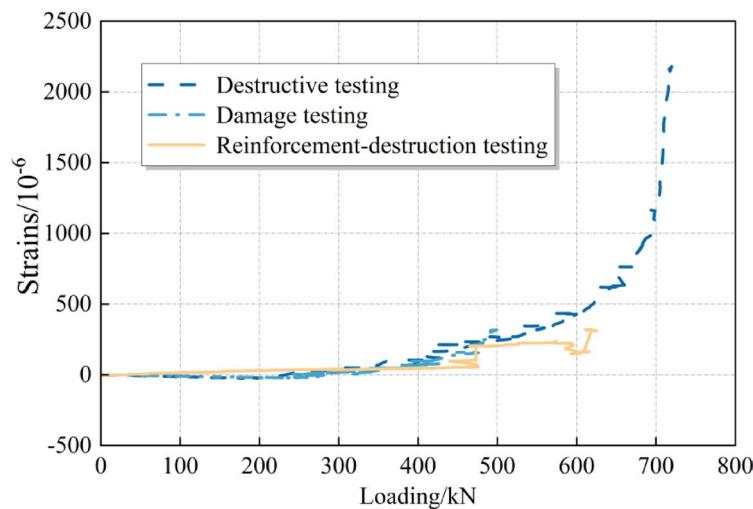
**Fig. 14.** Strain values at the lateral monitoring points of the segment.
