Multi-scale analysis of stress-corrosion failure and anti-corrosion strategies for anchor bolts in Tashan coal mine

Keywords Stress-corrosion cracking, Anchor bolt, Slow strain rate test, Pitting corrosion, Hot-dip galvanizing

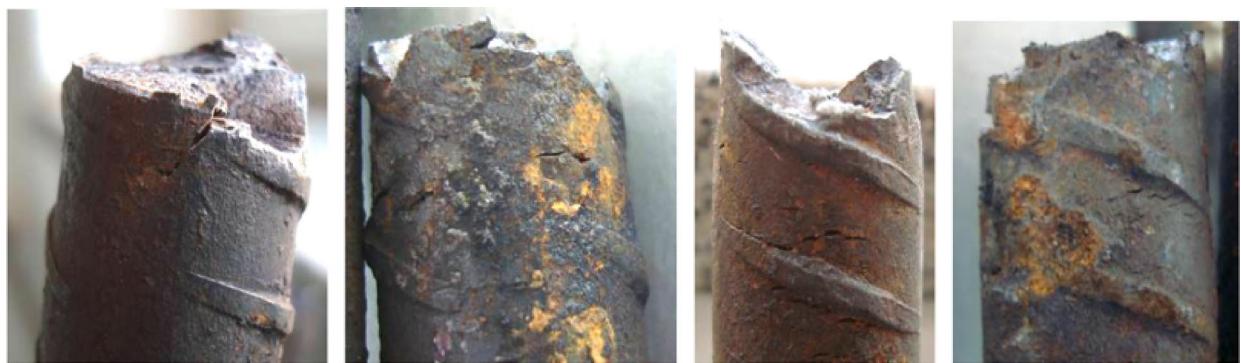
To analyze the failure mechanism of anchor bolts under stress corrosion in the Tashan mining area, typical failed anchor samples were collected underground. Fracture sections from the tail-threaded and free sections were taken for macroscopic and microscopic morphology observations, as shown in Figs. 2 and 3. Figure 2 shows that neither type of fracture exhibited obvious necking; instead, the cross-sections displayed step-like morphologies with clearly visible shear lips at the edges, indicating a predominantly brittle fracture feature.

Fig. 2. Anchor bolt specimens failed by stress corrosion.

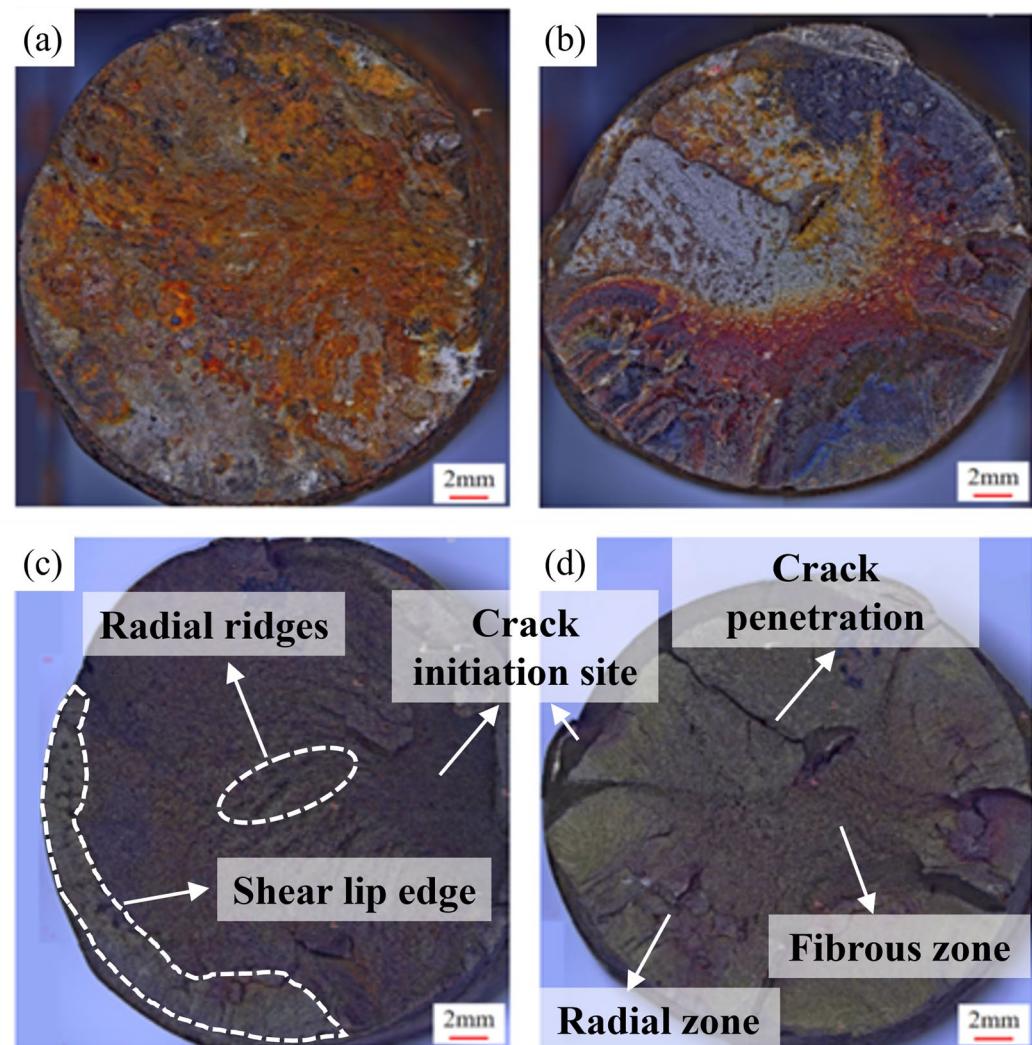
Fig. 3. Macroscopic fracture morphologies of failed anchor bolts: **a** and **c** correspond to the thread-section fracture surfaces before and after rust removal, respectively; **b** and **d** correspond to the free-section fracture surfaces before and after rust removal, respectively.

Using an ultra-depth optical microscope, the fracture surface morphology before and after rust removal was examined (Fig. 3). As shown in Fig. 3a and b, the fracture surfaces were uneven and irregular, with no evident necking. Mild oxidation corrosion was observed across the surfaces, accompanied by reddish-brown rust products. The rust on the thread-end fracture was relatively uniform and widespread, whereas in the free section the corrosion was concentrated along the ridge-like central area.

After removing surface rust, the fracture surfaces revealed typical stress corrosion features (Fig. 3c and d). In Fig. 3c, the right-hand edge of the thread-end fracture is identified as the crack initiation region, where corrosion pits induced by stress corrosion were present, reaching a depth of about one-quarter of the bolt diameter. The central part formed a radial zone with characteristic radial ridges; the crack propagation direction coincided with the radial lines and was perpendicular to the crack-source front edge. Shear lips were observed on the outer margin of the radial zone, opposite to the crack source. The asymmetric distribution of the three characteristic regions indicates that under the combined bending-tension load at the thread end, tensile stress concentration at the outer edge of the bolt initiated microcracks. Highly mineralized mine water in the crack channel continuously corroded and weakened the local metal microstructure. The crack gradually extended until the remaining cross-section could no longer sustain the applied load, at which point the crack propagated unstably, leading to fracture of the thread section with a typical stress corrosion fracture pattern.

Figure 3d shows the morphology of the free-section fracture. Multiple cracks extend from the outer edge toward the center, branching repeatedly during propagation to form a dendritic crack network. Corrosion pits on the outside of the crack convergence region mark the initiation sites of stress corrosion, while the central area constitutes the fibrous zone flanked by radial zones, giving the overall fracture a “radial-shear” pattern. This morphology indicates that the free section mainly endured pure tensile or combined tension-shear loads. Under high stress, the passive film on the metal surface was first destroyed, and the alkaline mine water further induced corrosion pit formation. Cracks propagated under tensile stress with increasing stress concentration, ultimately causing stress corrosion fracture failure of the anchor bolt.

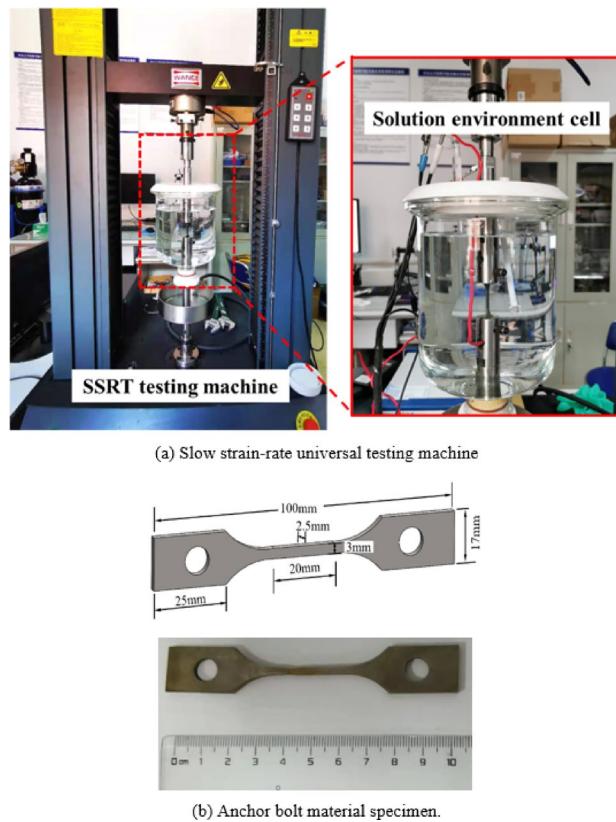
A precision electronic universal testing machine with servo-controlled loading and accurate strain-rate control was used as the loading device. A sealed corrosion cell containing the simulated mine-water solution was mounted at the machine center (Fig. 4a) to reproduce the near-neutral to slightly alkaline underground environment. The test specimens were machined from the base material of mining anchor bolts and strictly followed the geometric dimensions specified in Standard²¹, with a total length of 100 mm, a gauge length of 20 mm, and a rectangular cross-section of 3 mm × 2.5 mm (Fig. 4b). The anchor bolts were manufactured from a nominal 400 MPa yield-strength structural steel in accordance with the Chinese standard YB/T 4364 – 2014 Hot-rolled ribbed steel bars for rock bolts, where 400 MPa denotes the minimum specified yield strength of the grade. In this standard, the steel grade used in this study is designated MG400 and is required to satisfy yield strength ≥ 400 MPa, ultimate tensile strength ≥ 600 MPa, and elongation after fracture ≥ 16%. These properties are achieved in production through appropriate controlled rolling and/or heat treatment, which ensures a uniform internal microstructure and stable mechanical performance. The specified chemical composition (mass fraction, %) is C ≤ 0.25, Mn ≤ 1.60, Si ≤ 0.80, S ≤ 0.045, and P ≤ 0.045, with minor alloying additions permitted if necessary. Tensile tests on machined specimens taken from the production bolts yielded 0.2% proof strengths in the range 520–580 MPa, which is consistent with the manufacturer’s mill certificates and reflects the typical safety margin between the nominal strength class and the actual yield strength of production heats. Before testing, all specimen surfaces were sequentially ground with abrasive papers and cleaned with alcohol to remove surface defects, residual stresses, and contaminants.

Fig. 4. Experimental setup and test specimen. **a** Slow strain-rate universal testing machine, **b** Anchor bolt material specimen.

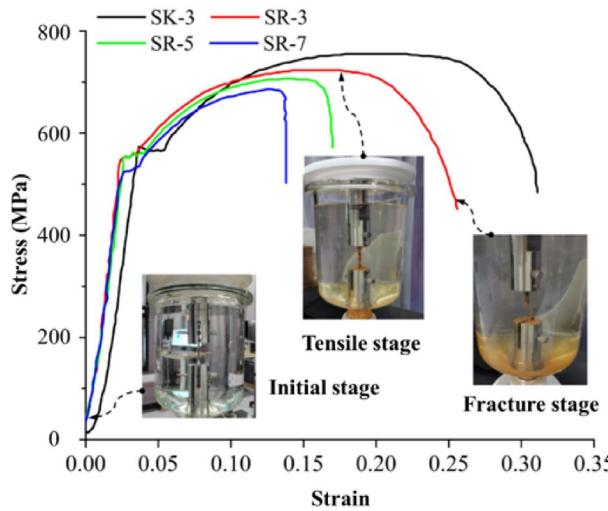
The stress-strain curves of the anchor bolt specimens under different strain rates and environmental conditions are shown in Fig. 5. As illustrated in Fig. 5, the overall shape of the stress-strain curves for specimens tested in the stress corrosion environment was broadly similar to that of specimens tested in air, undergoing successive stages of elasticity, yielding, work hardening, and necking. However, the strain ranges corresponding to each stage exhibited significant differences.

Comparing specimens SK-3 and SR-3 (both at a strain rate of $1 \times 10^{-3} \text{ s}^{-1}$) shows that the corrosive environment had a pronounced effect on the mechanical performance of the anchor bolts, mainly reflected in the reduction of plastic strain during the hardening stage and the decrease in ultimate strength, while changes in the elastic and yielding stages were relatively small. This indicates that corrosion primarily weakened the plastic deformation capacity and ultimate load-bearing capacity of the anchor bolts.

Further comparison of the stress-strain curves for SR-3, SR-5, and SR-7 specimens reveals that as the tensile strain rate decreased, the yield strength of the anchor bolt specimens gradually decreased, and the strain ranges of the hardening and necking stages were significantly reduced, showing a tendency toward reduced ductility and increased brittleness. This is mainly because at lower strain rates the contact time between the specimen and the corrosive medium was longer, allowing more corrosion pits to form on the surface, which intensified stress concentration effects, thereby suppressing plastic deformation and increasing the risk of brittle fracture.

Fig. 5. Stress-strain curves of anchor bolts in SSRT tests.

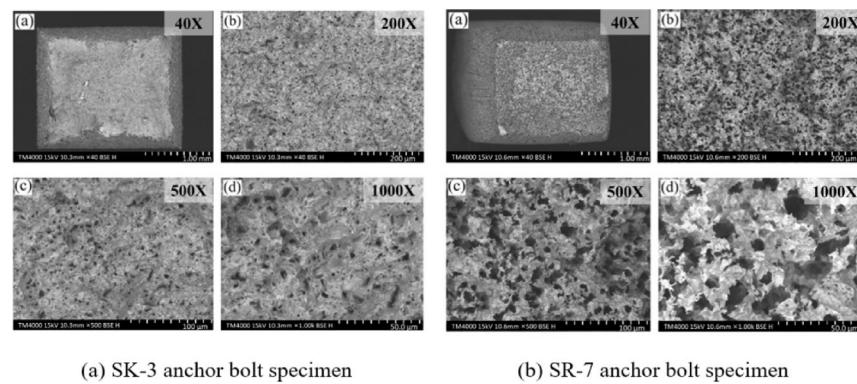
Fig. 6. SEM fracture morphologies of anchor bolts after SSRT: **a** Magnification 40×; **b** Magnification 200×; **c** Magnification 500×; **d** magnification 1000×.

Figure 6 compares the fracture morphologies of specimen SK-3 tested in air and specimen SR-7 tested in the stress corrosion environment.

As shown in Fig. 6a, specimen SK-3 fractured in air exhibited obvious cross-sectional contraction, displaying a typical ductile fracture morphology indicative of good plastic deformation capacity. The fracture surface was uneven with a distinct metallic luster, and the shear-lip, fibrous, and radial zones were clearly delineated, presenting the classic features of tensile fracture. Higher-magnification SEM images revealed a widespread distribution of equiaxed round dimples, characteristic of ductile microfracture.

In contrast, Fig. 6b shows that specimen SR-7 fractured under a weakly alkaline corrosive environment produced a generally flat fracture surface with a grayish appearance. The number of dimples decreased markedly, replaced by numerous corrosion pits with larger diameters and depths. The few remaining dimples were shallow and irregularly shaped, interspersed with the pits to form a “mud-crack” or reticulated pattern²²-a typical feature of stress corrosion fracture morphology. This phenomenon indicates that at low strain rates the contact time between the anchor bolt and the corrosive mine water was extended, intensifying the corrosion effect, particularly around inclusions where corrosion tended to localize. This led to a rapid decline in the material's plasticity and ultimately to sudden brittle fracture.

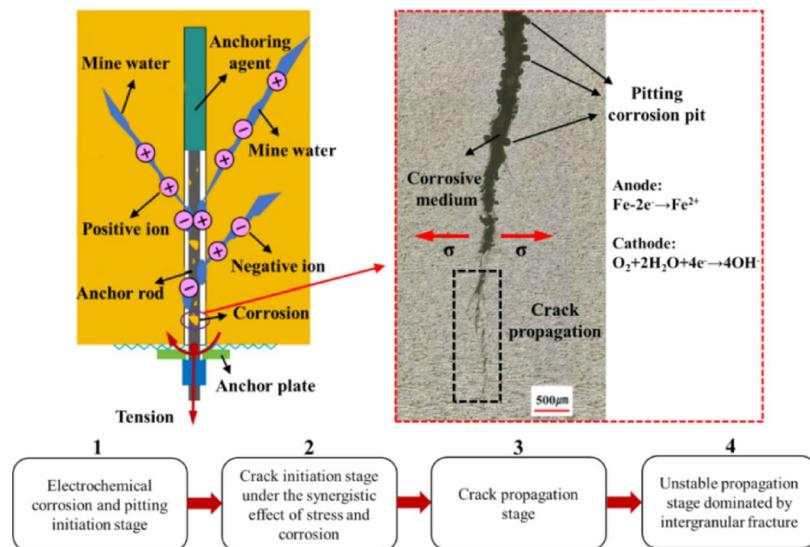
Fig. 7. Schematic illustration of the stress corrosion failure mechanism of anchor bolts.

By integrating the ionic composition and pH characteristics of the Tashan mine water with the preceding SSRT results and fracture morphology observations, a failure mechanism model of stress corrosion cracking (SCC) in anchor bolts is proposed. The process, illustrated in Fig. 7, can be divided into four stages:

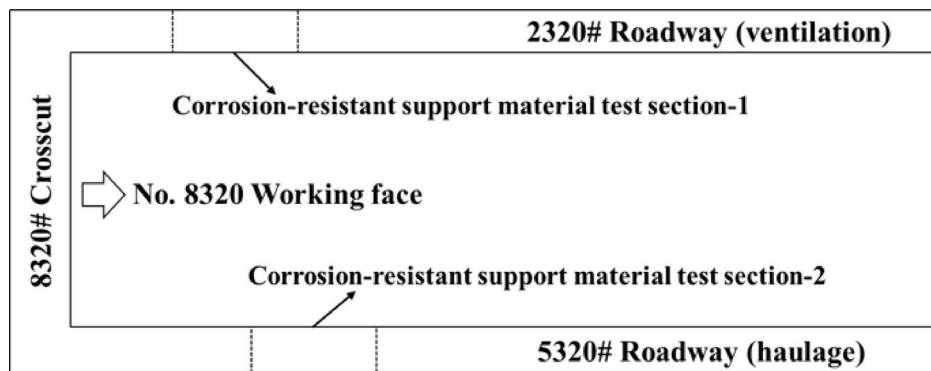
This anti-corrosion technology was deployed for field testing in two roadways (No. 2320 and No. 5320) of the 8320 working face in Tashan coal mine (see Fig. 8). The designed length of the 5320 roadway is 1760.819 m. The roadway adopts a rectangular cross-section and is driven along the coal seam floor, with a cross-section width \times height of $5,500 \times 3,800$ mm and a net width \times net height of $500 \times 3,60$ mm. The designed length of the 2320 roadway is 1576.314 m. This roadway also adopts a rectangular cross-section and is driven along the coal seam floor, with a gross cross-section width \times height of 5800×300 mm and a net cross-section width \times height

Fig. 8. Layout of the 8320 working face.

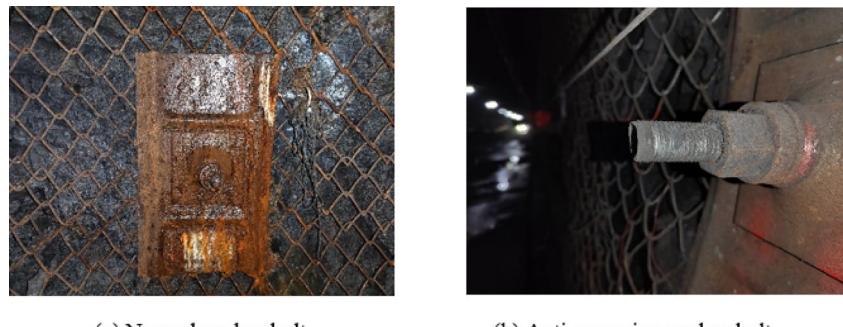
Fig. 9. On-site roof support with anti-corrosion materials in the two roadways of the 8320 working face. **a** Normal anchor bolt, **b** Anti-corrosion anchor bolt.

In the 8320 working face, when the roadway advanced into the severely roof-dripping zone, the conventional anchor bolts specified in the original design were replaced with hot-dip galvanized anti-corrosion bolts, and their in situ support performance in the corrosive environment was evaluated by field monitoring. Axial forces in selected roof bolts and anchor cables were recorded over a two-month period from 1 May 2025 to 30 June 2025. Monitoring was conducted in two roadway sections: in the 2320 roadway, the test section extended from steel-strip No. 1270 to No. 1440, corresponding to a length of approximately 170 m, and in the 5320 roadway, from steel-strip No. 1036 to No. 1174, corresponding to a length of approximately 140 m. A GMY400W intrinsically safe anchor-bolt load sensor was installed on each instrumented support between the bearing plate and the nut, so that the measured load corresponded to the axial force transmitted through the plate–nut interface. The sensors were factory-calibrated in accordance with the relevant metrology standards; before installation, all units were checked and zeroed under unloaded conditions. During underground operation, axial-force data were automatically acquired at a sampling interval of one reading every 3 min. In total, axial forces were monitored on 10 roof bolts and 12 anchor cables in the monitored roadways of the 8320 working face. The resulting support performance after approximately 60 days of exposure is illustrated in Fig. 9.

A comparison of the apparent condition of the support components in Figs. 1 and 9 shows that the surfaces of the hot-dip galvanized anchor bolts exhibited virtually no rust and retained their metallic luster, whereas the adjacent ordinary steel straps had already developed obvious corrosion. This demonstrates that the hot-dip galvanizing technology was highly effective in isolating the corrosive medium and suppressing corrosion development, thereby ensuring the integrity and stability of the roof support system and preventing the adverse effects of the stress corrosion environment.

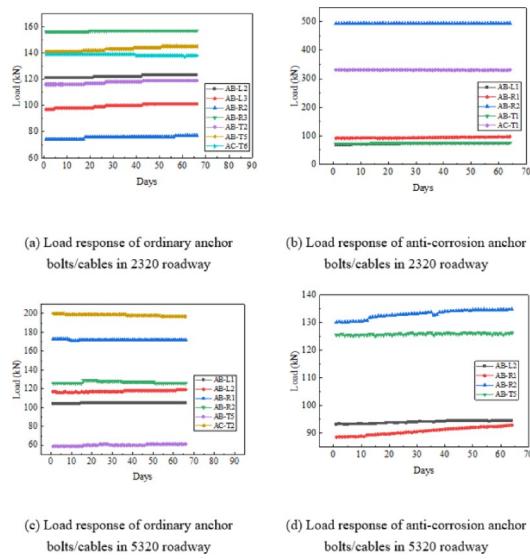
Fig. 10. Load data of anchor-bolt/cables in the test section. **a** Load response of ordinary anchor bolts/cables in 2320 roadway, **b** Load response of anti-corrosion anchor bolts/cables in 2320 roadway, **c** Load response of ordinary anchor bolts/cables in 5320 roadway, **d** Load response of anti-corrosion anchor bolts/cables in 5320 roadway.

To evaluate the actual effect of the anti-corrosion coating on the long-term service performance of anchor bolts, continuous mine-pressure monitoring was conducted for more than one month on both the anti-corrosion anchor bolts installed underground and uncoated anchor bolts of the same specifications. The variations in axial force of the anti-corrosion and uncoated anchors under identical operating conditions were compared (Fig. 10).

The monitoring data show that during this period the axial forces of both types of anchor bolts exhibited no significant differences and no obvious trend of mechanical performance deterioration. This phenomenon indicates that, within the current monitoring timescale (approximately one month after installation), although the uncoated anchor bolts had already begun to develop surface rust (e.g., flash rust or localized rust spots), the corrosion remained at an initial stage, mainly confined to the surface layer of the bolts. It had not yet penetrated deeply into the steel strands or caused substantial cross-sectional loss, and therefore had not materially weakened the overall load-bearing capacity, stiffness, or other core mechanical properties of the bolts.

By contrast, the hot-dip galvanized anti-corrosion anchor bolts showed no visible rusting during the monitoring period, demonstrating excellent corrosion resistance. Their load-bearing stability was superior to that of the ordinary products, further confirming their advantages and engineering applicability in corrosive environments.
