OPEN Study on the formation mechanisms and stability of a gently inclined and shallow accumulative landslide

The extremely heavy rainstorm on September 16, 2011, in Nanjiang County, Sichuan Province, induced many accumulative landslides. Most of these slopes were 3 ~ 5 m thick, sliding along the soil–bedrock interface, and the dip angle of the sliding bed was 10 ~ 20°. To study the reasons for and stability of this type of landslide, which mainly involved sliding along the soil–bedrock interface, this paper took the Qiling Village landslide as an example and conducted shear tests on the sliding bodies, sliding zone soils, and bedrock interfaces with different moisture contents and numerically simulated the stability of the slope. The research results revealed that the shear strength of the sliding soil and the soil–bedrock interface decreased with increasing moisture content. The shear strength of the sliding soil–smooth bedrock interface was the smallest; therefore, the landslide slid along the sliding soil–smooth bedrock interface. Under the action of heavy rainfall, the water level continued to rise, and the pore water pressure gradually increased. The coupling of pore water pr

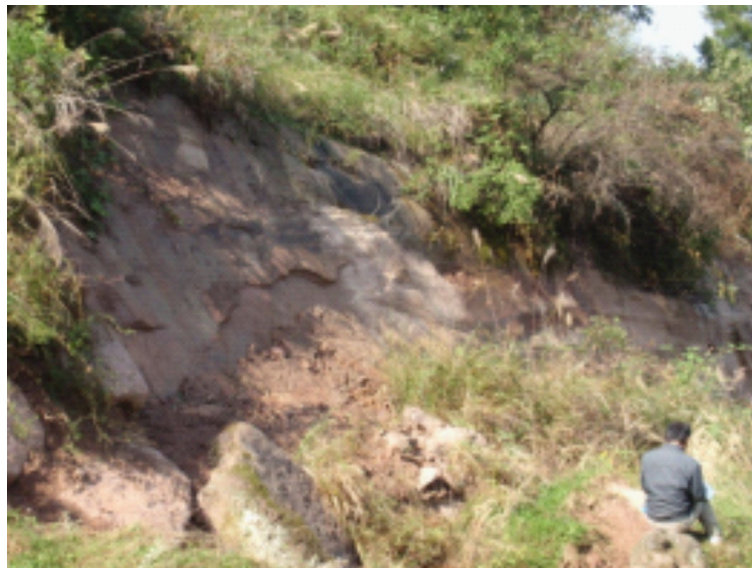
Fig. 2. The rear edge of the landslide.

The rear edge of the landslide is a steep slope with a gradient of approximately 35°. There are many solitary stones on the slope, and the vegetation is relatively developed. The rear edge of the landslide is bounded by a steep wall (Fig. 2), and the landslide body forms a “tongue” shape on the plane (Figs. 3 and 4). The landslide was divided into upper and lower parts, with the upper sliding bed exposed and the middle and lower parts being accumulation bodies. The boundaries of the landslide were obvious. The elevation of the landslide rear edge is 1220 m, and the elevation of the front edge shear outlet is between 1080 and 1100 m, with a difference of 130 m in elevation between the front and rear edges. The upper part of the landslide is relatively gentle, ranging from 13° to 16°, with the local maximum reaching 25°. The lower part is slightly steeper, ranging from 19° to 24°. The front edge of the landslide is a rice field and a small gully, forming the free face of the landslide. The upper part of the landslide is 146 m long and 55 m wide, and the lower part is 248 m long and 64 m wide, with an area of approximately 24,000 m². The main sliding direction of the landslide is 0°, and the thickness is approximately 1–5 m. The estimated volume of the landslide is approximately 7.2×10^4 m³, which represents a small landslide.

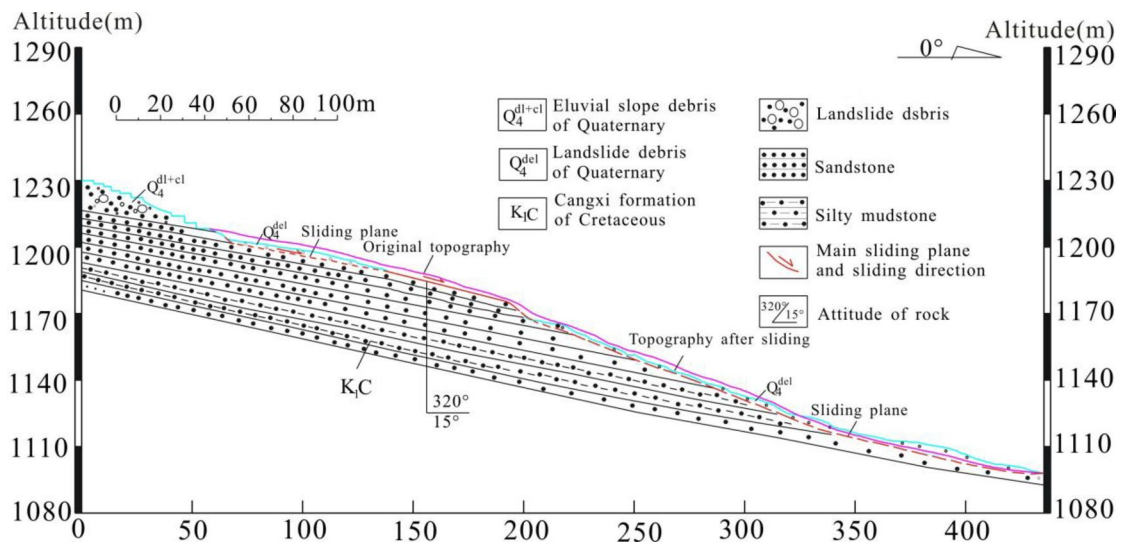
Fig. 5. I-I profile of the Qiling village landslide.

The sliding zone was located at the silty clay-bedrock interface according to field investigations. The slip zone soil is a mixture of powdery clay and a small amount of gravel. The soil texture of the local sliding soil is uneven, with rough cut surfaces and traces of rubbing; the soil feels smooth and wet and is in a soft plastic flow state. The middle part of the sliding surface (belt) has a deep burial depth, whereas the front and rear parts are relatively small. The longitudinal section has a folded line shape (Fig. 5) with slight undulations.

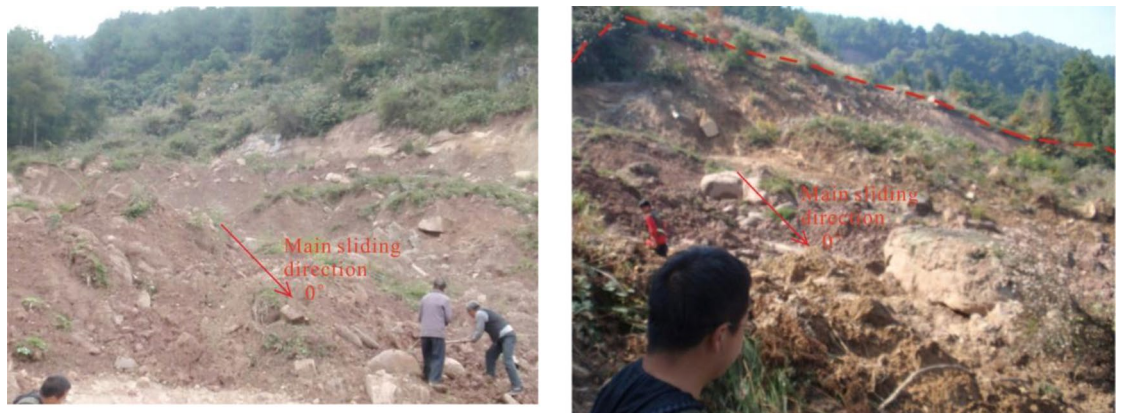
Fig. 8. Sliding source zones.

The source zones were located at the rear of the landslide, with a transverse width of approximately 55 m, a longitudinal length of 82 m, and a plane area of 4510 m². The thickness of the landslide body was small, ranging from 0.5 to 1 m. It was thick at the top and thin at the bottom in the vertical direction and thick on both sides and thin in the middle in the horizontal direction (Fig. 7). The main sliding direction of the landslide was 0°, with an overall slope of 15°, as shown in Fig. 8.

The sliding body in the sliding source zones formed accumulations of varying sizes, with obvious traces of soil movement and localized exposure of the sliding bed. The sliding body is mainly composed of loose deposits of Quaternary collapse and slope deposits, which consist of block gravel soil filled with angular gravel soil and sandy soil and are purple-red to yellow-brown in color (Fig. 8). The content of block stones ranges from 30 to 40%, with particle sizes ranging from 20 cm to 300 cm. The content of crushed stones ranges from 10 to 20%, with particle sizes ranging from 2 to 20 cm. The sorting and rounding are poor, and the contents of angular gravel, sandy soil, and silty clay soil range from 40 to 60%. The rock properties of block stones are mainly purple gray, light gray, grayish white fine sandstone and light gray, grayish white medium- to fine-grained feldspar quartz sandstone. Occasionally, purple-red silty mudstone is observed, which is consistent with the surrounding exposed bedrock lithology.

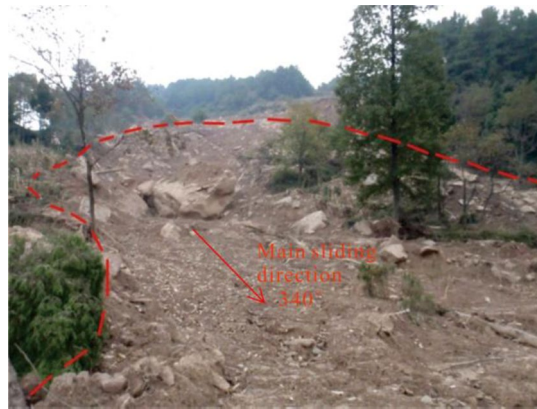
Fig. 9. Sliding zone.

The sliding zone has a longitudinal length of 160 m and a width of approximately 64 m (Fig. 9). The total thickness of the landslide body is relatively small, with an average thickness of approximately 50 cm, and locally exceeds 1 m. It is thin in the longitudinal direction and thick in the lower part, with almost the same thickness in the transverse direction (Fig. 10). The traces of soil movement are obvious, and the local sliding

bed is exposed. The sliding body is mainly composed of loose accumulations of Quaternary collapse deposits and slope deposits, which consist of block gravelly soil filled with angular gravel soil and sandy soil and are purple-red to yellow-brown in color. The content of block stones ranges from 50 to 60%, with particle sizes ranging from 20 cm to 11 m. The content of crushed stones ranges from 10 to 15%, with particle sizes ranging from 2 to 20 cm. The sorting and rounding are poor, and the contents of angular gravel, sandy soil, and silty clay soil range from 25 to 40%. The rock properties of block stones are mainly purple gray, light gray, grayish white fine sandstone and light gray, grayish white medium- to fine-grained feldspar quartz sandstone. Occasionally, purple-red silty mudstone can be observed. The block stones have the same lithology as the bedrock at the rear edge and the sliding bed of the upper landslide. Many trees and woods are arranged horizontally and vertically in the sliding body. Water flows out of the sliding body, and the sound of water flow can be heard. The flow rate is approximately 0.5 L per second.

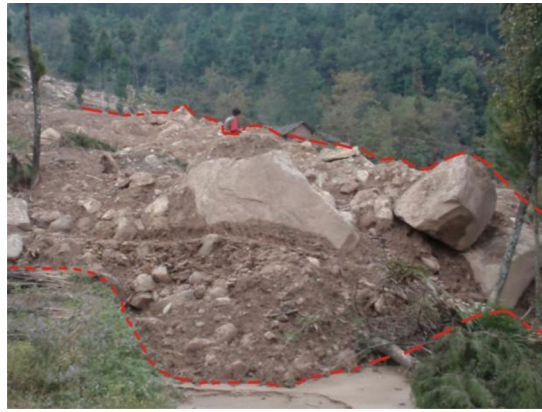
Fig. 11. Deposition zone.

The deposition zones were located at the front of the landslide at the shear outlet of the front edge of the landslide (Fig. 11). The area was 79 m long and 62 m wide, with a thickness of 3–6 m and a volume of approximately $2.45 \times 10^4 \text{ m}^3$. The accumulated material was gravelly soil, with gravel diameters ranging from 5 to 200 cm, including block stones with a maximum diameter of approximately 2 m. Many trees and small branches accumulated in the landslide area, and water flowed out of the landslide area at a flow rate of approximately 0.5 L per second.

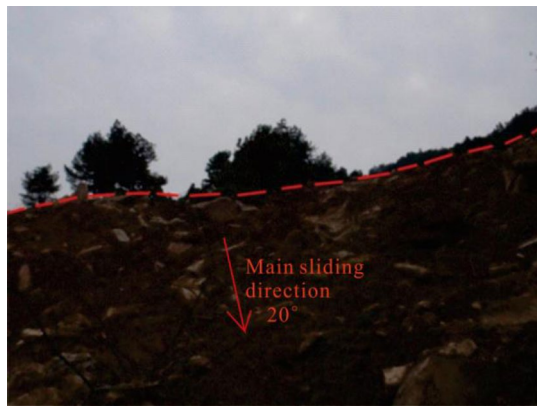
Fig. 12. Collapse zone.

The collapse zones were located on the upper left side of the landslide (Fig. 12), with a longitudinal length of 70–80 m. The accumulated material in the collapse area was powdery clay containing fragmented stones, with a maximum particle size of 40–50 cm. The content of fragmented stones was relatively high, reaching more than 50%. This area formed from traction after the main sliding body slid.

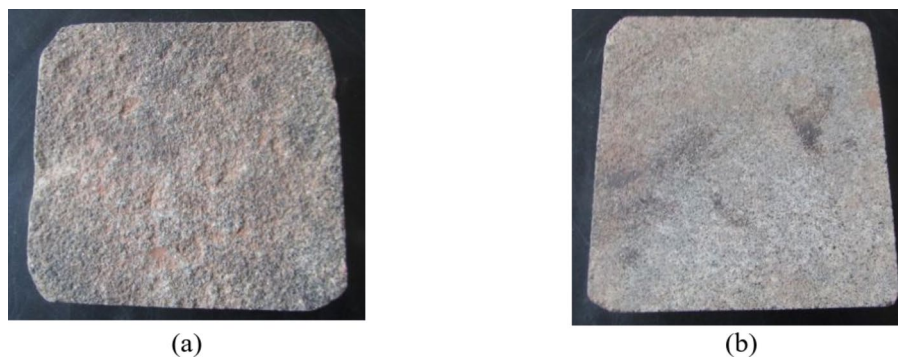
Fig. 16. Bedrock for the shear test. (a) Rough bedrock; (b) smooth bedrock.

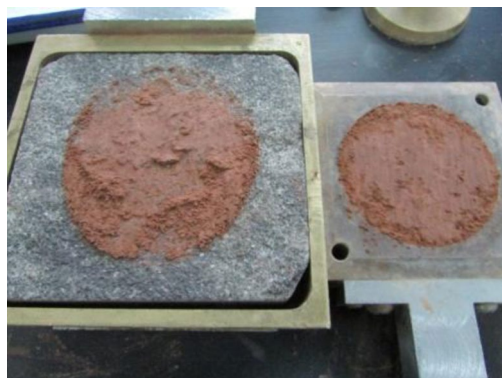
Fig. 17. Bedrock in the lower box.

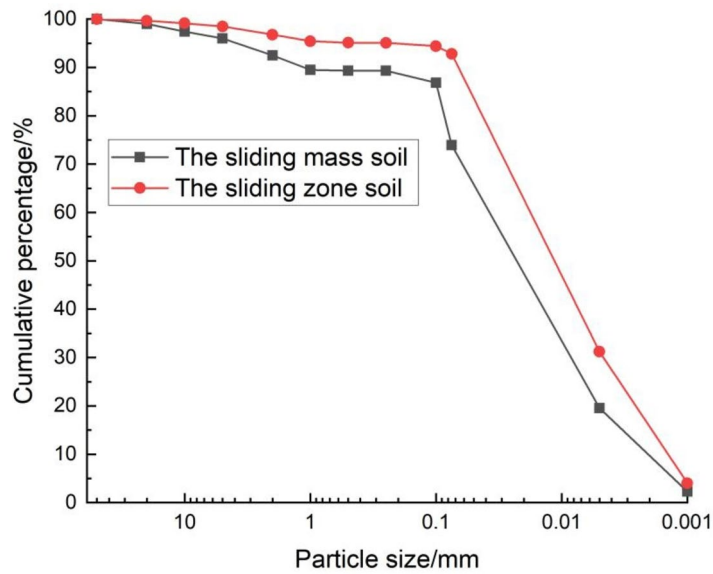
The sliding zone soil samples applied in this test were taken from the Qiling village landslide (Fig. 4). The physical parameters of the sliding zone soil samples are shown in Table 1. The particle size distribution curve of the sliding zone soil samples is shown in Fig. 18. The sliding zone soil was dried and sieved. Gravel larger than 5 mm was removed. The sliding zone soil was prepared with moisture contents of 10%, 20%, 25%, and 30%. The sliding zone soil was allowed to sit for 2 days with plastic wrap to allow the crushed stone soil to fully absorb moisture and ensure the uniformity of mixing between the soil and water after the sliding soil was prepared. Circular soil samples with a diameter of 61.8 mm and a height of 20 mm were produced. The dry density of the soil samples was 1.83 g/cm³.

Fig. 18. Particle size distribution analysis.

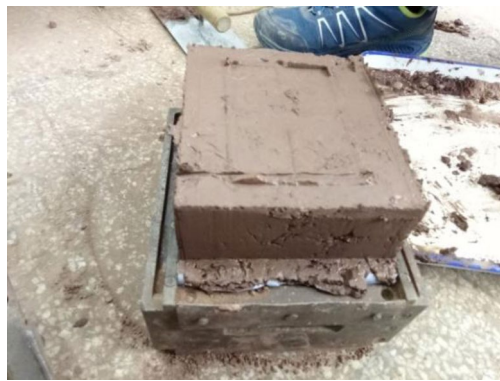
There were obvious shear bands in the sheared soil sample after the sample was sheared (as shown in Fig. 19). Their shear strengths are shown in Table 2. The shear strength index c of the sliding body first increased and

Fig. 19. Soil sample after shearing.

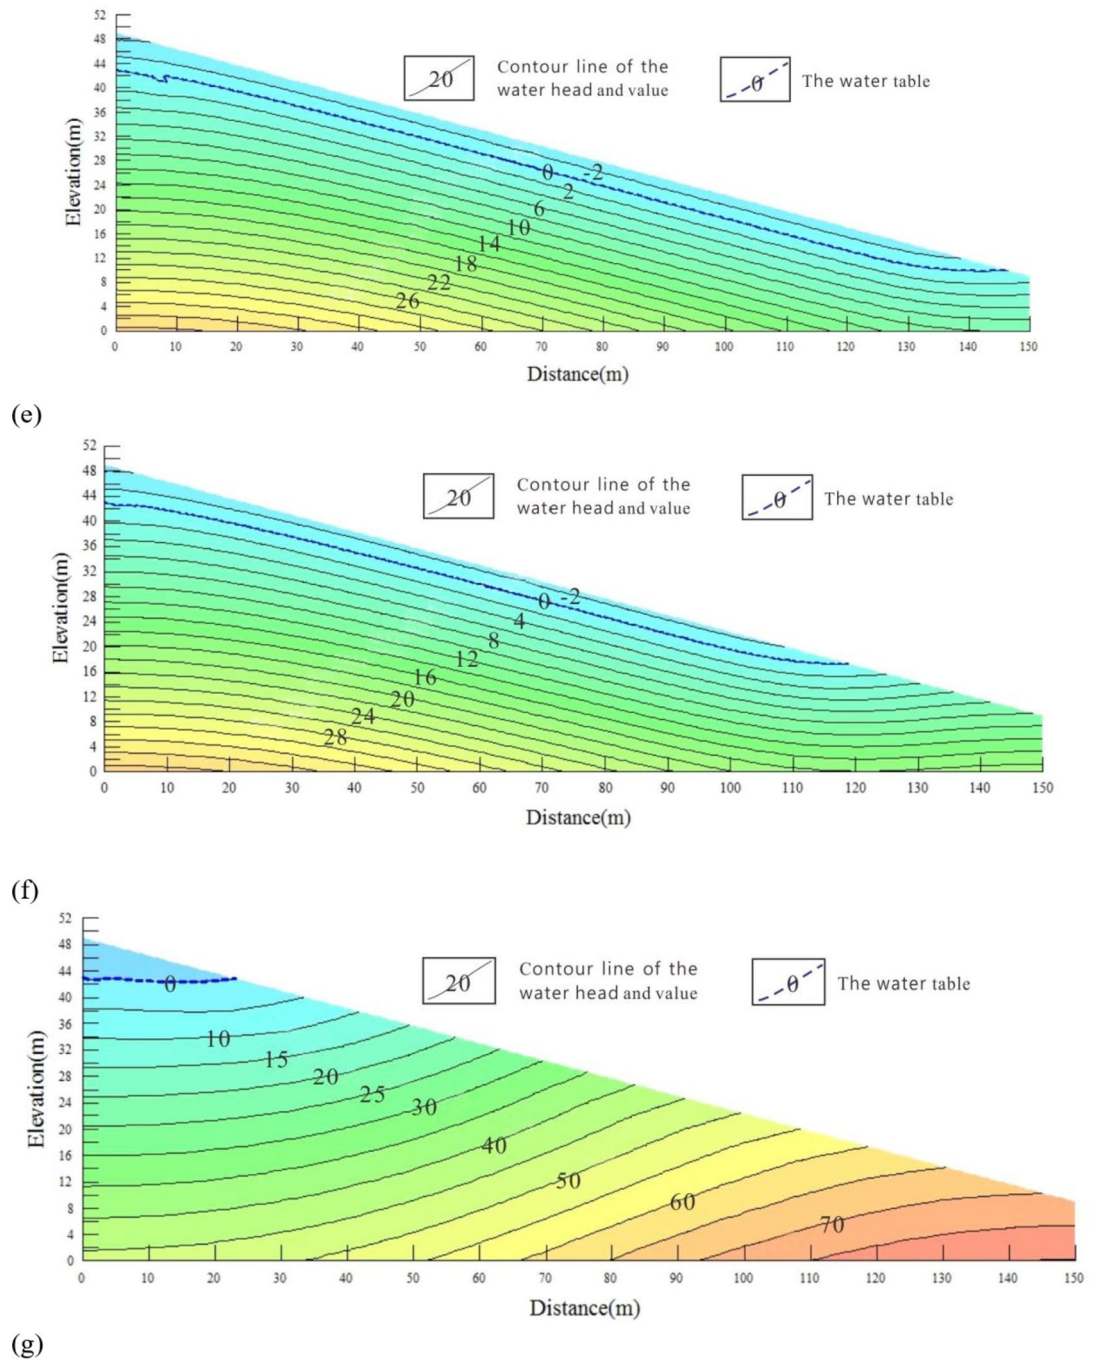
The variation law of the water head is shown in Fig. 27. During heavy rainfall, rainwater flows from top to bottom. First, the soil is saturated at the soil-bedrock interface at the front edge of the slope, forming a transient saturated seepage field. As the rainfall continues, the saturated area continuously moves from the front edge of the slope along the soil-bedrock interface toward the middle and rear parts of the slope, and the water level continues to rise, gradually increasing the water head. The numerical simulation results are consistent with the on-site pore water pressure monitoring results.

Fig. 27. Time variation of contour lines of the water head: (a) Initial state; (b) rainfall for 8 h; (c) 16 h of rainfall; (d) 24-hour rainfall; (e) 32 h of rainfall; (f) 40 h of rainfall; and (g) rainfall for 44 h.

- (2) Under the action of heavy rainfall, rainwater flows from top to bottom. First, the soil saturates at the soil-bedrock interface at the front edge of the slope, forming a transient saturated seepage field. As the rainfall continues, the saturated area continuously moves from the front edge of the slope along the soil-bedrock interface toward the middle and rear parts of the slope, and the water level continues to rise, gradually increasing the pore water pressure.

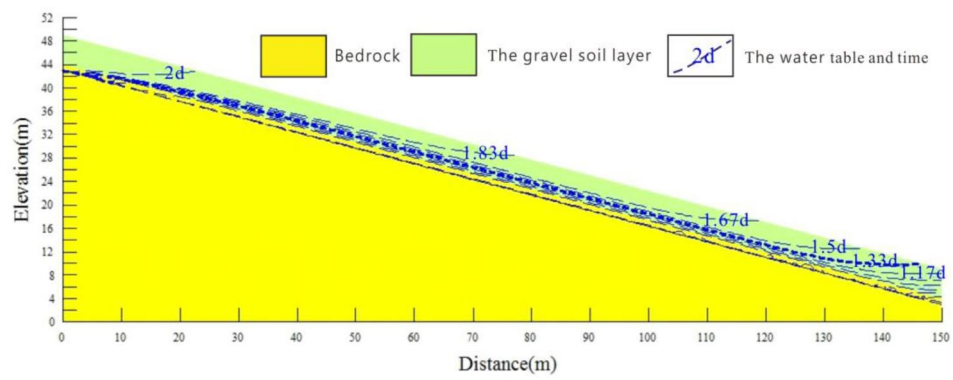
The distribution law of the transient water level is shown in Fig. 28. Rainwater can quickly infiltrate the base cover interface through advantageous infiltration channels, and the permeability of bedrock is very low, playing a role in water isolation. Therefore, stagnant water is generated at the base cover interface, forming a transient water level. First, the front edge of the slope is saturated at the base cover interface, and as the rainfall continues, the saturated area continues to expand toward the middle and rear parts of the slope, and the water level line also continuously rises toward the surface. The numerical simulation results are basically consistent with the on-site investigation results of the landslide.

Fig. 28. Distribution of infiltration lines.

- (3) Under the action of heavy rainfall, owing to the existence of water infiltration channels in the soil, rainwater can quickly infiltrate the soil-bedrock interface, and the permeability of the bedrock is very low, playing a role in water isolation. Therefore, stagnant water is generated at the soil-bedrock interface, forming a transient water level. First, the front edge of the slope is saturated at the soil-bedrock interface, and as the rainfall continues, the saturated area continues to expand toward the middle and rear parts of the slope, and the water level line also continuously rises toward the surface.

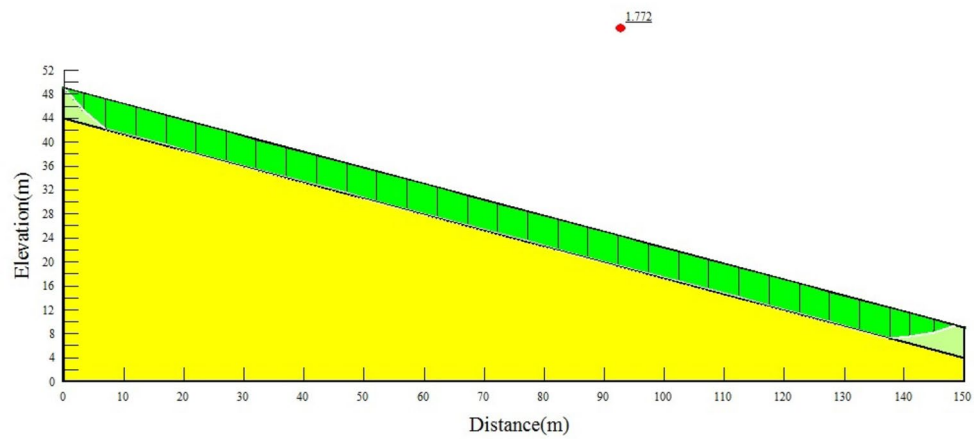
The simulation results of the seepage field were coupled with Slope/w, and then Slope/w was used to calculate its stability. The calculation blocks are shown in Fig. 29.

Fig. 29. Stability calculation of the 5-m overcover layer.

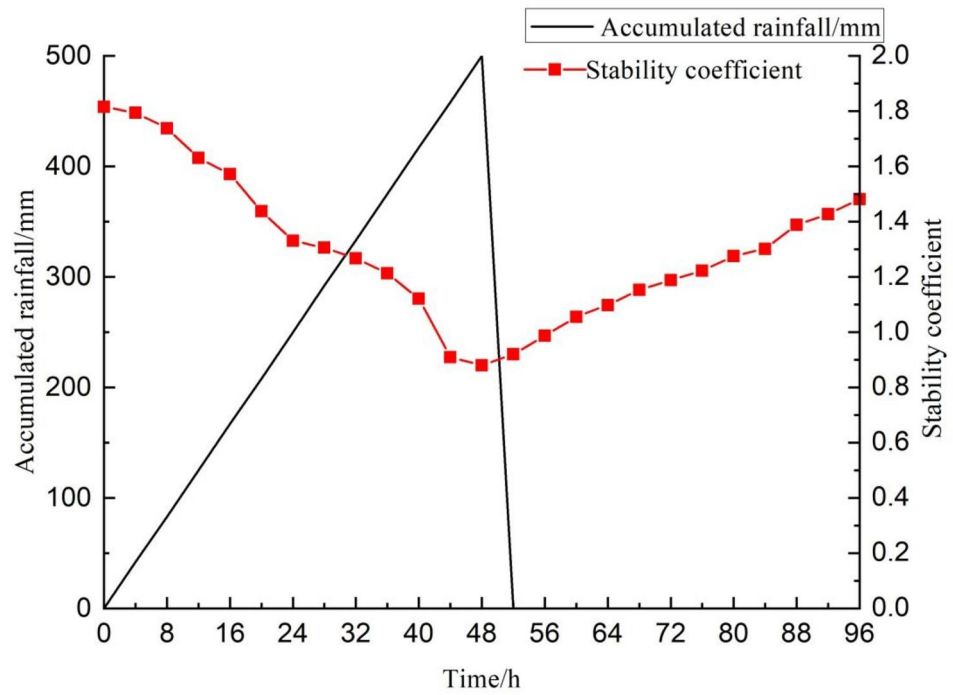
The stability coefficient of the 5-m accumulative slope with an increasing rainfall duration is shown in Fig. 30. The safety coefficient of the shallow accumulative slope was 1.816 before the heavy rainfall on September 16th, and it was in a stable state. As heavy rainfall began, rainwater quickly infiltrated through the dominant infiltration channel, increasing the moisture content of the slope soil. After 4 h of rainfall, the rainwater reached the soil-bedrock interface at the front edge of the slope, saturating the soil and increasing the pore water pressure. The stability coefficient of the slope slightly decreased; as heavy rainfall continued, rainwater gradually accumulated at the soil-bedrock interface of the slope. After the rainwater reached the soil-bedrock interface, the sliding soil gradually saturated and softened the sliding soil, resulting in a significant decrease in the shear strength index between the sliding soil and the bedrock surface. The loss of soil matrix suction and increase in pore water pressure at the soil-bedrock interface led to a decrease in the slope stability coefficient. When the rainfall lasted for 40 h, the stability coefficient of the soil slope decreased to 1.121, and at 44 h, the stability coefficient was 0.91, causing overall sliding of the slope. After the rain stopped, the accumulated water in the slope gradually seeped out, causing the groundwater level in the slope to gradually decrease, the pore water pressure to slowly decrease, and the stability coefficient of the slope to increase. The numerical simulation of landslide evolution stability process is consistent with the actual landslide instability process.

Fig. 30. Time-varying curve of the stability coefficient of the 5-m soil slope.

- (4) The coupling of pore water pressure and rainwater softening caused the Qiling Village landslide. The stability of the slope was greatly affected by pore pressure in the early stage of rainfall, and the influence of rainwater softening was greater in the later stage.

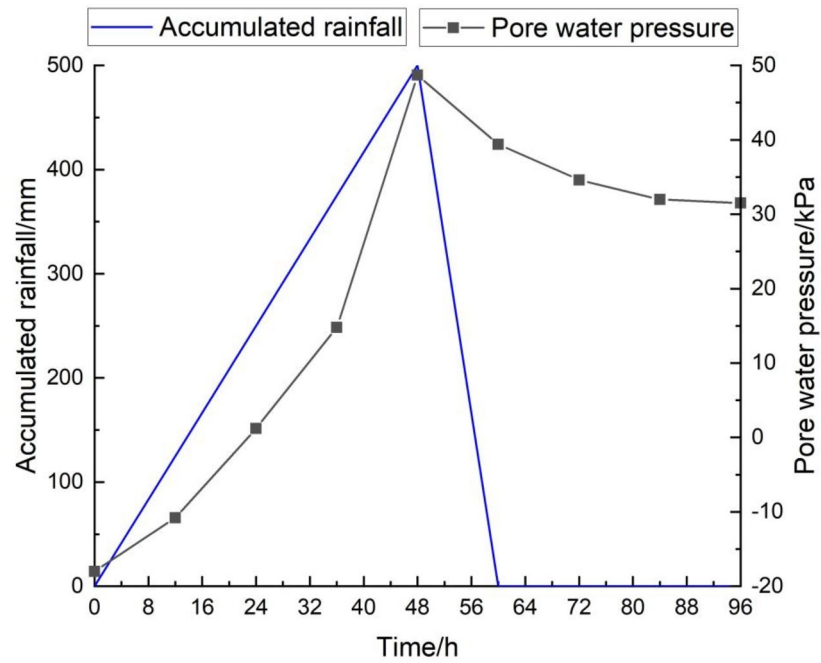
Fig. 31. Change in pore-water pressure with time.

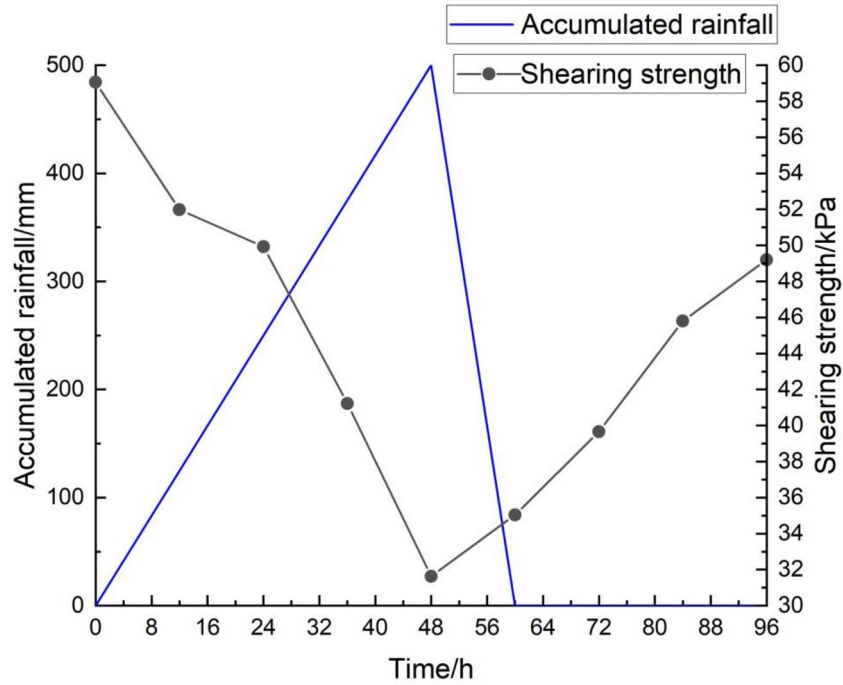
Fig. 33. The strength variation curve of sliding zone soil with rainwater infiltration time.
