OPEN Failure mechanism of a loess slope under extreme rainfall through a model test study of Shixiakou, Lanzhou

Keywords Loess slope, Rainfall induced, Failure mode, Instability mechanism, Fissure evolution

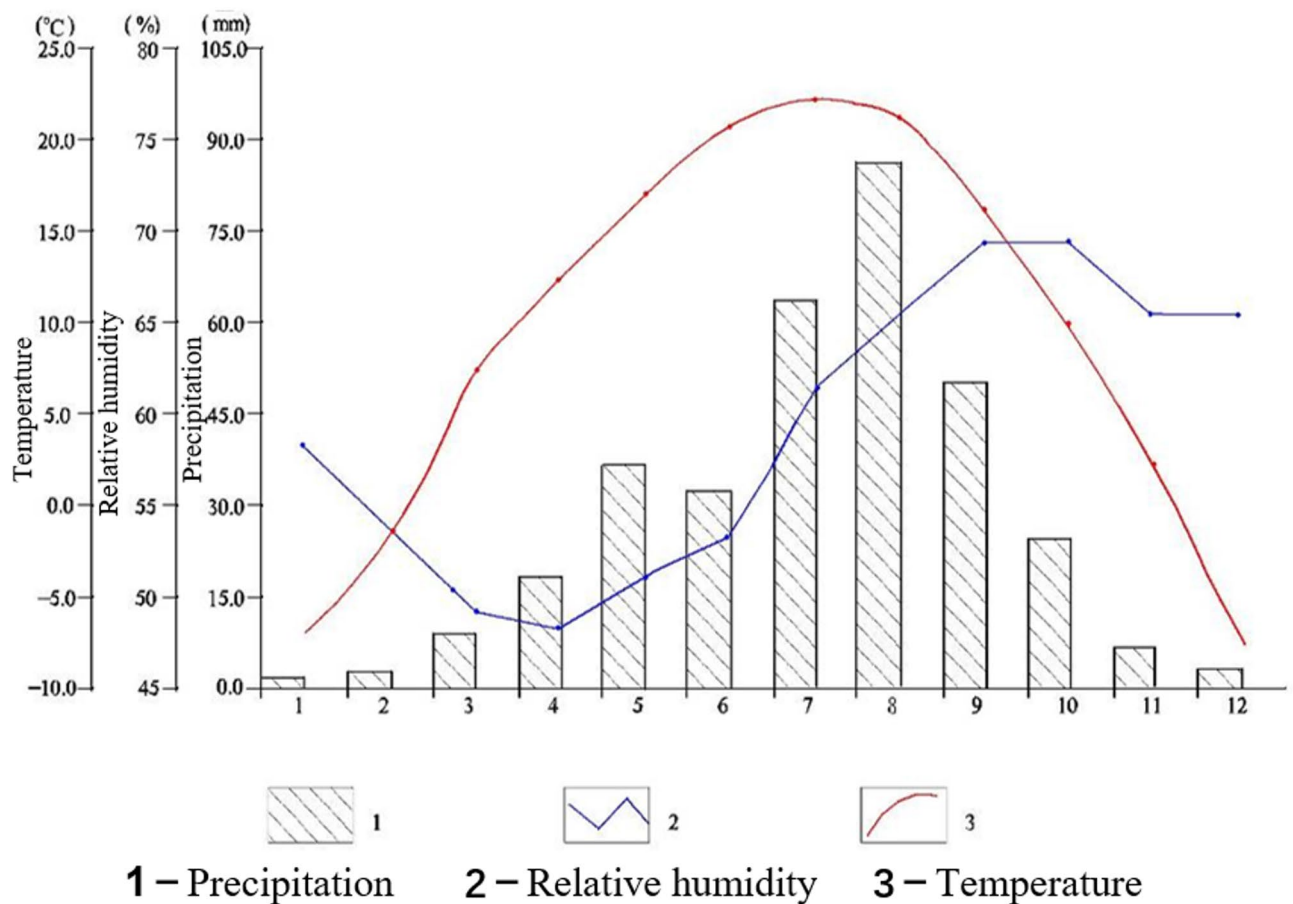
Fig. 2. Lanzhou meteorological elements map.

The Fig. 2 presents the long-term observational data from the meteorological station in Chengguan District, Lanzhou City. The average annual precipitation in the region is 311.7 mm. Precipitation exhibits a typical single-peak distribution throughout the year, with the main flood season occurring from July to September. This period accounts for over 60% of the total annual precipitation. The inter-annual fluctuation is characterised by a short cycle of 4 years and a long cycle of 8–11 years, with a maximum precipitation of 423.5 mm and a minimum of 189.2 mm in the year of extreme values. It is worth noting that the difference in precipitation extremes in August

is significant, with a maximum daily rainfall of 96.8 mm, a maximum hourly rainfall of 68 mm, and a maximum rainfall of 18.6 mm in 10 min. In addition, there is a record of 9 consecutive days of persistent rainfall in the region, with a cumulative rainfall of 168.3 mm. The superposition of such high-intensity, short-duration extreme precipitation events and persistent rainfall constitutes a unique rainfall feature in the region, which poses a significant threat to slope stability.

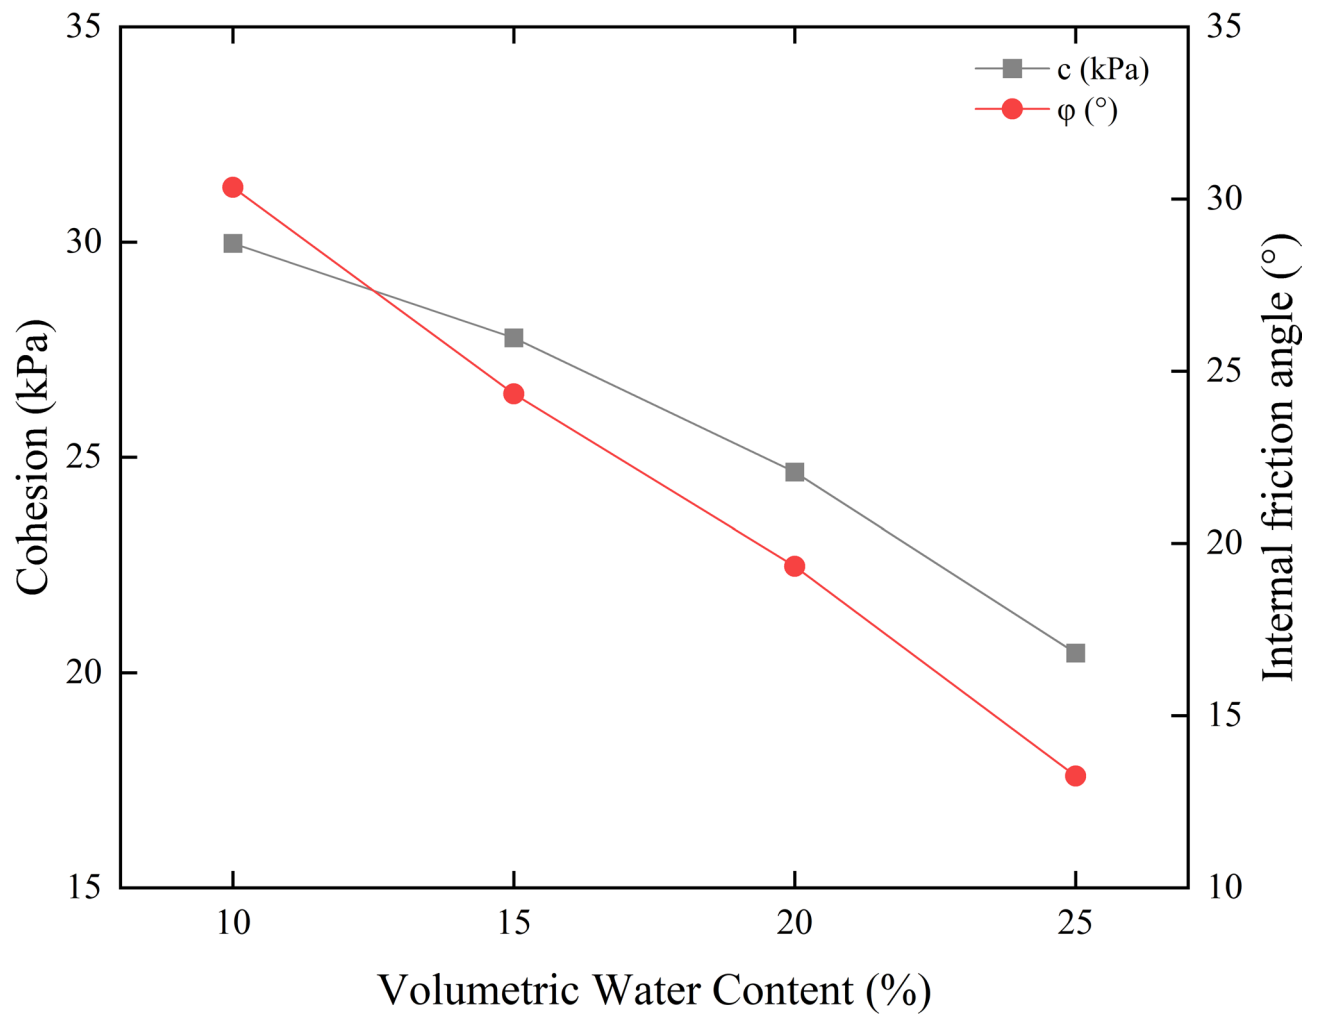
Fig. 4. Shear strength parameters versus water content.

Figure 4 illustrates the variation of shear strength parameters with water content, as derived from fitting the results of triaxial tests conducted under different confining pressures. Both the cohesion and the internal friction angle decrease significantly with increasing volumetric water content. When the water content rises

from 10% to 25%, the cohesion decreases by approximately 31.7%, and the internal friction angle decreases by approximately 56.3%. This indicates that water has a pronounced lubricating and softening effect on the loess, with a particularly severe impact on the frictional characteristics between soil particles. This core hydro-mechanical coupling relationship forms the fundamental basis for the subsequent analysis of the progressive instability of the slope induced by rainfall infiltration.

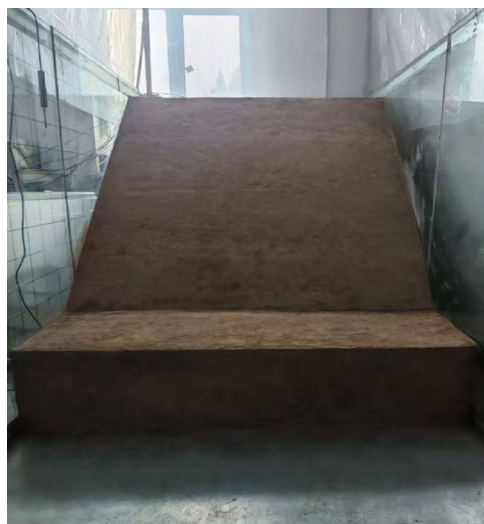
Fig. 5. Loess test slope.

According to the overview of the Jiuzhou landslide described in article 2.1, the slope length of the landslide is 75 m, and the slope angle ranges from 45° to 63°. By comprehensively considering the width data of the landslide rear edge and the landslide front edge, and based on the similarity theory and previous research results, the slope length of the test model is set to 1.5 m after conversion according to the slope scale of 1:50. This configuration resulted in a geometric scale of approximately 1:50 relative to the prototype Shixiakou landslide (length ~ 75 m, height ~ 60 m), determined by the prototype dimensions and laboratory constraints. For safety considerations, the slope angle of the test model is finally determined to be 45°. In addition, to reduce the influence of boundary effects, the height, width, and length of the slope body are set to 1.4 m, 1.45 m, and 2 m, respectively, to ensure that the slope length is close to the design requirement of 1.5 m. The model container's sidewalls were coated with Vaseline to reduce interfacial friction between the walls and loess material. Figure 5 illustrates the constructed loess test slope configuration.

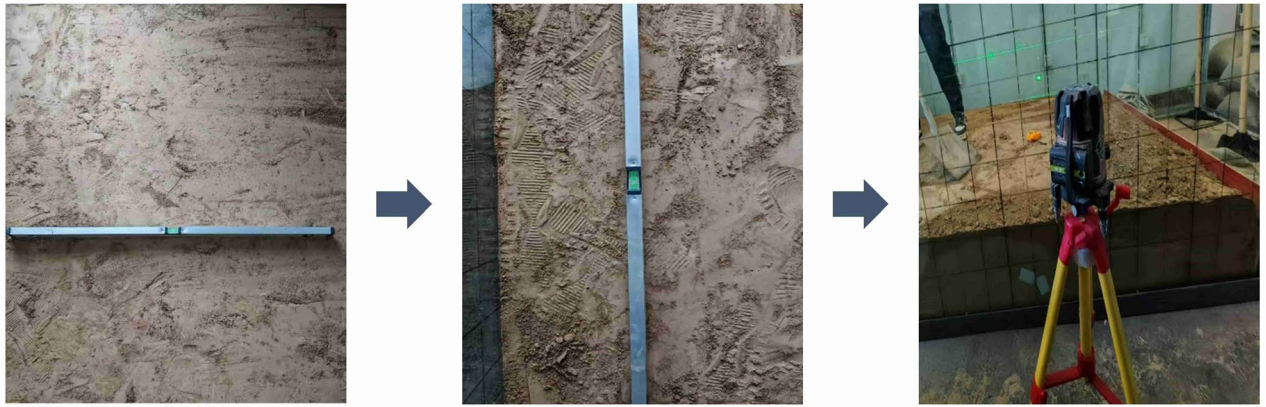
Fig. 6. Test loess filling to determine its horizontal.

The construction methodology employed a carefully designed triangular support structure to facilitate the layered filling process of the test slope. Each fill layer was controlled at a uniform thickness of 0.3 m, with the surface meticulously monitored and adjusted using a combination of infrared laser technology and precision leveling instruments. As clearly illustrated in Fig. 6, the achieved compaction characteristics of the constructed slope precisely matched those observed in natural loess formations. The initial moisture conditions of the test slope were maintained within a narrow range of 11.6% to 12.09% volumetric water content, while maintaining a consistent 1:1 slope gradient throughout the construction process.

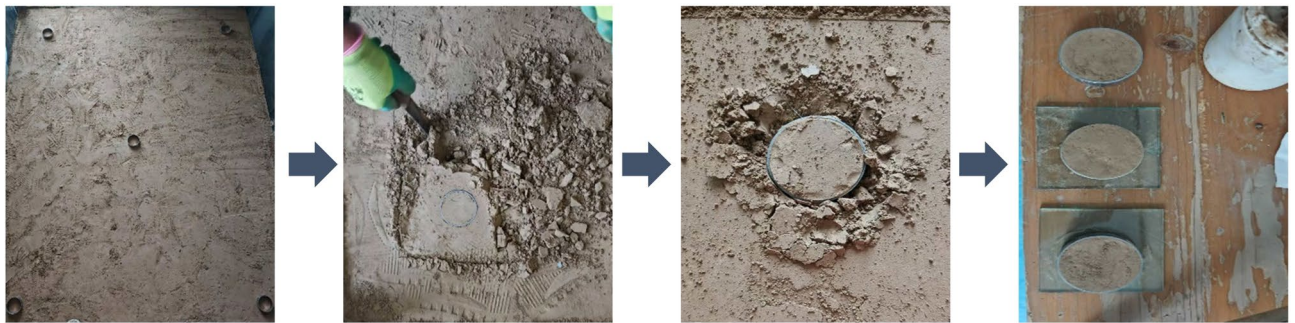
Fig. 7. The sampling process of the loess filling and breaking ring knife.

Quality assurance measures included comprehensive uniformity verification through systematic sampling at five strategically selected locations using a standardized ring sampler with dimensions of 61.8 mm in diameter and 20.0 mm in height (as documented in Fig. 7). These samples enabled precise measurement and verification of compaction characteristics for each layer. Notably, the compaction process for the model slope involved enhanced techniques that resulted in greater density compared to natural slope conditions, particularly due

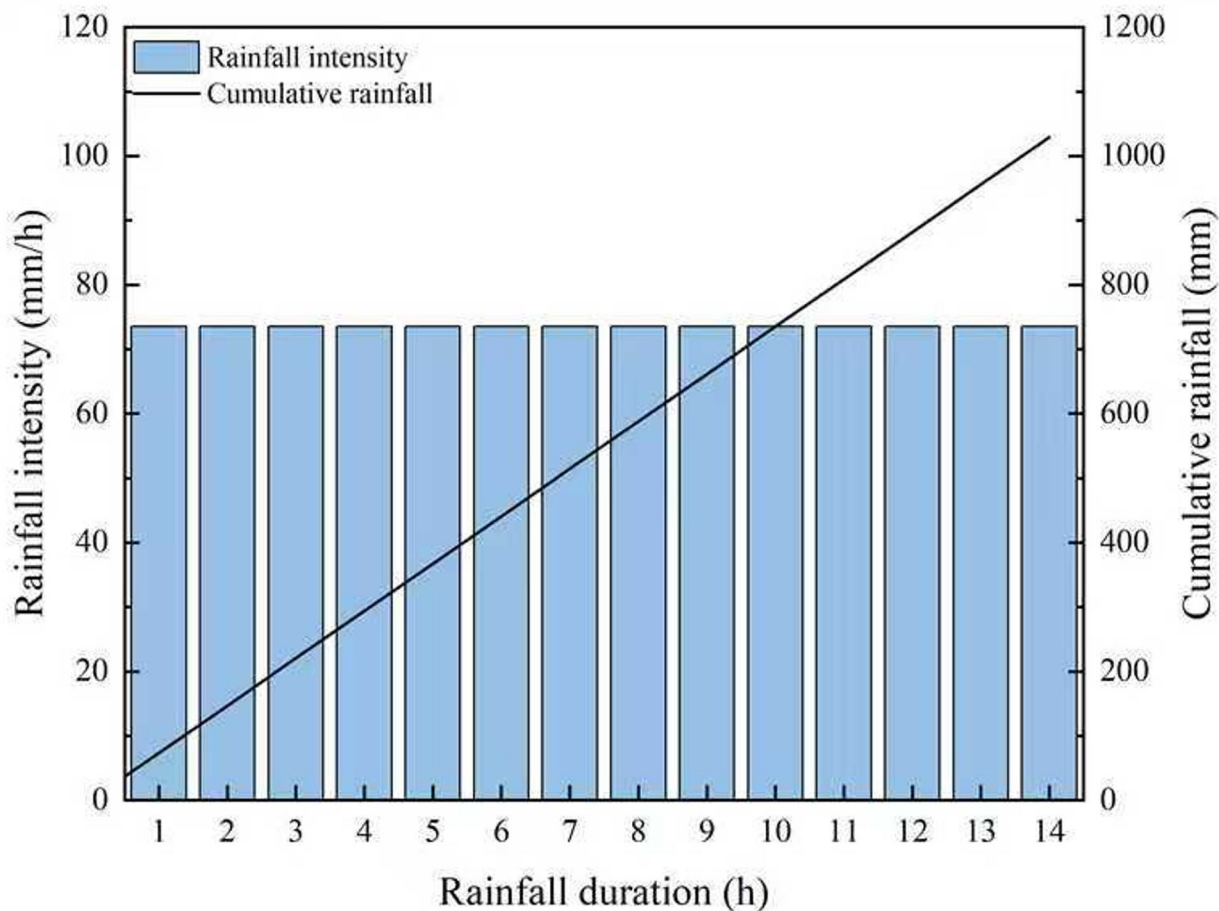
Fig. 11. Graph of rainfall relationship in model test.

mechanisms, a widely accepted simplification is to apply the same rainfall intensity as in the field prototype²⁷ (i.e., a 1:1 scaling ratio). This approach preserves the fundamental competition between rainfall supply and soil infiltration capacity, which is crucial for realistically triggering key instability processes such as surface runoff and internal pore-pressure generation. The simulated rainfall thus represents an intensified scenario to accelerate the failure progression for clear observation. The rainfall lasted for a duration of 14 h, starting at 8:00 a.m., with the rainfall pattern illustrated in Fig. 11. The simulated rainfall was driven by a pressurized water system, where rainfall intensity is regulated by adjusting the water pressure—higher pressure yields greater

intensity. In this study, by maintaining a constant water pressure of 0.5 MPa, a steady rainfall intensity of 73.5 mm/h was achieved.

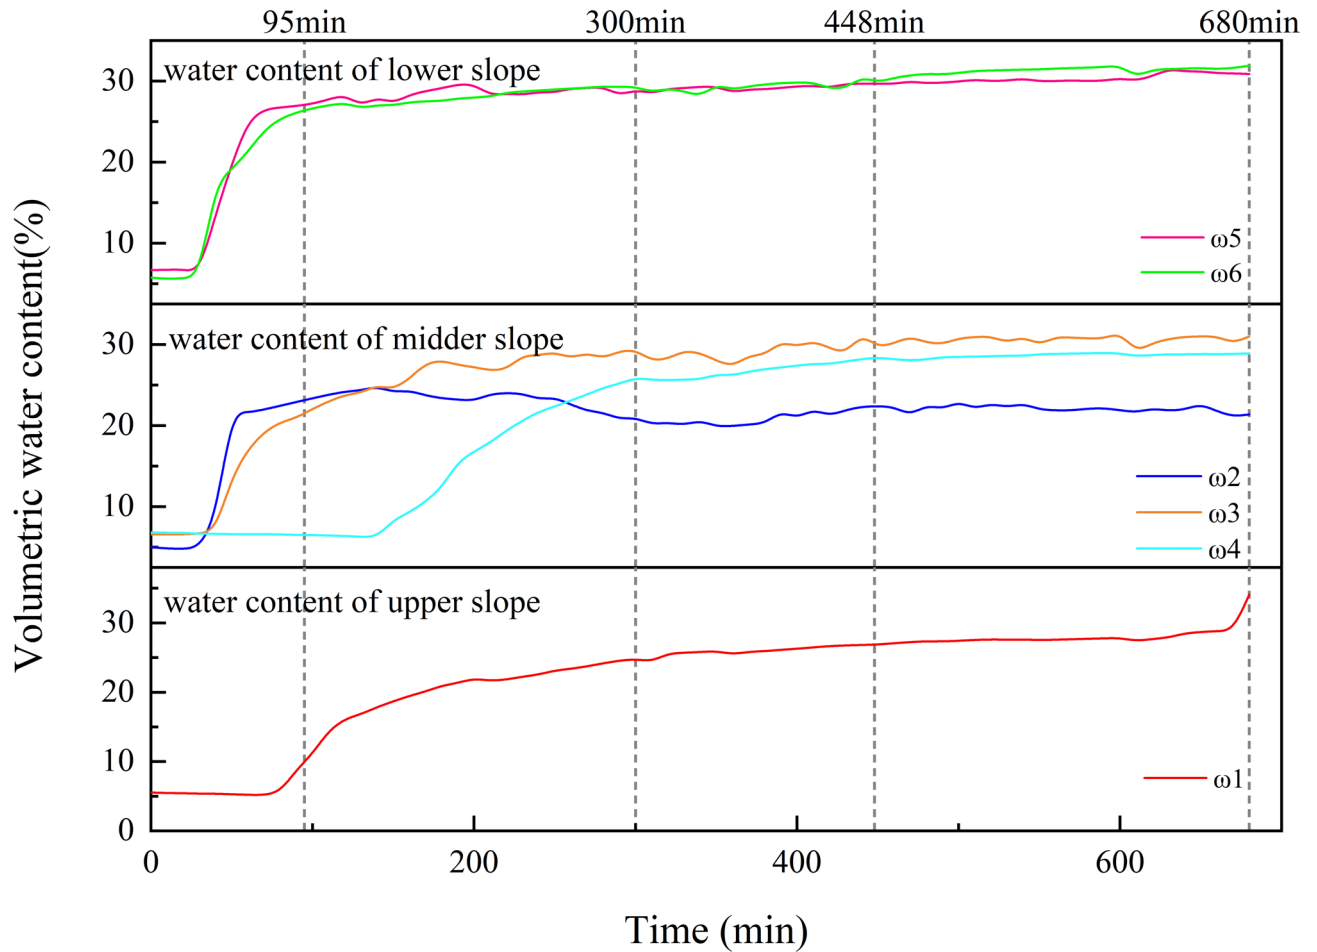
Fig. 12. Temporal variations of volumetric water content at different locations during rainfall infiltration.

Figure 12 illustrates the temporal variations in volumetric water content at different monitoring points within a loess slope during rainfall infiltration, revealing two distinct hydrological response patterns attributable to differences in slope structure.

At the slope crest, monitoring point ω_6 exhibits an immediate response to the wetting front, with moisture content rapidly increasing to near saturation 26.8% and then stabilizing. This reflects the direct infiltration pathways and strong water retention capacity characteristic of the crest area. In the mid-slope section, which includes points ω_2 , ω_3 , and ω_4 , a gradual response pattern is observed. Both ω_2 and ω_3 reach peak saturation relatively quickly, undergo partial drainage, and eventually stabilize at a lower moisture level. Notably, although ω_2 and ω_4 are situated at the same depth, the arrival time of the wetting front differs significantly—63 min for ω_2 compared to 300 min for ω_4 . This delay is attributed to localized subsidence in the mid-slope region, which diverts preferential flow away from ω_4 , resulting in a lower maximum saturation of about 24.5%. Additionally, a sudden increase in moisture content at ω_4 after 130 min is likely associated with the development of micro-

fractures induced by gravitational forces and water infiltration. These fractures enhance local permeability and facilitate accelerated seepage. At the slope toe, monitoring point ω_1 shows a gradual hydrological response: moisture content increases slowly, attains a moderate saturation level, and subsequently changes only minimally. This behavior indicates a slower infiltration and redistribution process in the toe region, consistent with its more delayed reaction to rainfall infiltration.

The spatial and temporal differences in volumetric water content across the slope clearly demonstrate the development of preferential flow paths within the loess slope. The heterogeneity in moisture distribution, particularly the formation of these preferential pathways, directly influences the heterogeneous deformation behavior and failure mechanisms of loess fill slopes under rainfall conditions, underscoring the critical role of local structural variations in overall slope stability.

Monitoring data indicate that spatial heterogeneity in volumetric water content and surface erosion were the main contributors to slope toe failure. Figure 12 reveals significant variation in volumetric water content at the slope toe, where the value at ω_6 increased to 29.1%, indicating the presence of lateral seepage in the embankment area. This lateral flow enhances vertical infiltration capacity, accelerating the downward migration of moisture. Furthermore, Fig. 16 demonstrates higher permeability beneath the embankment compared to the slope surface, suggesting that a slip surface may have developed within the saturated zone near the slope toe. It is noteworthy that, as shown in Fig. 15, under the combined influence of overburden weight and pore water pressure, fissures initially formed at Retaining Fill I, providing preferential pathways for rainwater infiltration and ultimately leading to the failure of the slope toe.

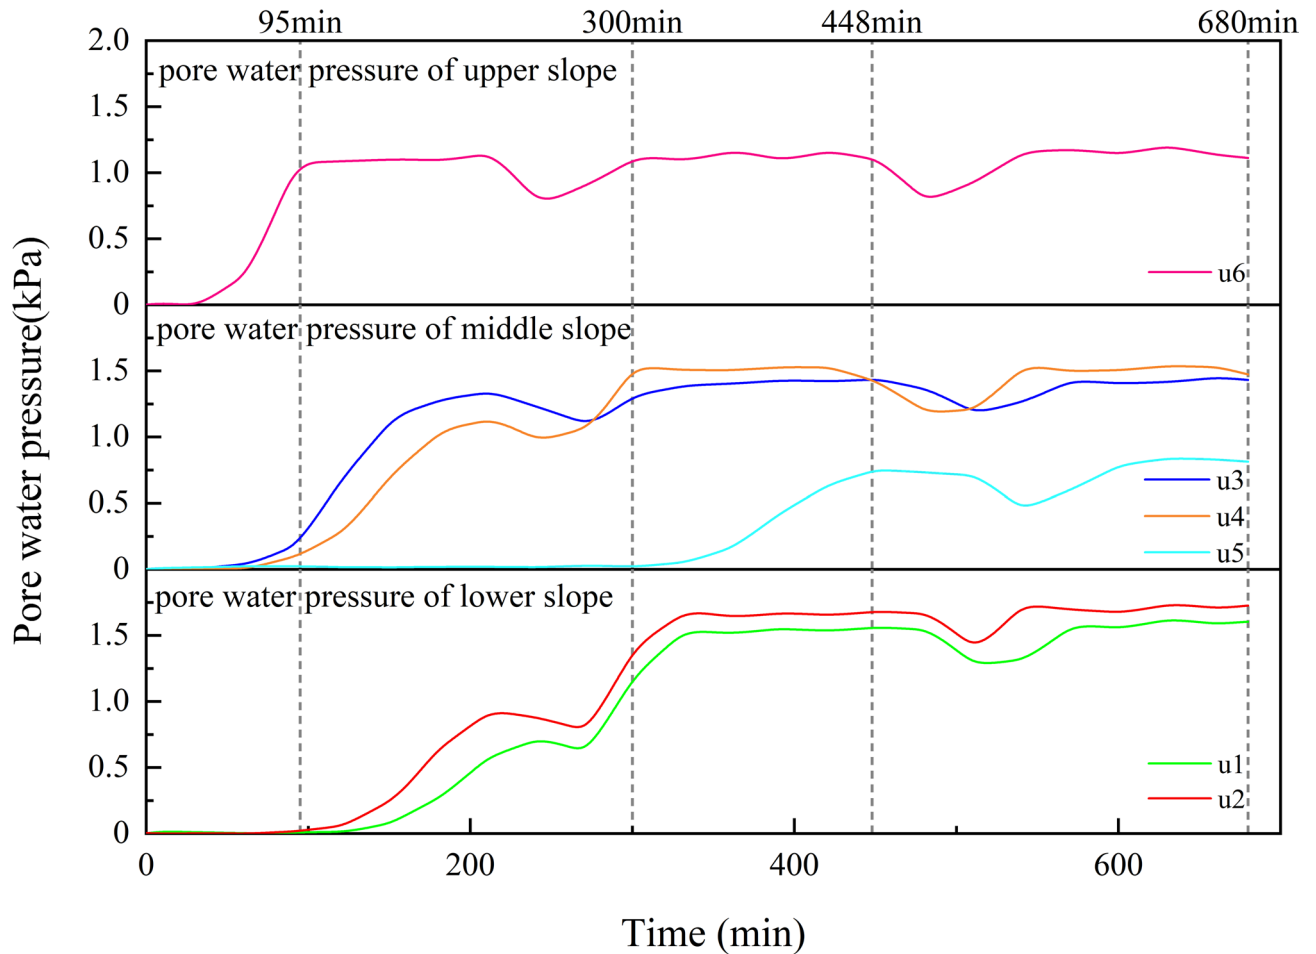
Fig. 13. Three-stage evolution of pore water pressure prior to slope failure.

Figure 13 illustrates the pore water pressure variations in different sections of the experimental slope before failure. The piezometer u6 at the upper slope exhibited the most rapid response, which can be attributed to the increase in hydrostatic pressure caused by rainwater accumulation at the slope crest.

Overall, the evolution of pore water pressure displayed a three-stage pattern: an initial gradual rise as the wetting front reached each monitoring point, followed by significant fluctuations during the phase of accelerated slope deformation, and finally a continuous decline upon the onset of instability. It is noteworthy that the amplitude of pore water pressure changes in the middle and toe sections was considerably greater than that in the upper slope, indicating that these regions were subjected to more pronounced stress concentration during the deformation process.

The removal of toe support also induced stress concentration in the mid-slope section. As shown in Figs. 13 and 14, pore water pressure at points u3 and u4 displayed an increasing trend, while the horizontal earth pressure at p2 fluctuated around 0.42 kPa. Under these conditions, numerous tensile cracks developed in the central part of the slope, significantly exacerbating the overall damage to the slope structure. Therefore, a systematic understanding of fracture evolution is essential for elucidating the failure mechanism of loess slopes, which will be further discussed in subsequent sections.

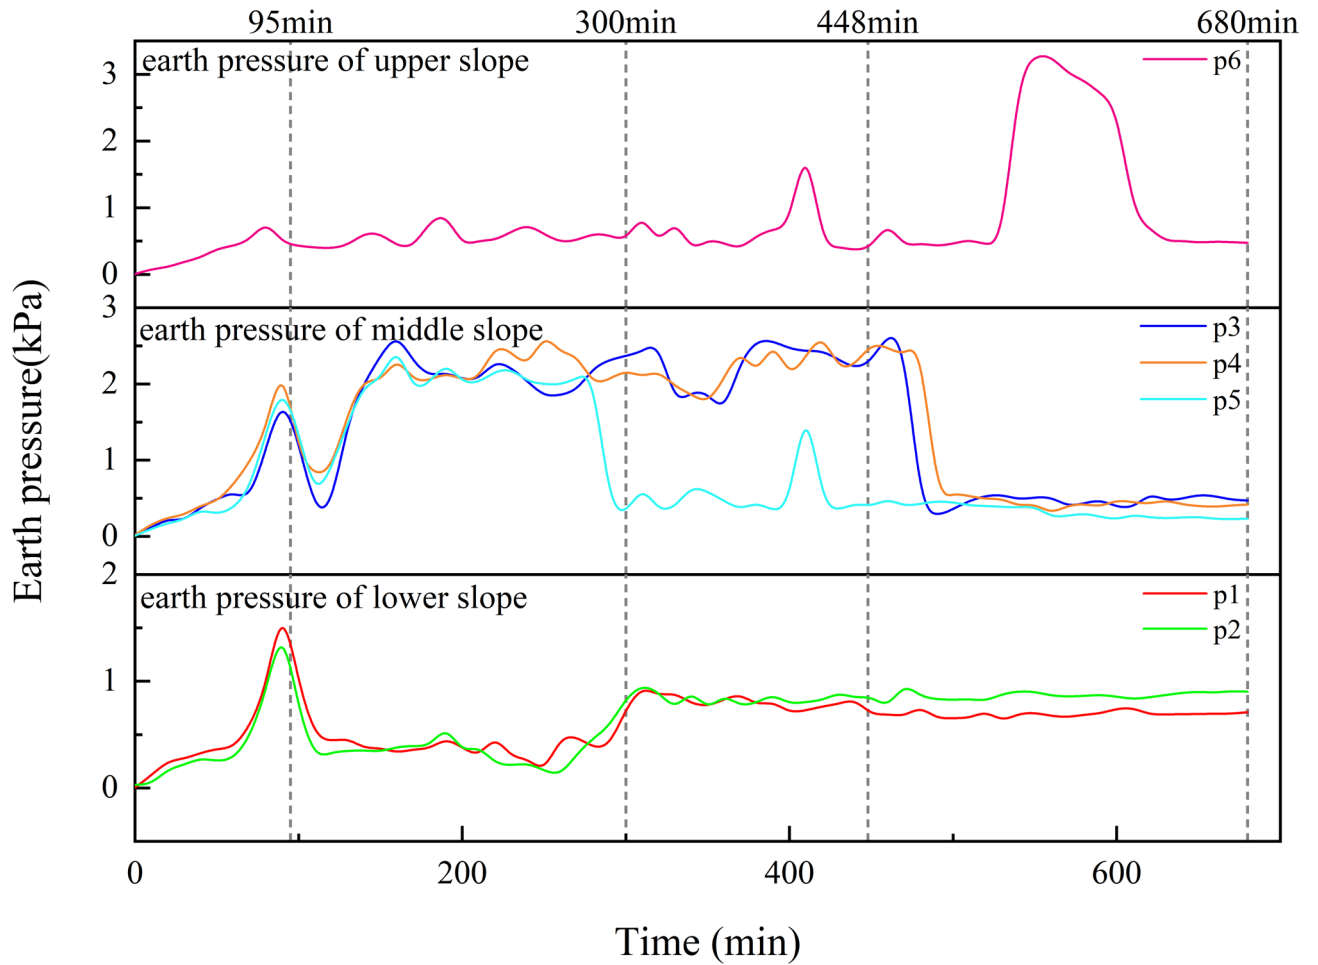
Fig. 14. Evolution of horizontal earth pressure during rainfall infiltration.

Figure 14 illustrates the evolution of horizontal earth pressure in the slope during rainfall infiltration. Compared to volumetric water content and pore water pressure, the earth pressure responded more rapidly to rainfall, indicating the immediate influence of infiltrating water on the redistribution of gravitational stress. During the initial stage 0–95 min, the variation trends of earth pressure at all monitoring points were consistent. With continued rainfall and water accumulation at the slope crest, the horizontal earth pressure peaked at approximately 530 min, then gradually decreased as the wetting front propagated downward. Detailed analysis of the mid-slope sensor p4 revealed a close correlation between its pressure variation and moisture movement as well as local deformation: the initial increase corresponded to the rise in volumetric water content at ω_3 , followed by fluctuations around 2.35 kPa influenced by changes in pore water pressure at u4 and mid-slope

deformation, culminating in an abrupt decrease during slope failure. Additionally, significant fluctuations were recorded by the upper-slope sensor p5 between 530 and 680 min, showing a high consistency with the variations observed at the mid-slope sensor p3.

The experimental results highlight two key findings: First, the notable pressure increment observed at p4 during slope failure indicates that horizontal stress concentration plays a critical role in the instability mechanism. Second, the amplitude of earth pressure variation in the slope crest was substantially greater than that in the middle and lower sections, underscoring the controlling influence of the crest on overall slope stability. These response patterns reflect the development of compression zones and stress concentration areas during soil deformation, providing important insights into the stress transfer mechanisms in rainfall-induced failures of loess slopes.

Subsequent basal slope instability (95–300 min) Prolonged rainfall induced a coupled interaction between horizontal earth pressure and pore water pressure in the saturated zone, leading to localized slip and collapse failure. The failure mechanism stems from two primary factors. First, the unique pore structure and mineral composition of the loess resulted in differential settlement under continuous infiltration, triggering shear deformation, while the near-saturation of the superficial soil significantly reduced its shear strength. Second, as illustrated in Fig. 13, the accumulating gravitational load at the slope crest caused pore water pressure at monitoring points u5 and u6 in the locally disturbed zone to peak, further weakening the soil's shear resistance and promoting progressive displacement at the slope toe. Concurrently, the horizontal earth pressure at points p3 and p4 exhibited notable fluctuations and a continuous increase, as shown in Fig. 14, further compromising slope stability.

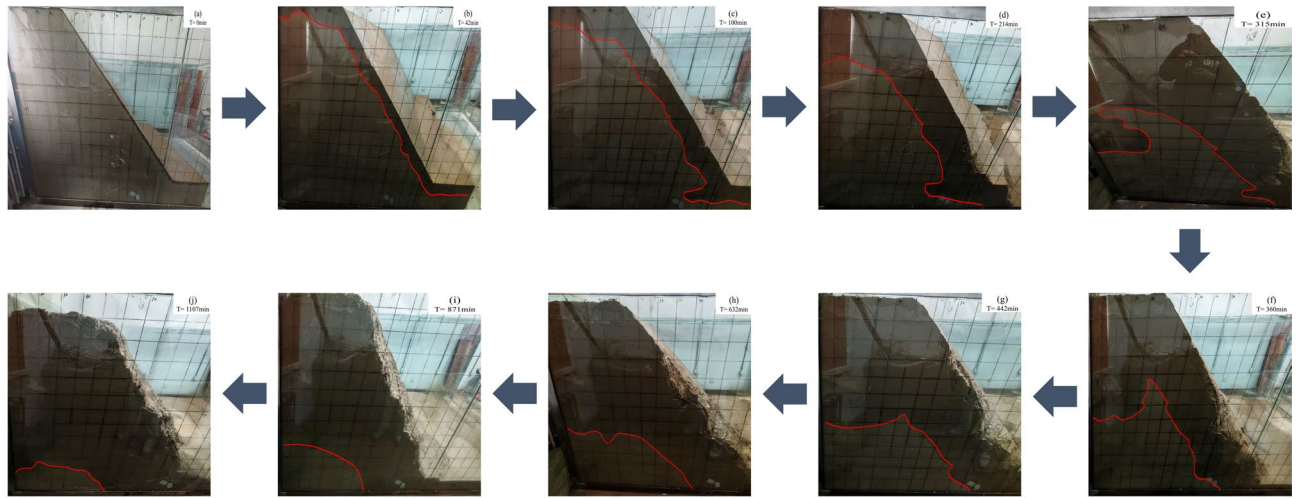
Fig. 16. Wetting front advancement at successive time points.

Initial surface scouring (0–95 min) Based on multi-temporal wetting front observations through the glass sidewall, the recorded migration rates of the wetting front at monitoring sensors in Sects. 1-1 range from 2.383 to 4.162 mm/min, with a mean value of 3.343 mm/min. Comparative analysis of rainfall infiltration rates at

measuring points ω_1 , ω_3 , and ω_5 reveals a decreasing trend in infiltration capacity from the upper to the lower part of the slope. Specifically, the highest infiltration rate occurs in the embankment area, followed by the slope surface, while the lowest is observed in the mid-lower slope region.

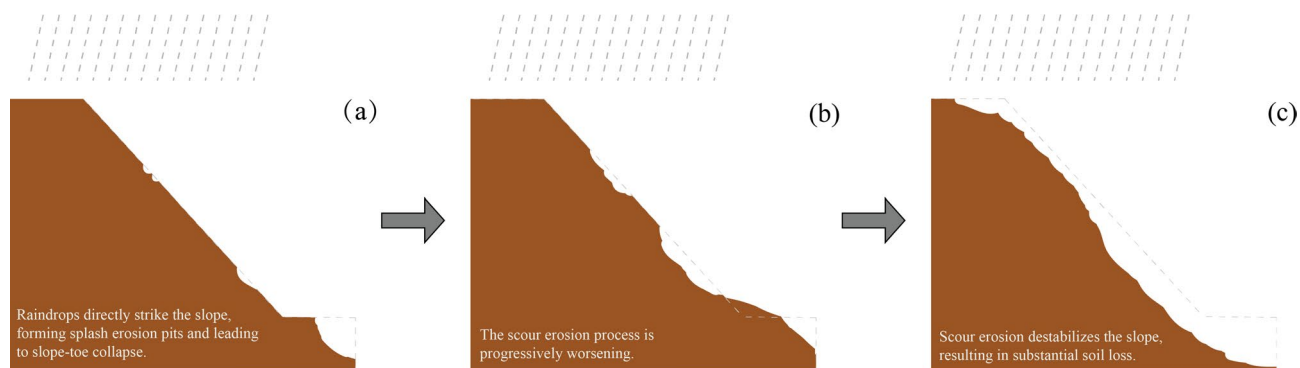
Fig. 18. Schematic diagram of the process of rainfall-induced slope erosion and failure.

As depicted in Fig. 18a, the initial rainfall phase involves raindrop impact directly on the slope surface, generating splash erosion pits and triggering localized collapse at the slope toe. This process compromises the original slope structure, inducing differential settlement in the central slope region where initial microfractures develop. Under the coupled influence of differential settlement and rainwater infiltration, accumulated plastic deformation progresses to brittle fracture failure. The emerging fracture network not only disrupts soil continuity but also establishes preferential pathways for moisture migration.

During fracture propagation, controlled by spatial heterogeneity in soil strength and moisture distribution, fractures exhibit arcuate transverse expansion. Significantly, preferential flow networks develop within the slope prior to visible fracture formation. Concurrent intensification of surface scour erosion, illustrated in Fig. 18b, further degrades slope integrity and accelerates longitudinal fracture extension.

The final instability stage involves interconnection between rear-edge fractures and leading-edge shear surfaces, forming a continuous slip plane as shown in Fig. 18c. Driven by rapid discharge of accumulated water behind the fractures, the slope undergoes rapid sliding accompanied by substantial soil loss. Crucially, unlike sand-clay slopes where failure is primarily governed by pore water pressure, loess slope instability represents a dynamic coupling process between fracture development and erosion mechanisms. This understanding provides a vital theoretical foundation for loess slope hazard mitigation.
