Public remotely sensed data raise concerns about history of failed Jagersfontein dam

Luis Alberto Torres-Cruz[✉] & Christopher O'Donovan

A mine waste deposit known as a tailings dam recently failed in the town of Jagersfontein, South Africa. The failure occurred amidst global concern about the safety record of these structures. Herein we use public remotely sensed data to gain insights into the construction history of the dam. The data suggest a construction sequence that is inconsistent with sound tailings management practices: asymmetric deposition, erosion gullies, large ponds and absence of beaches. These observations highlight the criticality of adhering to good construction practices and the potential of public data to monitor such adherence. Additionally, we present commercially available very high resolution satellite images to illustrate some of the immediate consequences of the failure.

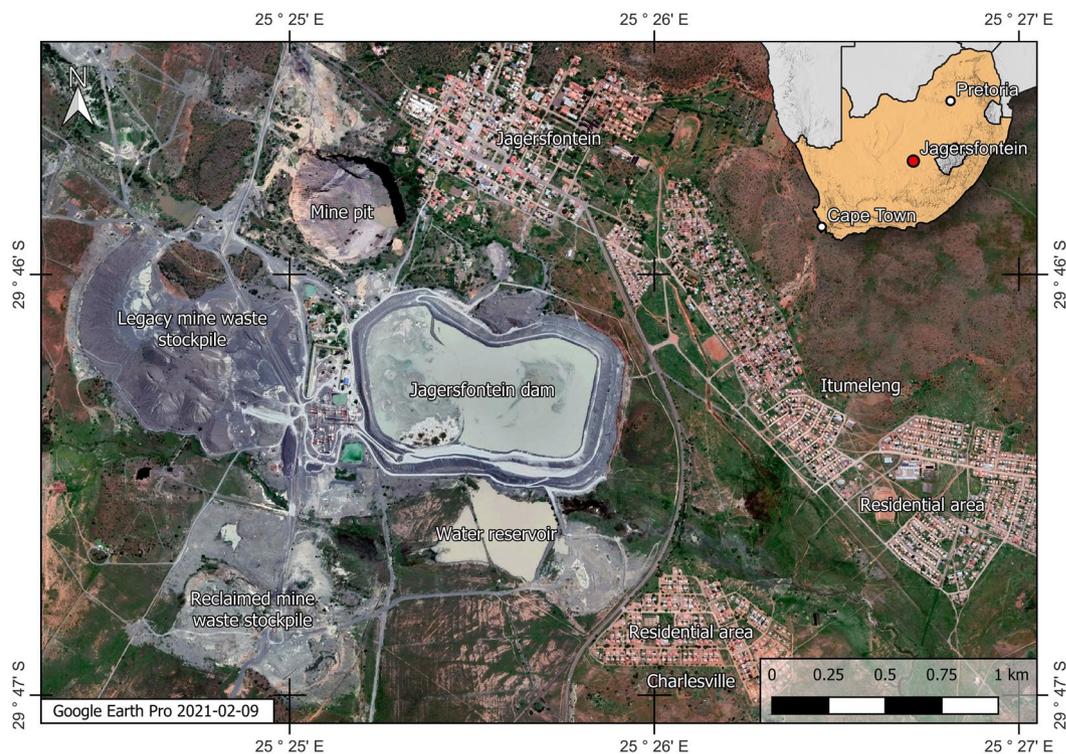
Figure 1. The Jagersfontein dam and its surroundings 19 months before failure, created using QGIS software version 3.26 (<http://www.QGIS.org>).
