## Study on the disaster mechanism and prevention technology of embankment slip-collapse after extreme rainfall in the loess area

This study investigates railway embankment slip-collapse disasters triggered by July 2021 extreme rainfall in Zhengzhou, China, through field investigations, in-situ tests, laboratory tests, field monitoring, and numerical simulations. The research results indicate that: (1) Zhengzhou loess experiences accelerated strength degradation when moisture content exceeds plastic limit, with shear modulus, cohesion, and internal friction angle decreasing rapidly beyond this threshold. (2) Embankment slip-collapse, a geohazard characterized by shallow failures in slope surfaces, is primarily triggered by hydro-mechanical coupling under extreme rainfall, with deformation severity controlled by infiltration intensity. (3) Three stages of slope stability division criteria are proposed, namely metastable zone, critical instability zone, and instability zone. The critical threshold of moisture content of 20.71% under these conditions provides a quantifiable benchmark for early warning systems targeting surface collapse prevention. (4) A steel grouting pipe reinforcem

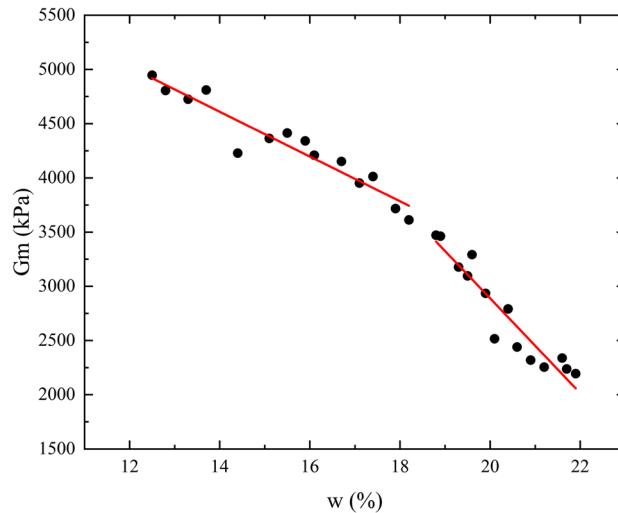
**Fig. 2.** Test area loess  $G_m$ - $\omega$  relationship distribution diagram.

A total of 28 groups of pressuremeter tests were conducted at depths of 9–12 m below the ground surface. The relationship between shear modulus  $G_m$  and loess moisture content  $\omega$  was shown in Fig. 2. It could be observed that as the moisture content increased gradually from 12.5%, the shear modulus indicated a decreasing trend. When the moisture content was below 18.5%, the rate of decrease was slow. However, when the moisture content

exceeded 18.5%, the rate of decrease in shear modulus accelerated. Therefore, a segmented linear regression method was employed to fit the relationship between shear modulus and loess moisture content, and the results were presented in Eqs. (1) and (2).

The segmented linear regression method yielded good fitting results. When  $12.5\% \leq \omega < 18.5\%$ , the correlation coefficient  $R^2$  was 0.91, and the rate of shear modulus decrease was: for every 1% increase in moisture content, the shear modulus decreased by 206.3 kPa. When  $18.5\% \leq \omega < 21.9\%$ , the correlation coefficient  $R^2$  was 0.89, and the rate of shear modulus decrease was: for every 1% increase in moisture content, the shear modulus decreased by 437.0 kPa.

The pressuremeter test was a horizontal load test, and the lateral expansion of flexible membrane compressed soil deformation, so the value of the shear modulus reflected the soil's resistance to lateral deformation. When the moisture content was lower than the plastic limit of 18.5%, the loess was in a semi-solid state and the soil was relatively hard. At this time, an increase in moisture content kept the soil in a semi-solid state, resulting in a slow rate of decrease in the shear modulus. When the moisture content exceeded 18.5%, the loess was in a plastic state and the soil hardness decreased. At this time, an increase in moisture content put the soil in a plastic state, leading to a significantly increased rate of decrease in the shear modulus.

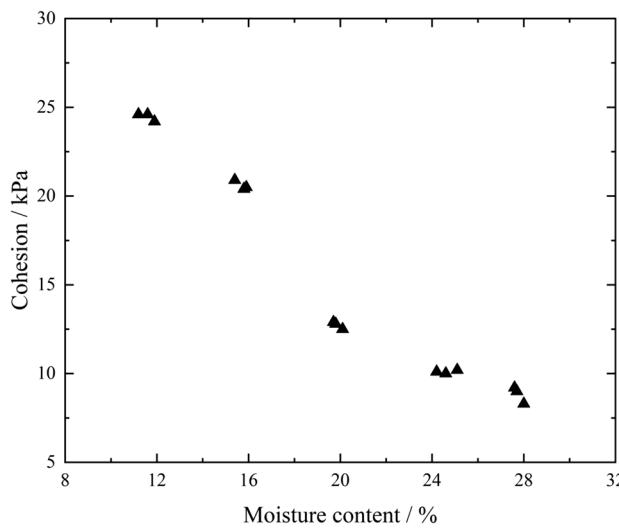
**Fig. 3.** Tested loess cohesion—moisture content diagram.

The test results of cohesion and internal friction angle of loess samples at various moisture states were shown in Figs. 3 and 4. Deterioration characteristics of the cohesion and the internal friction angle of loess could be concluded as follows.

1) Both the cohesion and the internal friction angle of the loess in Zhengzhou decreased as the moisture content increased. As the moisture content increased from 11.2 to 28.0%, the cohesion of the loess decreased from 24.6 to 8.3 kPa, resulting in a decrease of 16.3 kPa and a loss of 66.26%. Meanwhile, the internal friction angle decreased from  $21.8^\circ$  to  $19.8^\circ$ , leading to a decrease of  $2^\circ$  and a loss of 9.17%.

2) When the moisture content approached the plastic limit, the cohesion of the loess in Zhengzhou experienced a sharp decline with the increase of moisture content. The trend of cohesion variation with moisture content was shown in Table 3. As the moisture content increased from 15.8 to 20.1%, the cohesion dropped sharply from 20.4 to 12.5 kPa, resulting in a decrease of 7.9 kPa. The proportion of cohesion loss at this stage accounted for 48.5% of the total loss, and the average rate of cohesion decrease was the highest, which was 1.84 kPa/%. The maximum rate of cohesion loss in this stage was due to the moisture content increasing from below the plastic limit to above the plastic limit. As shown in Table 2, the plastic limit range of loess samples ranged from 18.1 to 19.2%. As the moisture content increased from 15.8 to 20.1%, the thickness of the water film

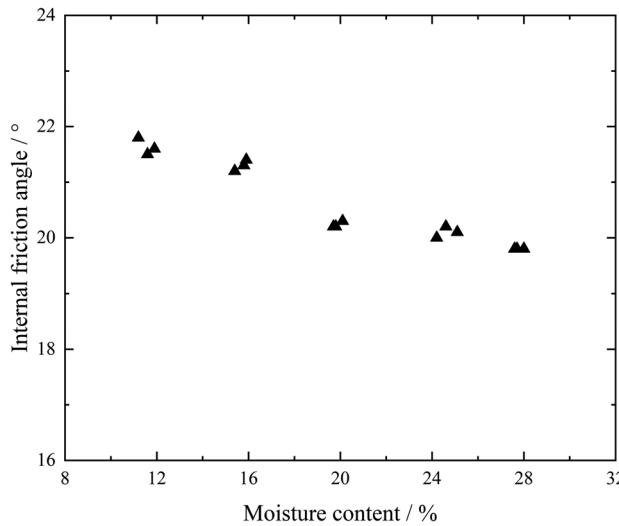
**Fig.4.** Tested loess internal friction angle—moisture content diagram.

3) When the moisture content approached the plastic limit, the internal friction angle of the loess in Zhengzhou decreased abruptly with the increase of moisture content. The trend of internal friction angle variation with moisture content was shown in Table 4. As the moisture content increased from 15.8 to 20.1%, the internal friction angle decreased sharply from 21.3° to 20.3°, resulting in a decrease of 1°. The proportion of internal friction angle loss at this stage accounted for 50% of the total loss.

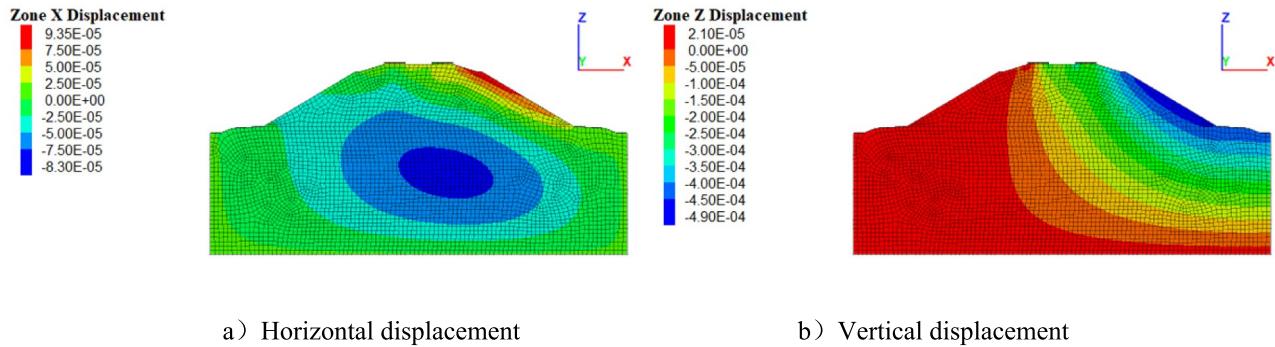
**Fig. 8.** Displacement nephogram under low-intensity seepage condition.

The horizontal and vertical displacements at the calculation time of 120 h were extracted, as shown in Fig. 8. At the calculation time of 120 h, the entire right slope surface was the region of maximum horizontal and vertical displacements. The maximum values of horizontal and vertical displacements were 0.009 cm and -0.049 cm (negative values indicate settlement), indicating that the vertical displacement had a greater impact on the total displacement of the embankment.

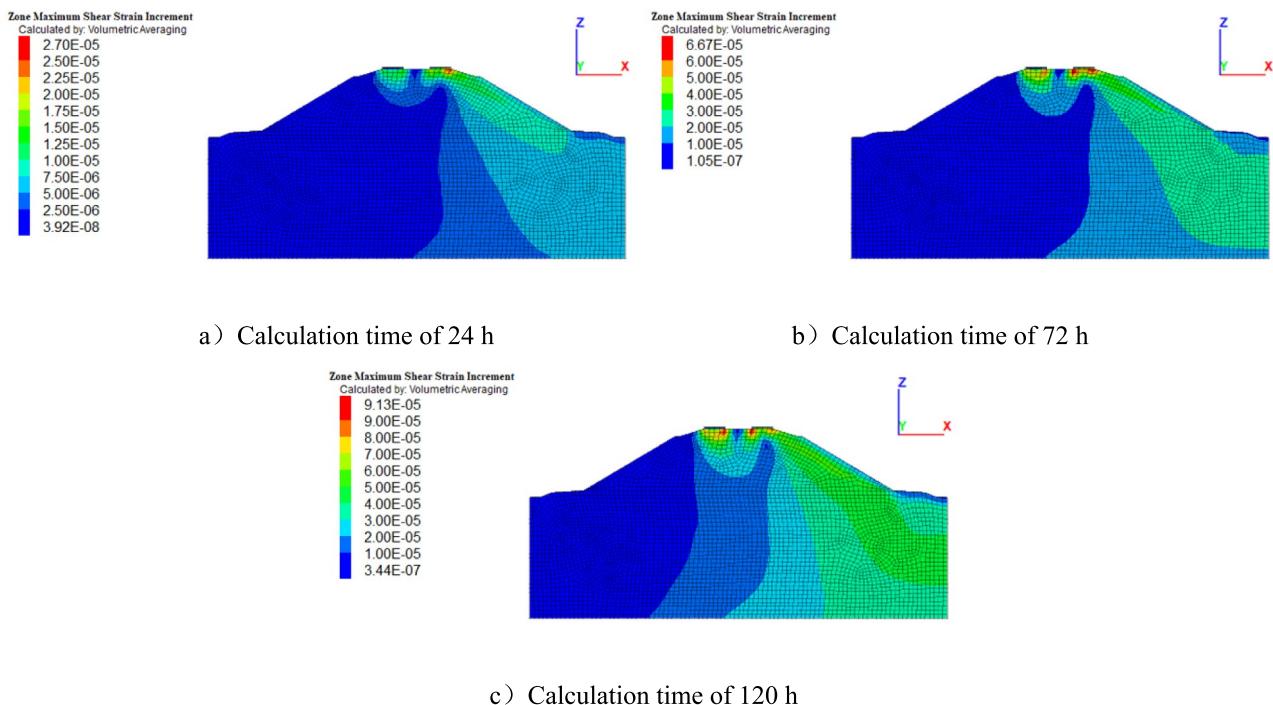
**Fig. 9.** Maximum shear strain nephogram under low-intensity seepage condition.

As could be seen in Fig. 9, the maximum shear strain appeared on the right embankment slope under the influence of rainfall seepage. As time went on, the continuous effect of seepage caused the maximum shear strain to continuously develop downward along the slope. Under the low-intensity seepage condition, the maximum

value of shear strain on the slope was relatively small, and no slope slip-collapse was formed on the embankment slope.

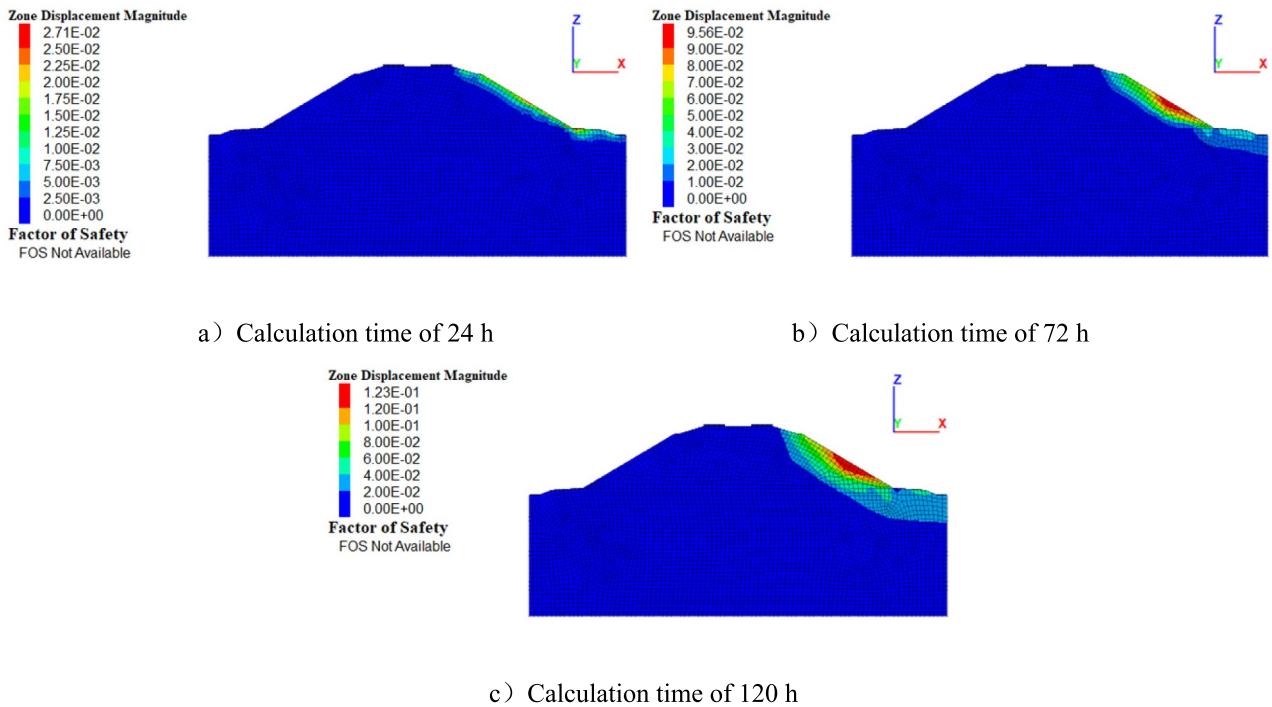
**Fig. 13.** Magnitude displacement nephogram under high-intensity seepage condition.

As shown in Fig. 13, due to the large amount of seepage, a significant region of extreme values of magnitude displacement quickly appeared on the right side of the embankment. At the calculation time of 24 h, the soil thickness of the extreme value region was approximately 0.5 m, with the maximum displacement reaching 2.71 cm. As time progressed, under the continuous action of seepage, the affected range of the extreme value region deepened continuously, and the maximum value of magnitude displacement kept increasing. At the calculation time of 120 h, the thickness of the extreme value region increased to 2.5 m approximately, and the maximum displacement increased to 12.30 cm. Compared to the medium-intensity seepage condition, the area affected by rainfall deepened further and the magnitude displacement continuously increased with the duration of seepage.

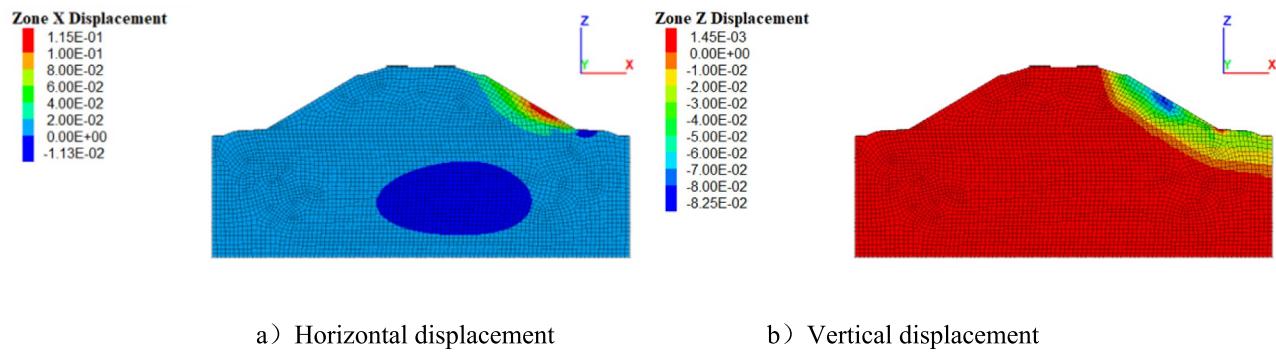
**Fig. 14.** Displacement nephogram under high-intensity seepage condition.

From Fig. 14, it could be observed that at the calculation time of 120 h, the influence of seepage on the horizontal and vertical displacements of the embankment was primarily on the right slope. The maximum values of horizontal and vertical displacement were 11.50 cm and  $-8.25$  cm, respectively (negative values indicate settlement). Compared to the previous two conditions, both horizontal and vertical displacement significantly increased. Besides, vertical displacement still had a greater impact on the magnitude displacement of the embankment.

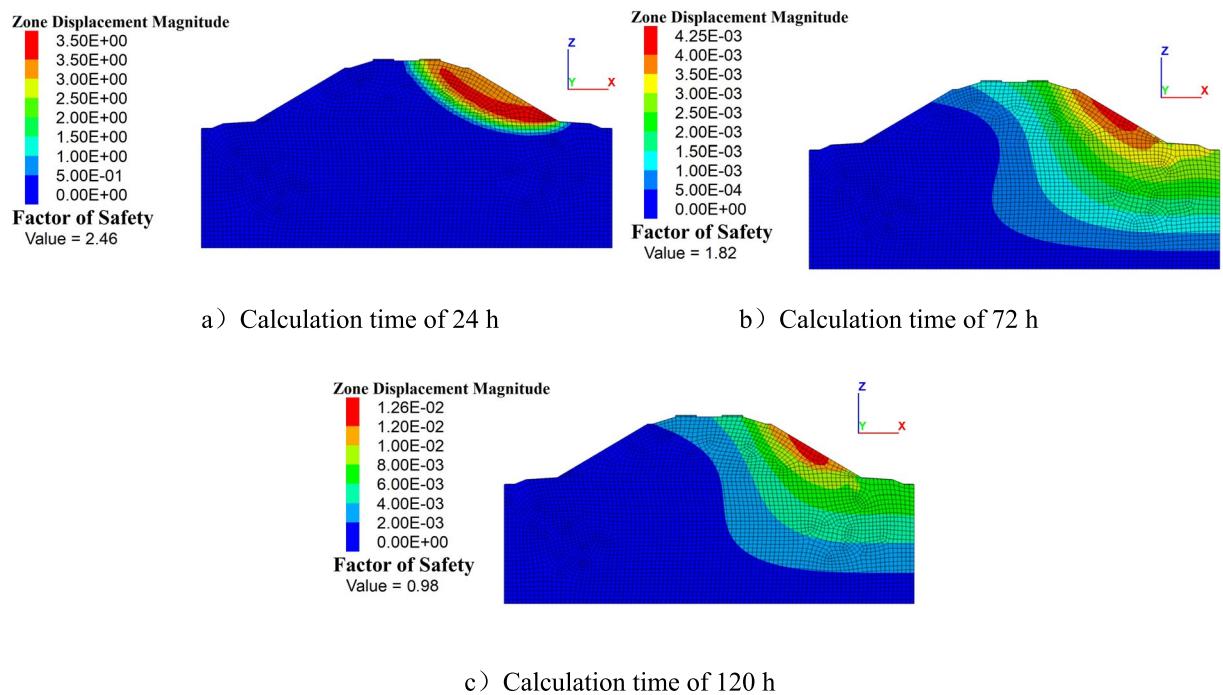
**Fig. 16.** Maximum shear strain nephogram under high-intensity seepage condition.

Strength reduction analysis was conducted on the soil of the embankment slope under low, medium, and high-intensity seepage conditions. As shown in Fig. 16, the stability coefficients of the embankment slope under low, medium, and high-intensity seepage conditions were 2.46, 1.82, 0.98 respectively. The stability coefficients that are larger than 1 indicate that the loess embankment slope has no potential for instability under low and medium-intensity seepage conditions, while the stability coefficient that is less than 1 demonstrates that the loess embankment slope is in instability state under the high-intensity seepage condition.

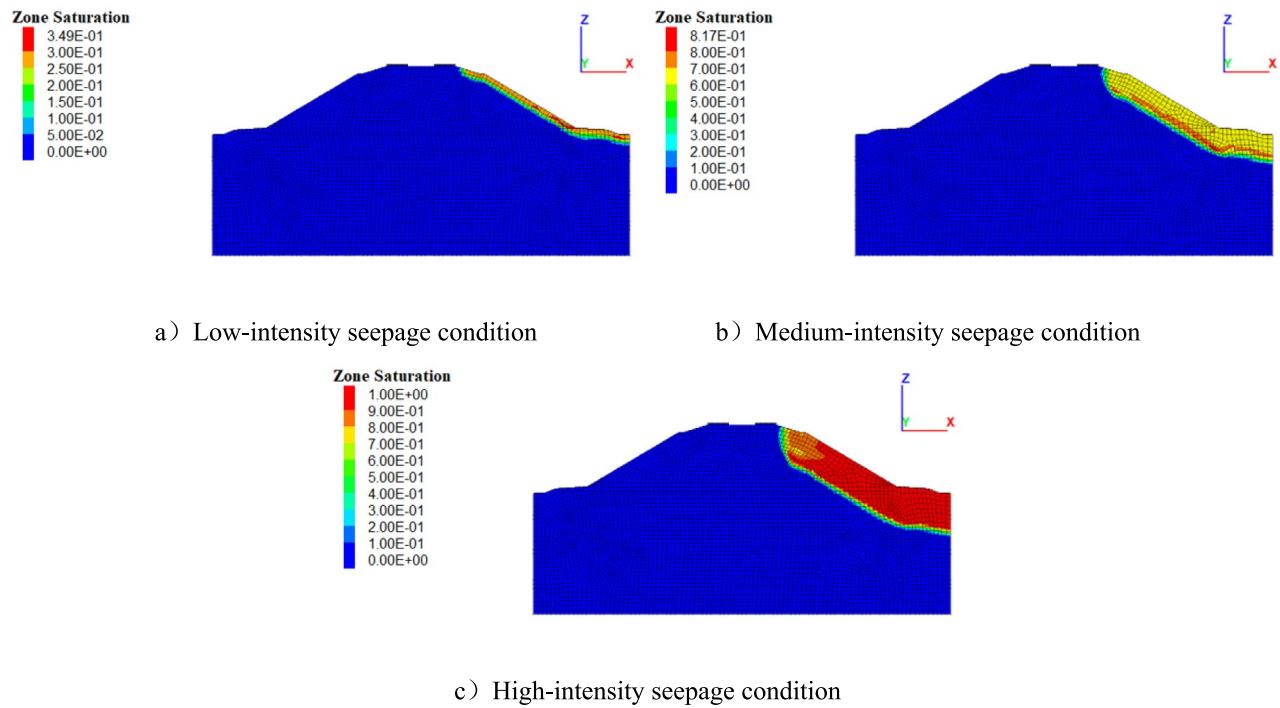
**Fig. 17.** Saturation nephogram at the calculation time of 120 h.

To analyze the seepage range of the embankment slope under different seepage conditions, saturation nephogram at the calculation time of 120 h for each condition were extracted (Fig. 17). It could be observed that at the calculation time of 120 h, the range of seepage mainly developed in the relatively shallow layer of the right slope under low-intensity seepage condition. The depth of soil saturation was approximately 0.6 m thick

below surface layer, with the corresponding soil saturation of 25.0–34.9%. As the seepage intensity increased, the depth of seepage also increased, with the depth of the soil infiltrated by rainwater rising continuously. Under medium-intensity seepage condition, the depth of the soil infiltrated by rainwater increased to 2.0 m, with the corresponding soil saturation increasing to 60.0–81.7%. Under the high-intensity seepage condition, the depth of the soil infiltrated by rainwater increased further to 3.0 m, with the corresponding soil saturation increasing to 90.0–100.0%. As the seepage intensity increased, the infiltrating water could not quickly flow along the slope surface, but could only seep deeper into the embankment slope, leading to a continuous increase in the depth of seepage and soil saturation.

The analysis was based on the results of the previous in-situ pressuremeter tests and numerical simulations. For loess with a relative density of 2.71 and a void ratio of 0.687, under low-intensity seepage condition, the soil saturation ranged from 25.0 to 34.9%, with corresponding soil moisture content ranging from 6.34 to 8.85%. At this point, the soil moisture content was relatively low, resulting in higher shear modulus, cohesion, and internal friction angle. Consequently, the total displacement of the slope was small, and there was no slip on the embankment slope. Under medium-intensity seepage condition, the soil saturation ranged from 60.0 to 81.7%, with corresponding soil moisture content ranging from 15.21 to 20.71%. In this condition, the shear modulus ranged from 4.36 to 2.58 MPa, the cohesion ranged from 20.9 to 12.5 kPa, and the internal friction angle ranged from 21.2° to 20.3°. Under high-intensity seepage condition, the soil saturation ranged from 90.0 to 100.0%, with corresponding soil moisture content ranging from 22.82 to 25.35%. The corresponding soil shear modulus,

cohesion and internal friction angle further reduced. Meanwhile, the soil shear strength reduced to less than the shear stress, and the embankment slope formed a slip-collapse.

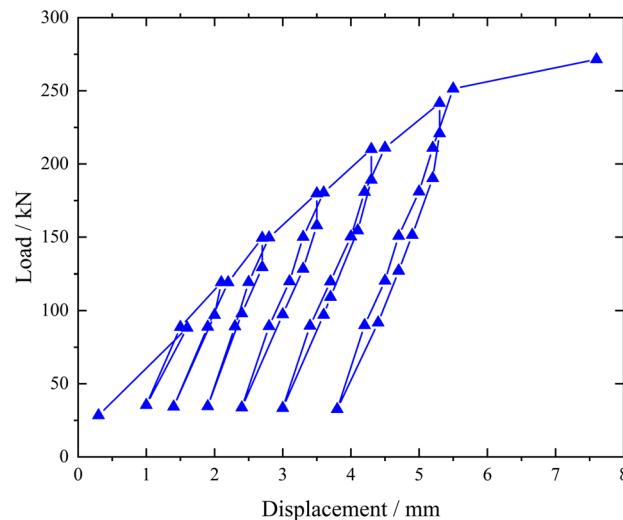
**Fig. 20.** Pull-out test curve of steel grouting pipe of group 1.

The results in Fig. 20 indicated that the displacement of the steel grouting pipe could still converge when the load was applied up to 251 kN. However, when the load increased to 271 kN, the displacement increment caused by the subsequent load level twice that caused by the previous load level, suggesting that the displacement was no longer convergent. Therefore, the anchoring force obtained from the first set of pull-out tests was 251 kN.

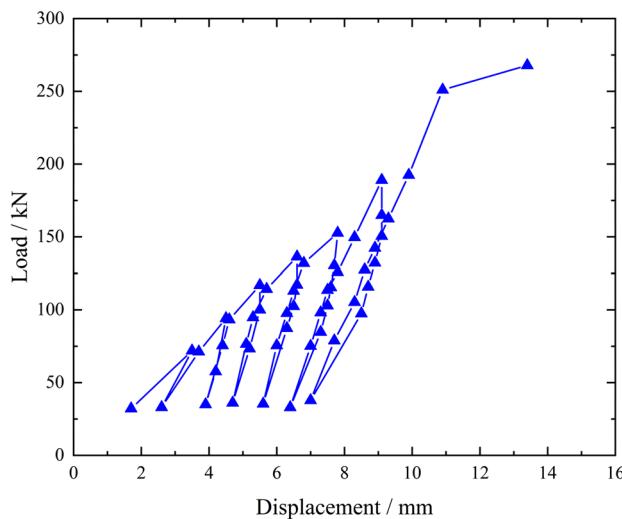
**Fig. 21.** Pull-out test curve of steel grouting pipe of group 2.

The results in Fig. 21 indicated that the displacement of the steel grouting pipe could still converge when the load was applied up to 251 kN. When the load increased to 268 kN, the displacement increment caused by the subsequent load level twice that caused by the previous load level, indicating that the displacement is no longer convergent. Therefore, the anchoring force obtained from the second set of pull-out tests was also 251 kN.

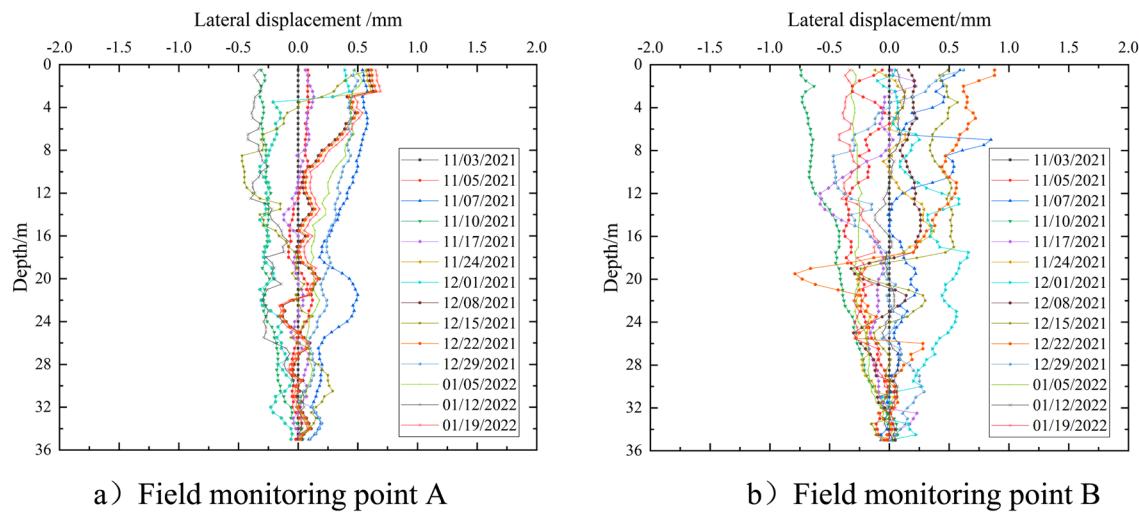
**Fig. 25.** Field monitoring results after reinforcement.

To verify whether the stability of the embankment slope has been improved after reinforcement, field monitoring measures of displacement inclinometer were employed. As shown in Fig. 25, from November 2021 to January 2022, the overall lateral displacement of the embankment slope was minimal, with lateral displacements less than 1 mm. Therefore, it is concluded that the reinforced embankment slope is in a stable state after reinforcement.

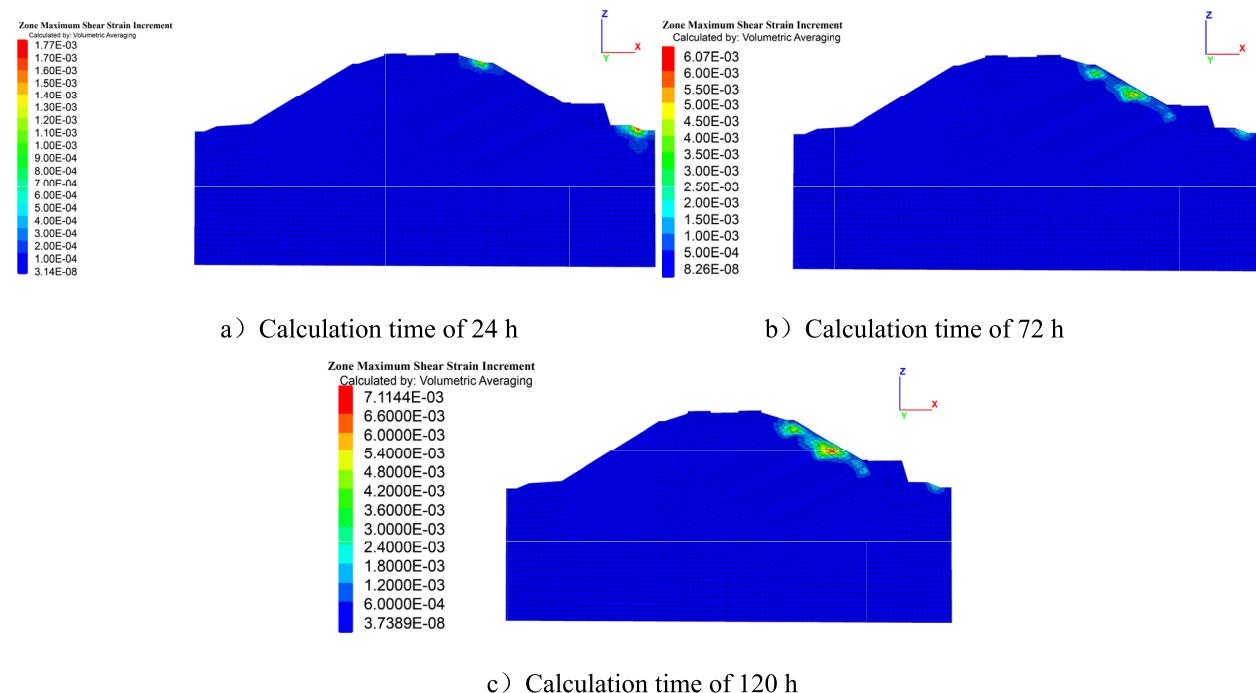
**Fig. 29.** Maximum shear strain nephogram under high intensity seepage condition after reinforcement.

As shown in Fig. 29, an area of maximum shear strain quickly formed in the shallow part of the right-side slope of the embankment under the influence of seepage. After that, as the seepage continued, the area of maximum shear strain expanded constantly. The area with the largest values of shear strain primarily concentrated in the region where the steel grouting pipes connected with the crown beam. Meanwhile, due to the effect of the retaining wall at the foot of the slope, the shear strain did not develop continuously to the foot of the slope, preventing the formation of a slope surface collapse.

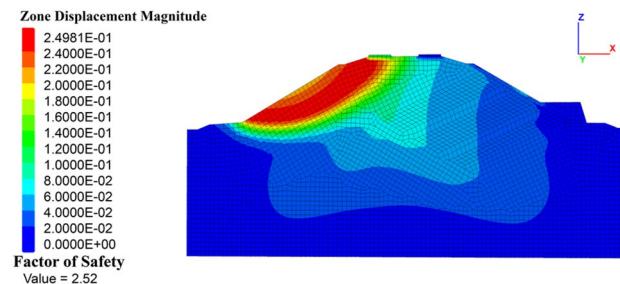
**Fig. 30.** Magnitude displacement nephogram of embankment instability after reinforcement.

Strength reduction analysis was conducted on the soil of the embankment slope under this condition and the displacement distribution was examined during the instability of the slope, as shown in Fig. 30. The stability coefficient of the embankment slope was 2.52, indicating that the combination of steel grouting pipes and retaining wall enhanced the stability of the slope. At the same time, the slope failure occurred on the left side of
