## OPEN Root cause analysis and evaluation of corrective actions for discharge boom suspension failure in bucket wheel excavator

The article analyzes the failure of a bucket wheel excavator's discharge boom suspension. The failure caused significant operational disruption and financial losses. The study includes metallographic tests and FEM analysis of the damaged axle, revealing a fatigue fracture due to inappropriate material microstructure and a structural notch. The fracture led to the boom falling, damaging the excavator and conveyor. Corrective actions involved redesigning the axle and using suitable materials, verified through extensive testing, to enhance durability and prevent future failures, ensuring safer operation.

**Keywords** Bucket wheel excavator, Discharge boom, Fracture, Redesign

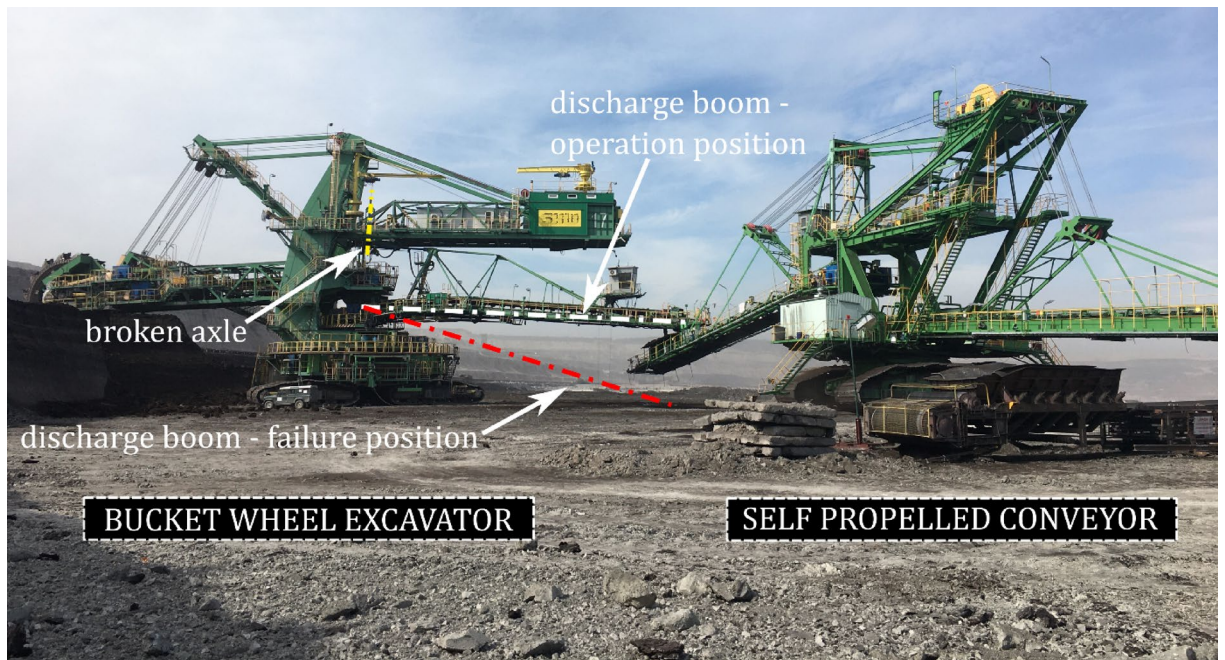
The case described in the article concerns damage to a component of a bucket wheel excavator, which in this case cooperated with self-propelled conveyor. Figure 3 shows the position of two machines relative to each other during normal operation. This bucket wheel excavator is used on site of operation to work with hard-mineable deposits. It was also designed for this purpose, and therefore it is characterized by a compact design. The failure in the presented case concerns the axle to which a luffing hydraulic cylinder (Fig. 4), controlling boom's position, is attached. This is one of the pivot points of the discharge boom relative to the rest of the excavator. This makes it possible to rotate within the range of  $-9.1^\circ$  do  $+9.8^\circ$ . This range of motion allows the excavator to work with a belt conveyor or with a self-propelled belt conveyor.

Fig. 3. General view of the excavator and conveyor before the failure.

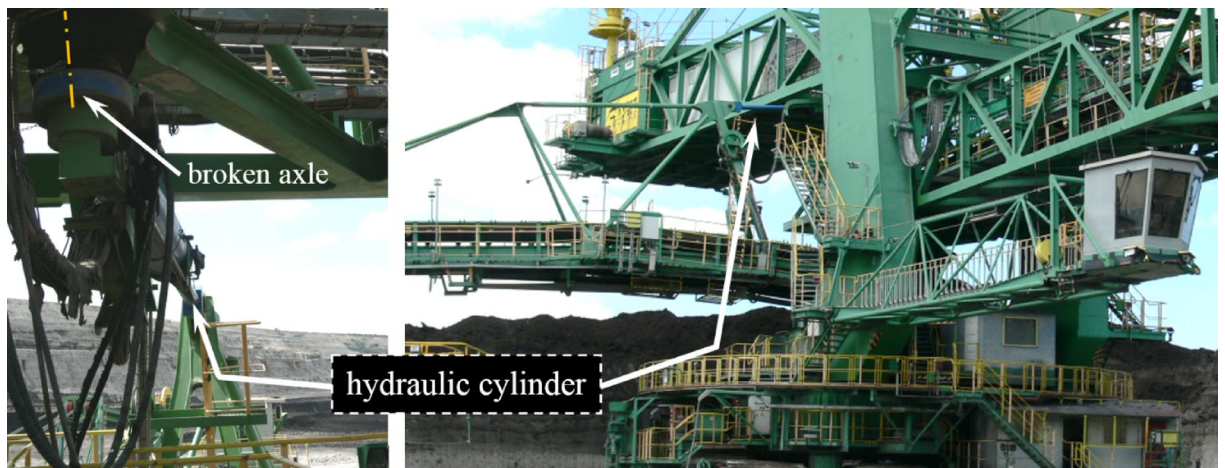
Fig. 4. Location of luffing hydraulic cylinder.

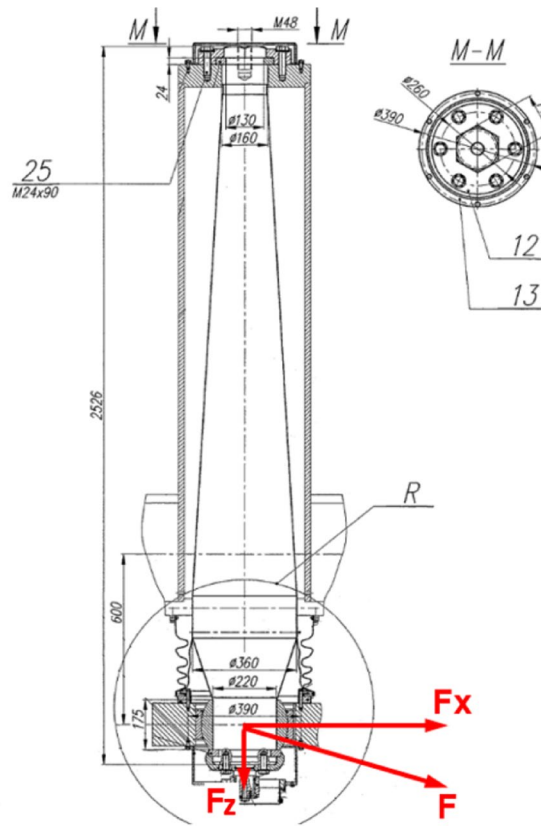
The load analysis was carried out on the basis of the data provided by the machine designer. Due to the nature of the damage, combination for the H1b—fatigue load case was taken into account according to the DIN22261-2 standard. Permanent loads (deadweight E, incrustation V) and live loads (excavated material F, dynamic loads D) were assumed. Table 2 presents calculated loads in the luffing cylinder for three considered positions of the discharge boom. This load in the luffing cylinder is the force acting on the suspension axle as shown in Fig. 15. The maximum calculated force is  $F = 1499$  kN.

Load case	Discharge boom luffing position	Luffing cylinder force components (Fig. 14) [kN]		Total luffing cylinder force F [kN]
		$F_x$	$F_z$	
H1b	up	1451	– 11	1451
	horizontal	1464	219	1481
	low	1444	402	1499

**Fig. 15.** Diagram of load operation on the discharge boom suspension axle.

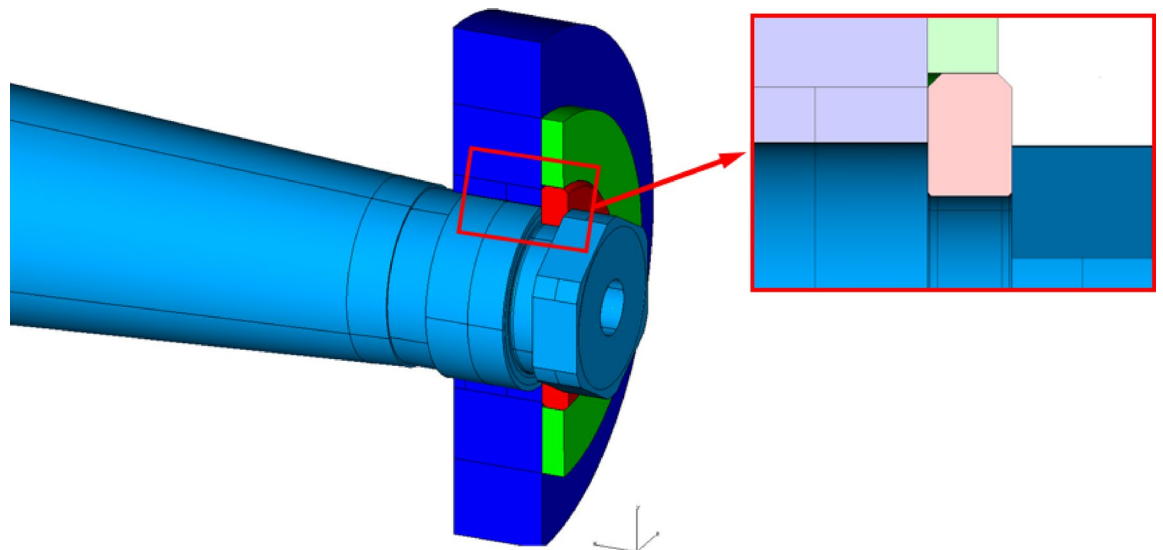
**Fig. 16.** Details of the the geometrical model of axle and the securing elements (cross-section and detailed view).

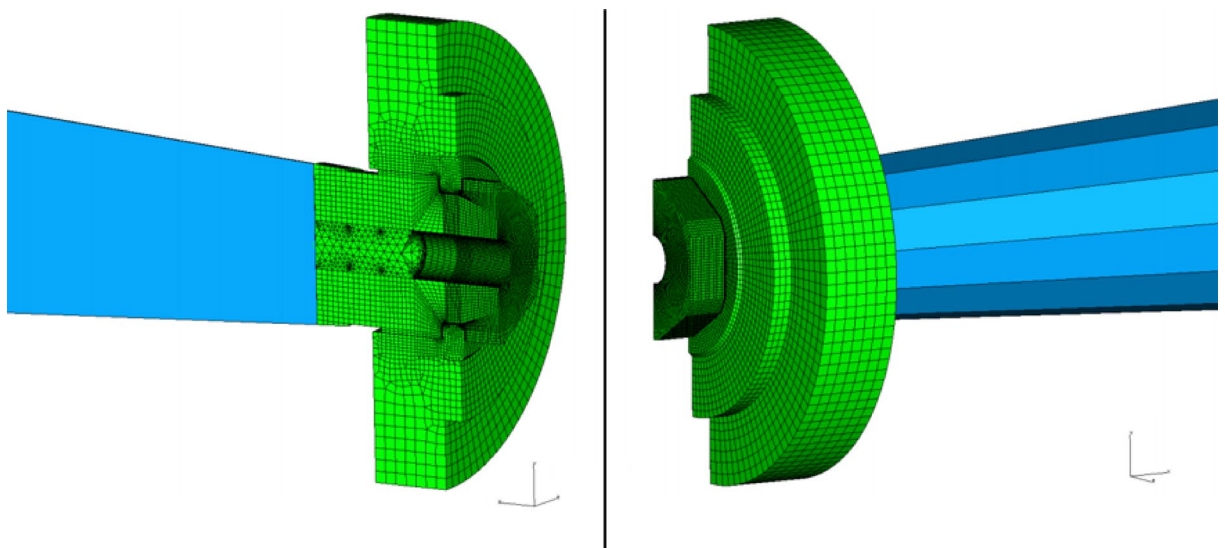
The next step was to create a geometrical model of the axis and its cooperating elements<sup>34</sup>. Solid finite elements were generated on the model in the upper support area (green color in Fig. 17), while in the rest of the model beam elements (blue color in Fig. 17) were considered. In addition, a constraint and a specified force were applied. In the most important part of the axle (area of breakage), the model was prepared with use of solid elements hexa 8 (in outer regions of axle) and tetra 10 (inner axle region). The rest part of the shaft has

**Fig. 17.** Details of the FEM model of axle and securing elements (cross-section view).

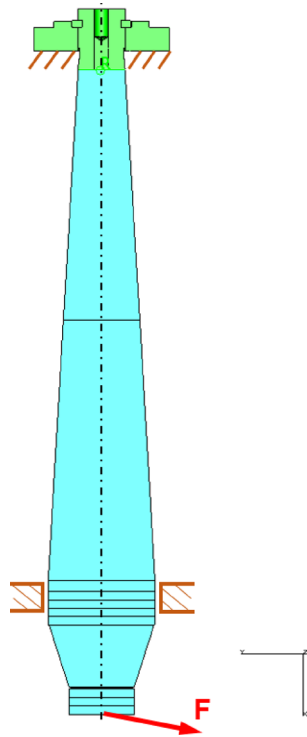
**Fig. 18.** Computational model with applied boundary conditions.

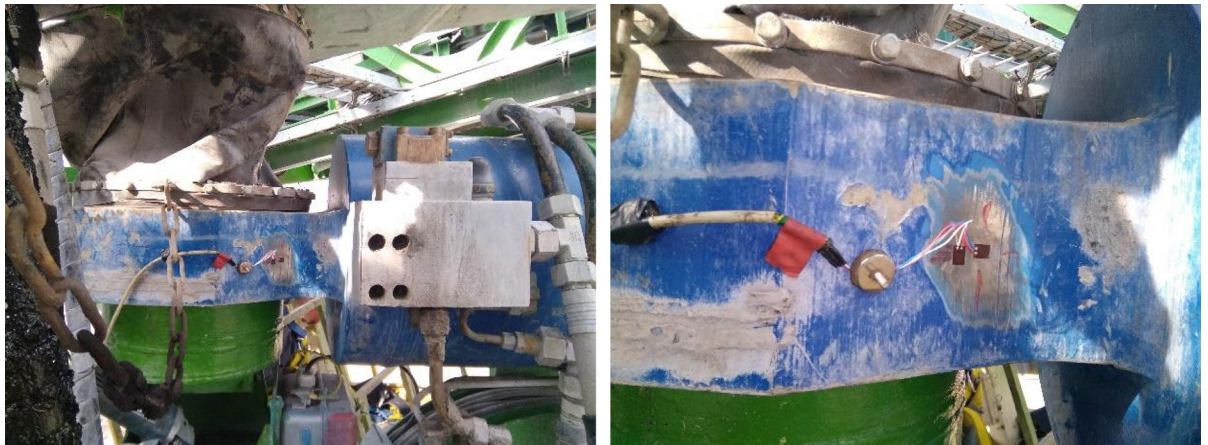
After repair, studies have been carried out to check the actual loads acting on the discharge boom axle. A measurement system with strain gauges located on the eye of the luffing hydraulic cylinder (Fig. 24) and data recorder was build. In the next step, the system was calibrated and the load on the suspension system was recorded in variable excavator operating conditions. This load recorded during the travel of the excavator, with the discharge boom perpendicular to the direction of travel, is shown in Fig. 25. Table 3 shows the maximum values of the load changes recorded during the tests.

**Fig. 24.** Location of strain gauges.

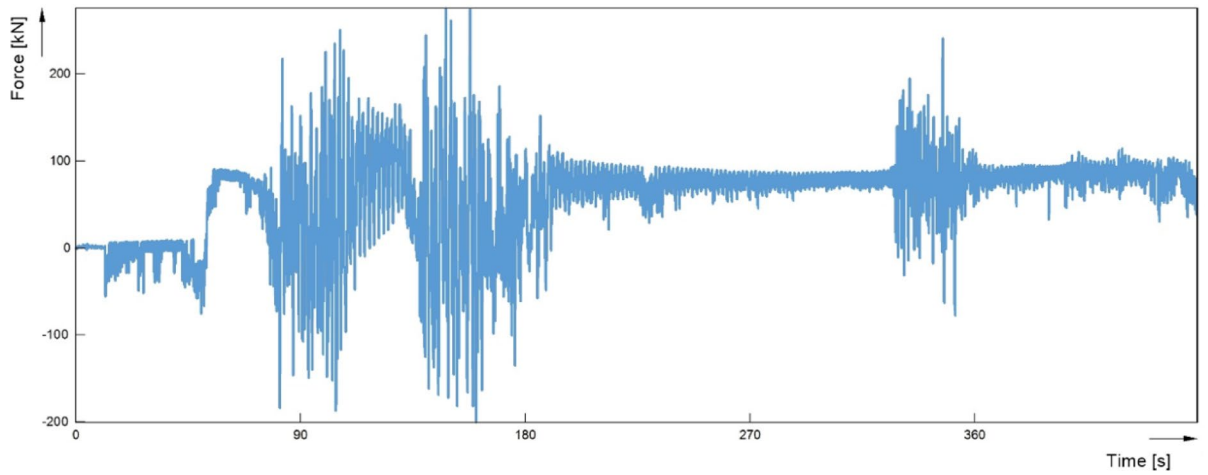
Identified total operating load acting on the axle is 18% higher than calculated according to the DIN22261-2 standard. During the measurements, an increase in loads was observed in the lower position of the boom, especially during machine traveling. The measurements were carried out for the full spectrum of technological loads of the excavator and the maximum values, resulting from all operational loads, were taken into account in the calculations.

Fig. 25. Course of recorded variable loads.

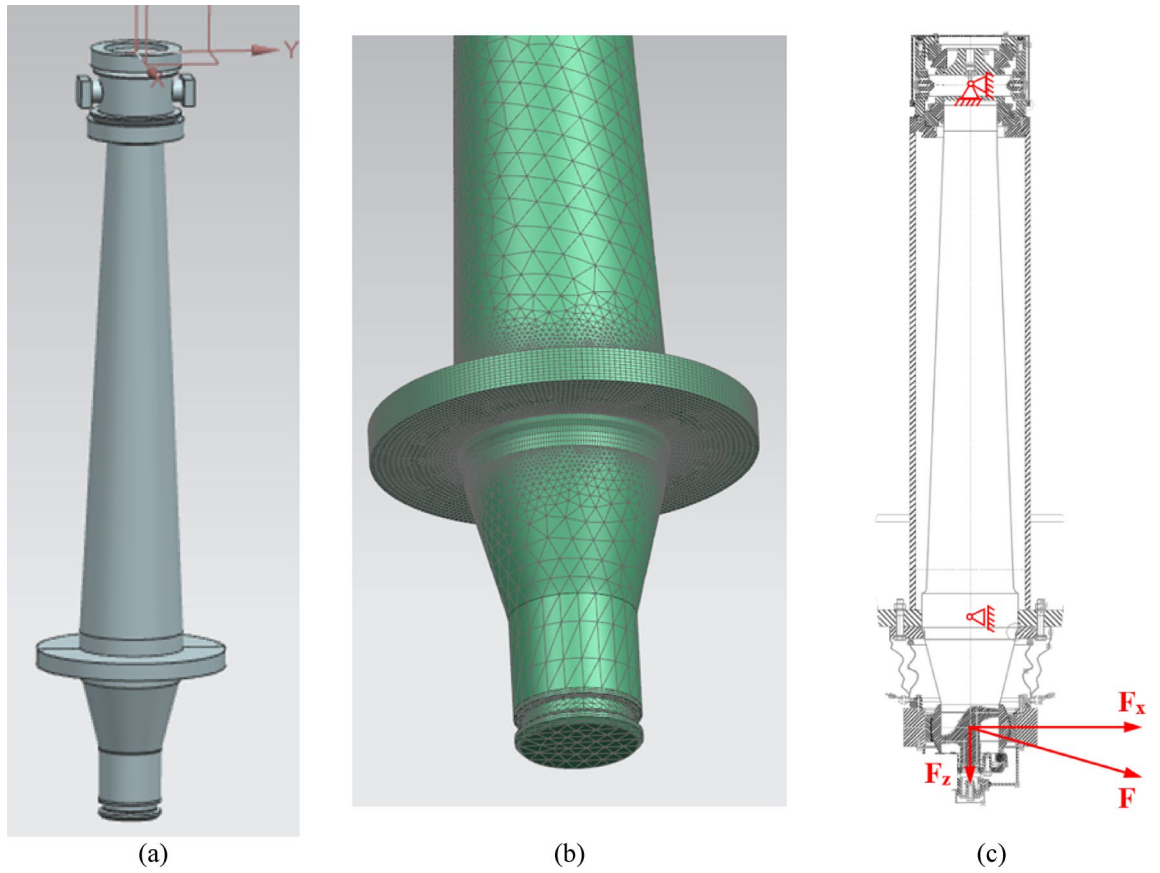
The new design of the axle and its upper support has been verified with use of FEM<sup>34</sup>. Firstly, a solid geometrical model of the axle and neighboring elements has been created (Fig. 27a). The neighboring elements considered in the simulation of both the original and modified axles are the upper and lower bearing hubs, the upper axle vertical support elements. In the upper part of the axle, contact connections were defined between these elements in order to correctly consider the load transmission. On this basis, model has been meshed with use of solid elements (Fig. 27b). Finally, a simulation model with boundary condition applied according to the scheme shown in Fig. 27 c has been created and then calculated. The force applied as a load acting onto axle was equal to  $F = 1769\text{kN}$ , which is maximal value received from tests on the real object described in previous section.

**Fig. 27.** Geometrical (a) and discrete (b) model of the new design of the discharge boom suspension with scheme of the applied boundary conditions to the axle (c).

due to replacement of the groove with two spherical bearings (GE-200AW and GE-180-AW Fig. 26) and an additional axle in the most vulnerable joint. The new suspension axle was manufactured from steel 40HM with a suitable microstructure without the Widmanstätten pattern to fulfill PN-EN 10083-3 standard<sup>33</sup> requirements.
