Model experimental study on the mechanism of collapse induced by leakage of underground pipeline

Keywords Underground space, Pipeline leakage, Collapse mechanism, Groundwater, Physical model test

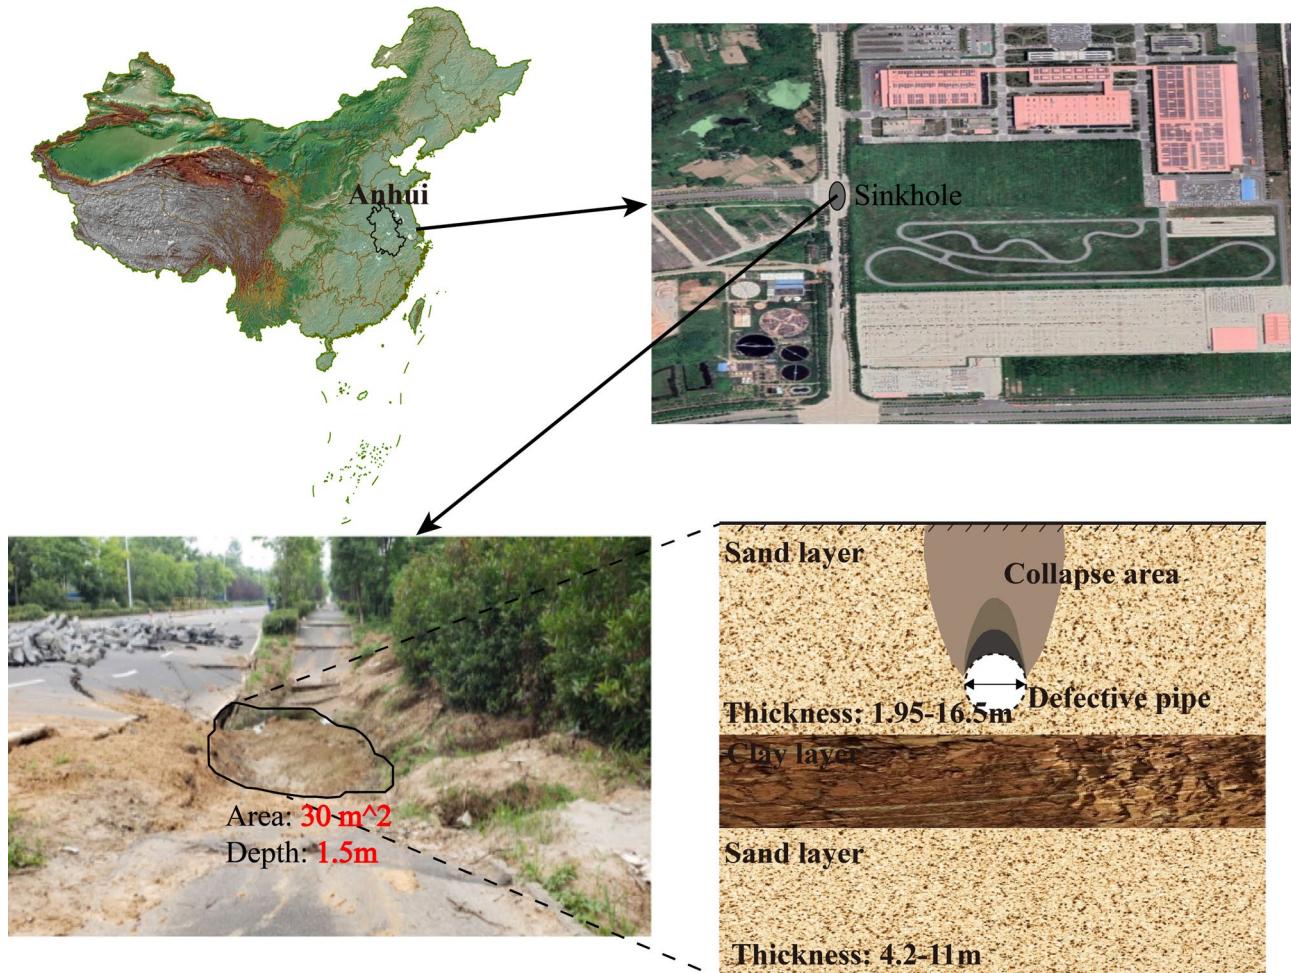
Figure 2. Location and stratigraphic information of the collapse area. The map was generated using Adobe Illustrator 2021, Illustrator Free Download & Free Trial | Adobe Illustrator. The satellite imagery was generated using Google Earth Pro7.3.6, Google Earth.

The area along the Yangtze River in Anqing City is located in the flood area of the Quaternary Yangtze River alluvial plain, the thickness of the overburden layer is 30–60 m, the lower part is Cretaceous sandstone, the submerged water table depth is 0.5~2.0 m, and the pressurized water table depth is 0~6 m. The riverfront area primarily features two sand layers, with a central layer of plastic silty clay. The buried depth of the top plate first layer is 0.7~5.7 m, the buried depth of the bottom is 3.25~18.4 m, and the thickness is 1.95~16.5 m; the buried depth of the top plate of the second layer is 20.0~34.45 m, the buried depth of the bottom plate is 31.0~38.65 m, and the thickness is 4.2~11.0 m. In February 2019, a collapse occurred on the central section of Changfeng Road in Yingjiang District, Anqing City, covering an area of approximately 30 m^2 with a depth of nearly 1.5 m, as shown in Fig. 2. The collapse caused the surrounding road surface to become "suspended", exposing the roadbed and other underlying structures, and severely tilting the sidewalk trees. The collapsed section is located within the Yangtze River alluvial floodplain zone, with a sewage pipeline installed within it. It was observed that the

sewage pipeline was placed in the bad sediment in the diffuse beach area, and the excavation depth of the sewage pipeline at the collapsed section was about 8 m, mainly distributed in the sand layer, and covered with 1.5 m of artificial fill in the upper part of the sand layer. According to investigations by relevant authorities, the cause of the incident was a leak in the shallow sewage treatment pipeline, which created a pressure difference between the inside and outside of the pipe. Groundwater carried away the fine sand beneath the road surface, resulting in the road surface being unsupported and ultimately collapsing.

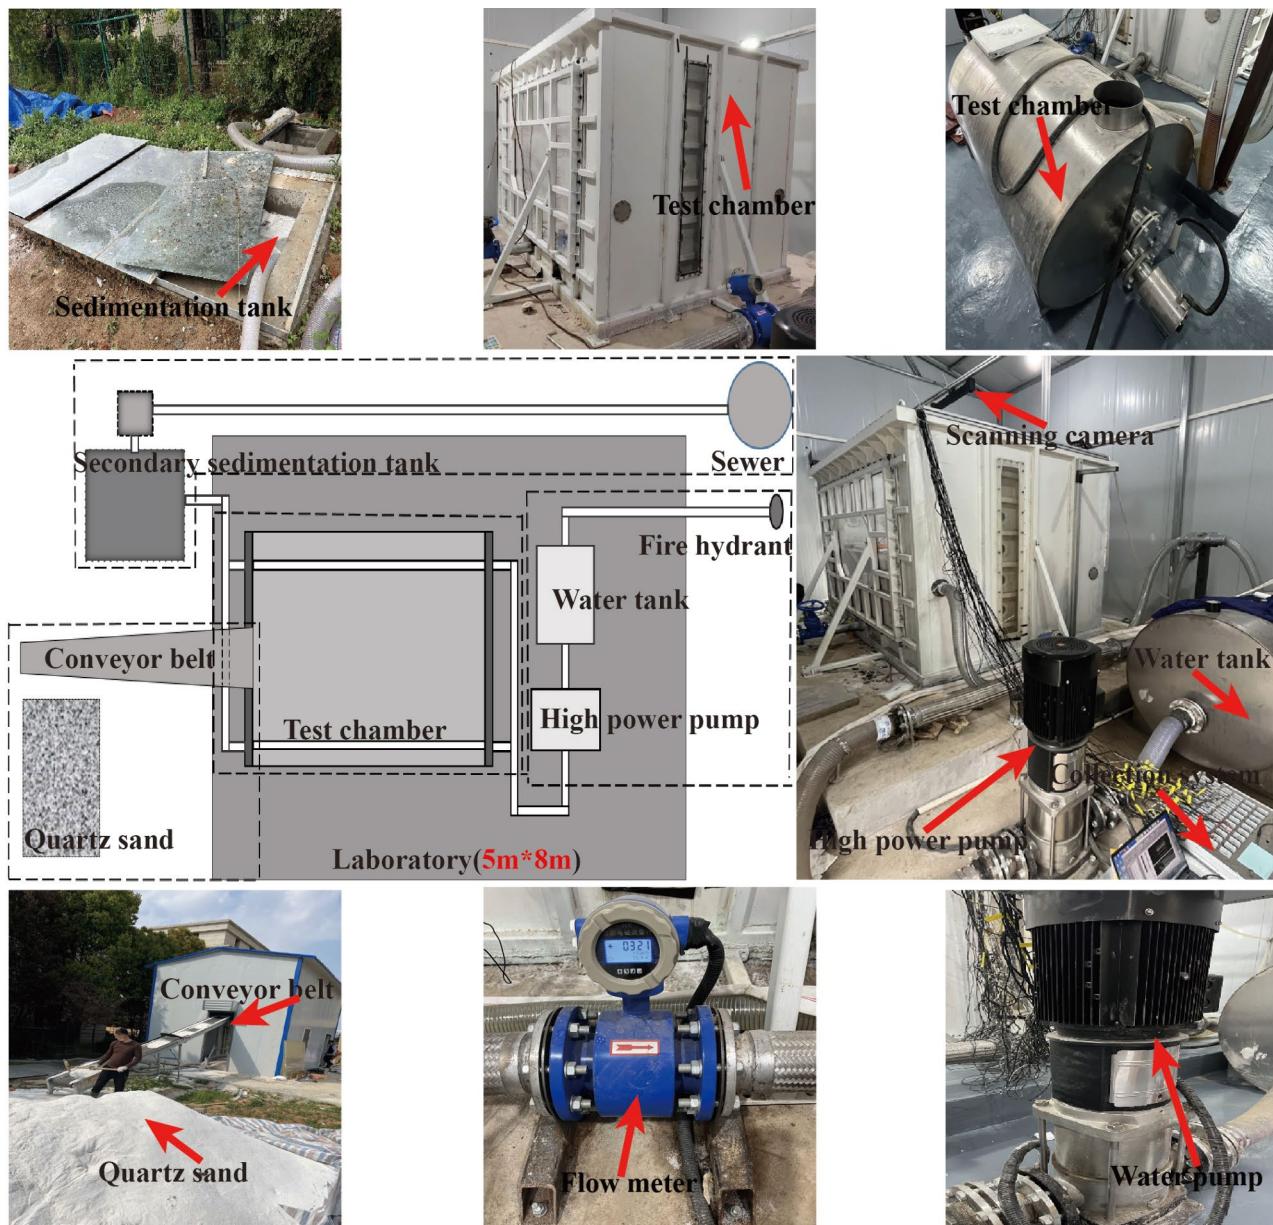
Figure 3. Physical model test system.

In this study, an independently designed collapse simulation platform was used to carry out the simulation test of underground pipeline leakage and collapse. The simulation test device mainly consists of four parts: model box system, flow control system, leakage sedimentation system, and monitoring system, as shown in Fig. 3.

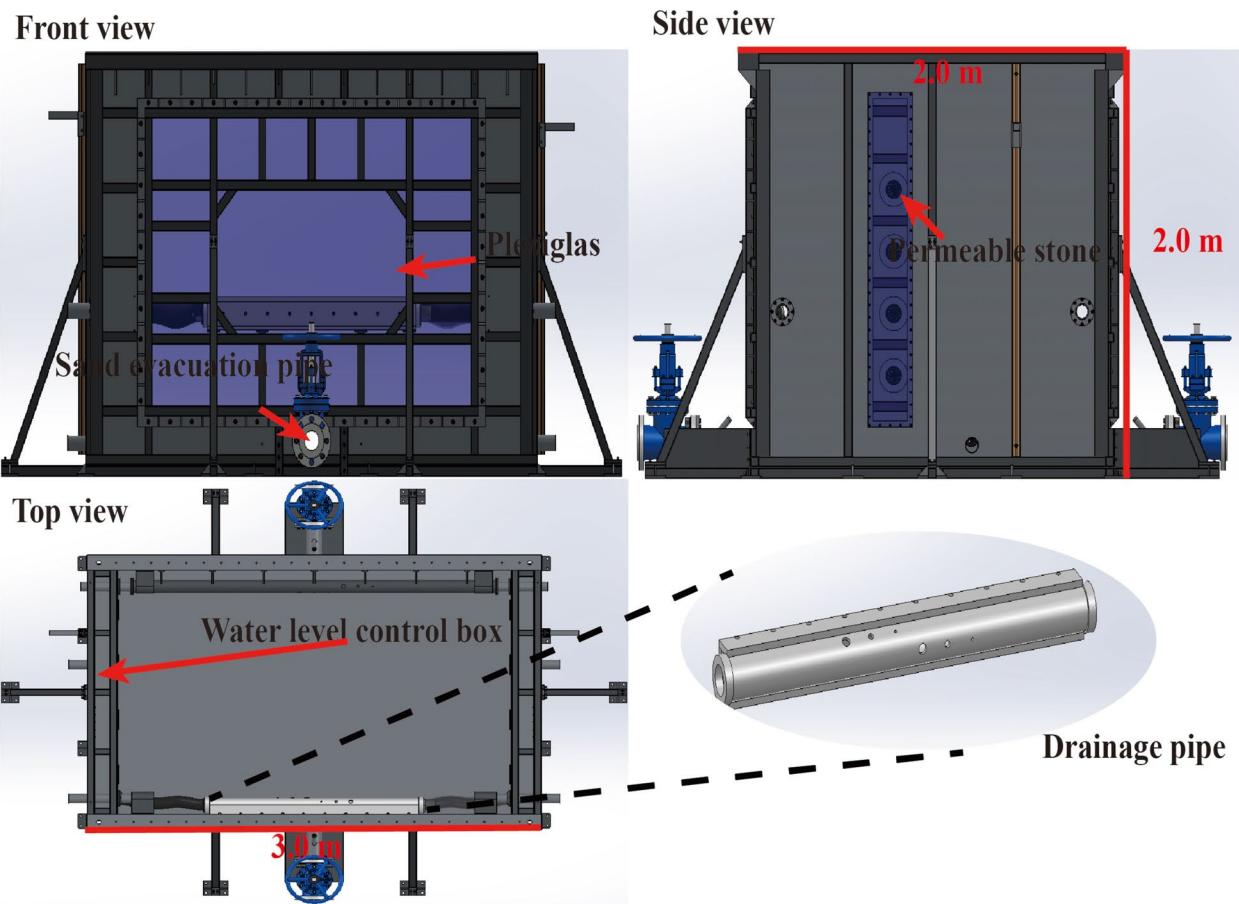
Figure 4. Model box design information.

As described in Section "Engineering background", the buried depth of the ground collapse underground drainage pipeline in Anqing City was about 8 m. The geometric similarity ratio of the model test is 1:10, and considering the thickness of the pipeline, the diameter (D) and the buried depth (L) of the drainage pipeline in the model test are 10 cm and 80 cm in the model test respectively. To account for the influence of self-weight stress fields, the gravity similarity ratio in the model test is 1, matching the field conditions. The design of the model box is shown in Fig. 4. The model box is made of Q235 steel plates with 6 mm thick sides and 8 mm thick bottom, and high strength bolts are used to connect the parts. The overall dimensions of the model box are $3\text{ m} \times 2\text{ m} \times 2\text{ m}$,

with observation windows made of 2 cm thick plexiglass at the front and rear to monitor internal erosion and settlement. Water level control boxes are installed on both sides of the model box, measuring $2\text{ m} \times 0.2\text{ m} \times 2\text{ m}$. The inside of the water level control boxes are equipped with 40 permeable dividers of 10 cm in diameter to ensure that it is difficult for the sand to pass through. Zoueshtiagh and Merlen⁴⁵ pointed out that the change of the diameter of the orifice has no effect on the critical flow rate of the full fluidization of the soil damage when the leakage loss is upward through the experiments. Inside the model box, a 10 cm diameter plexiglass pipeline is installed, with a 20 mm circular defect located above the middle of the pipeline. The flow control system in the test has a maximum flow rate of $42\text{ m}^3/\text{h}$ and a head of 40 m; the leakage sedimentation system mainly separates water and sand through a sedimentation tank; the monitoring system consists of a DIC monitoring system and a pressure sensor system, and the working principle is shown in Fig. 5.

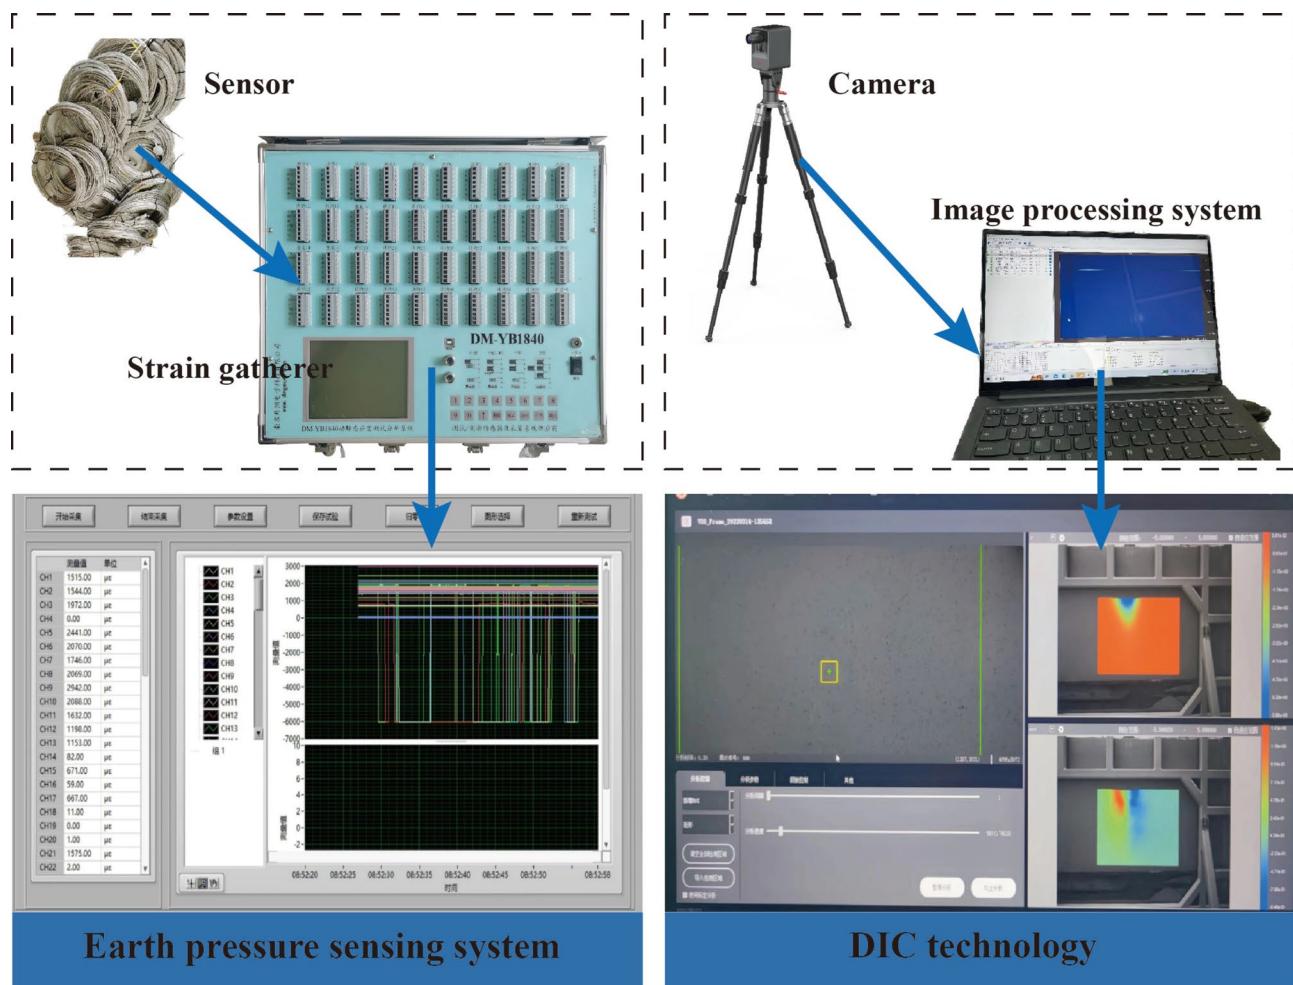
Figure 5. Monitoring system.

In this test, approximately 30 tons of quartz sand has been used as the test material to reduce the influence of impurities. During the test, the collapse displacement in stratum was captured by a visual displacement analyzer (Fig. 5) with a resolution of 1200 w. The displacement measurement accuracy can reach 0.01 mm, and three photos can be taken per second to record the collapse process. The changes in soil pressure were tracked using DMTY strain-type soil pressure sensors (Fig. 5), which have a measuring range of 0.05–10 MPa and a measurement accuracy of $\leq 0.5\%$ F.S. The main steps of the test were as follows:

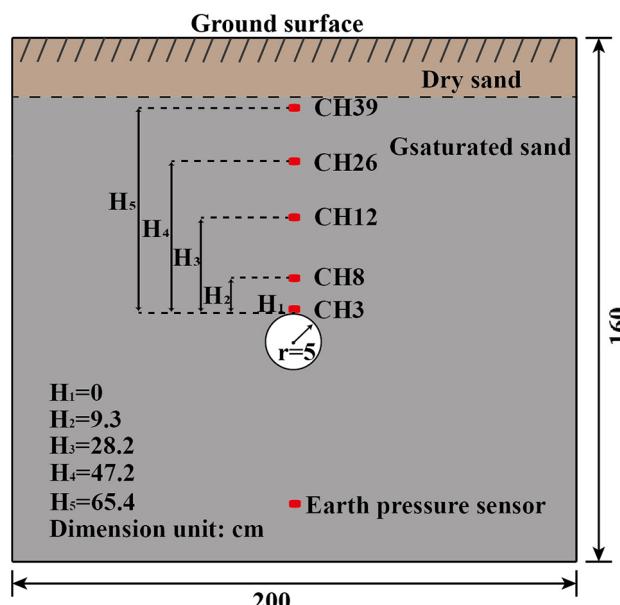
**Figure 6.** Vertical sensors distribution.

The distribution of vertical pressure sensors is shown in Fig. 6, with distances from the pipeline defect positions of 0 cm, 9.3 cm, 28.2 cm, 47.2 cm, and 65.4 cm, respectively. The acquisition frequency of the pressure sensor was set to 40 times per second during the test, with data collection starting from the moment the water pump

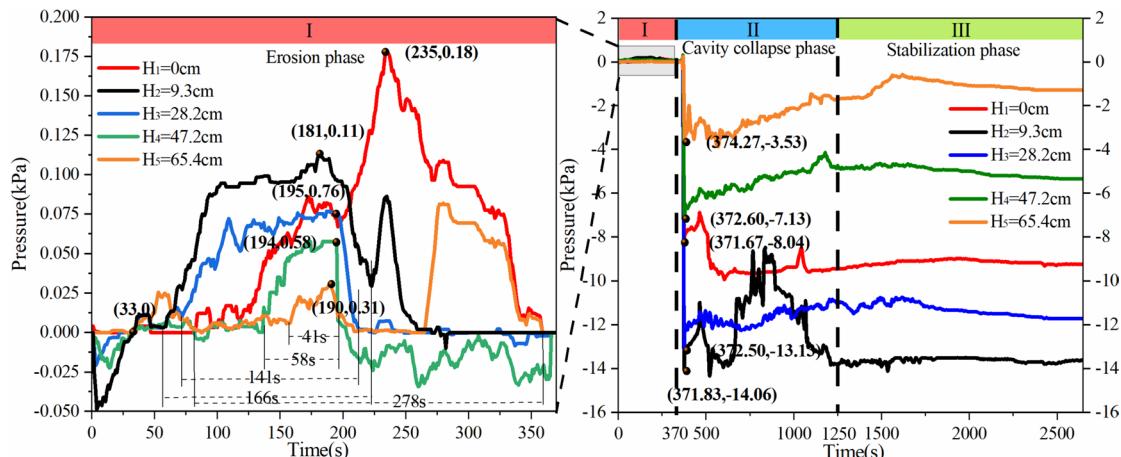
Figure 7. Stress evolution in the vertical direction.

initiates collapse. The test lasted for 2648 s, and each soil pressure sensor obtained 105,920 data. To facilitate data analysis, the average value of stress per second was taken. The evolution of vertical stresses in the strata during the test is shown in Fig. 7. Based on the test results, the evolution process is divided into three stages: the first stage where seepage failed to erode the strata, known as the initial stage; the second stage where the soil particle skeleton of the strata was eroded, known as the erosion stage; and the third stage where collapse development gradually stabilized, known as the stable stage.

In the initial stage, the stress evolution at positions H_1 , H_2 , H_3 , H_4 , and H_5 in the vertical direction is generally consistent. As shown in the left diagram of Fig. 7, the stress evolution curve is convex-shaped with relatively small variations in stress magnitude. At the H_1 measurement point, the longest stress evolution time is 278 s, with the maximum variation being 0.18 kPa. Assuming the internal particles of the soil are spherical and under the same stress conditions, when the pipeline leakage initially occurs, the seepage force formed during the leakage process are insufficient to cause damage to the soil skeleton, thus the soil remains stable. However, the seepage force acting on the finer particles inside exceed their maximum restraint force, causing these finer particles to erode along the soil skeleton under the impact of water flow. Therefore, the stress variation within the soil remains relatively small during this initial stage. In the vertical direction during the initial stage, disturbances are greater the closer they are to the pipeline defect, and the duration of disturbance is longer.

During the erosion stage, there is a short-term intense stress drop phenomenon. In the vertical directions H_1 , H_2 , H_3 , H_4 , and H_5 , stress decreases by 8.04 kPa, 14.06 kPa, 13.15 kPa, 7.13 kPa, and 3.53 kPa respectively within 2.59 s. In the later part of this stage, the stress evolution curves gradually rise and stabilize. It can be observed that during this stage, seepage force gradually exceeds the maximum restraint force of the coarse particles constituting the soil skeleton, leading to movement of soil particles. At this point, the soil skeleton is eroded, causing structural damage to the soil, and forming cavities near the pipeline defect. The cohesion between sand particles in the stratum is low, allowing cavities to develop rapidly. It is observed that the top cylindrical area of the cavity suddenly sinks, briefly forming a cylindrical collapse pit. The closer the upper stratum and the pipeline defect are during this stage, the more pronounced the collapse erosion, and the faster the stress response.

During the early stable stage from 1250 to 2000s, the curve shows slight fluctuations. The overlying soil undergoes instability due to seepage, resulting in sand flow phenomena and the formation of regular conical collapse pit that slowly expand. In the late stable stage, complete collapse development occurs, and collapse stabilizes. At this point, the stresses at H_1 , H_2 , H_3 , H_4 , and H_5 are -9.24 kPa, -13.67 kPa, -11.72 kPa, -5.33 kPa, and -1.58 kPa respectively. It can be seen that at this stage, collapse is complete, and there is still sand covering the pipeline defect, measuring 22.01 cm (Fig. 8). H_1 , located near the defect, shows relatively minor stress variations under the overlying sand and seepage effect.

From the vertical stress evolution curve, it is observed that in the initial stage, there is minimal stress variation at each monitoring point, and the evolution curve is convex-shaped. At this point, the pipeline leakage has just begun, and the seepage force acting on the coarse particle skeleton of the soil is insufficient to induce particle movement; thus, the soil above the pipeline defect remains stable. During the erosion stage, a significant stress drop occurs. By 370 s into the test, the stress distribution at points H_1 , H_2 , H_3 , H_4 , and H_5 has noticeably changed, with collapse cavities appearing above the pipeline defect. During this stage, the seepage forces are sufficient to mobilize coarse particles, leading to soil structural damage. In the stable stage, the stress curve shows slight fluctuations. During this period, the stress decreases in the overlying soil above the pipeline defect, and collapse develops laterally, accompanied by sand flow phenomena. Collapse development completes during this stage, and there remains a 22.01 cm sand covering the pipeline defect. It is evident that the closer the location is to the pipeline defect, the more severe the erosion, the greater the disturbance amplitude, and the longer the disturbance duration.

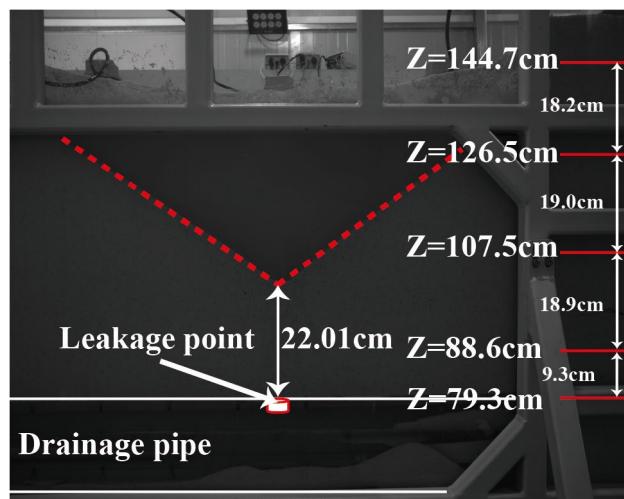
Figure 8. Different strata division.

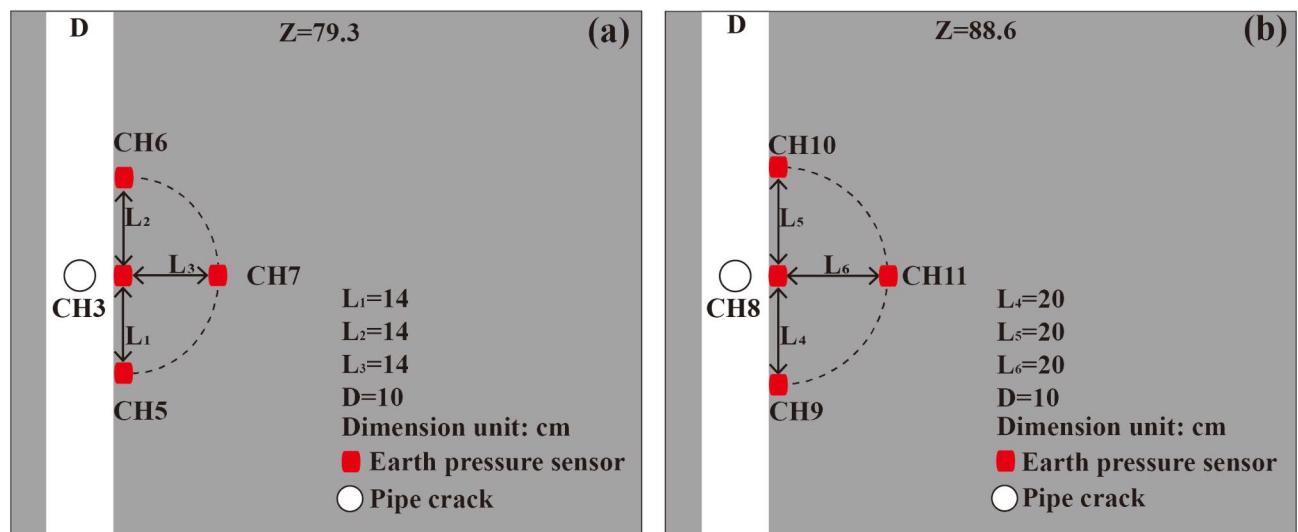
Figure 9. Distribution of horizontal sensors in the first group.

The sensors in the first group are positioned at heights of $Z=79.3$ cm and $Z=88.6$ cm respectively, as shown in Fig. 9. The distribution of sensors forms a semicircle centered at the collapse centers CH3 and CH8, with radii of 14 cm and 20 cm respectively. The horizontal soil stress evolution at $Z=79.3$ cm is depicted in Fig. 10, where it can be observed that the stress evolution at the collapse centers aligns with the curve at point H_1 from Section "Analysis and discussion of stress evolution in the vertical direction". The stress evolution trends at points L_1 and L_2 on the circle are largely consistent, while L_3 shows slight differences. At L_1 and L_2 , the stress slowly changes in the initial stage, displaying a convex curve. At 235 s, the maximum stress reaches 0.18 kPa and stabilizes at 1.41 kPa and 1.07 kPa in the second and third stages respectively. At L_3 , the stress remains constant at 0 kPa in

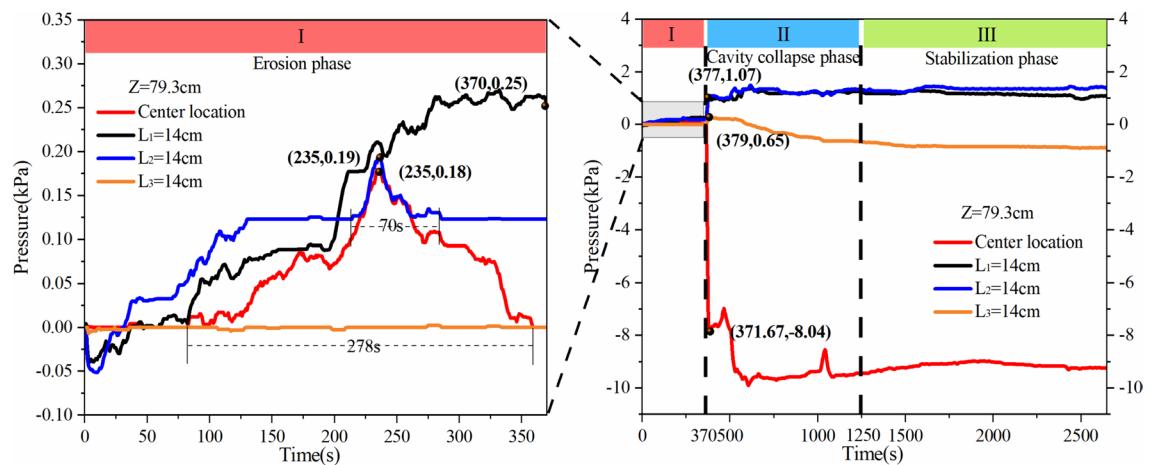
Figure 10. Stress evolution in the $Z=79.3$ cm stratum.

the first stage, decreases by 0.64 kPa in the second stage, and stabilizes at -0.88 kPa in the third stage, with the stress drop being only 9.52% of that at the center points. The sensors at $Z=79.3$ cm are horizontally aligned with the pipeline defect, and considering the conical shape of the collapse pit, stress variations are primarily influenced by the thickness of the overlying soil. Hence, the stress drop occurs at L_3 . Meanwhile, at L_1 and L_2 , due to their proximity to the model boundaries, boundary effects are significant, resulting in minor stress increases under seepage effects in the overlying strata.

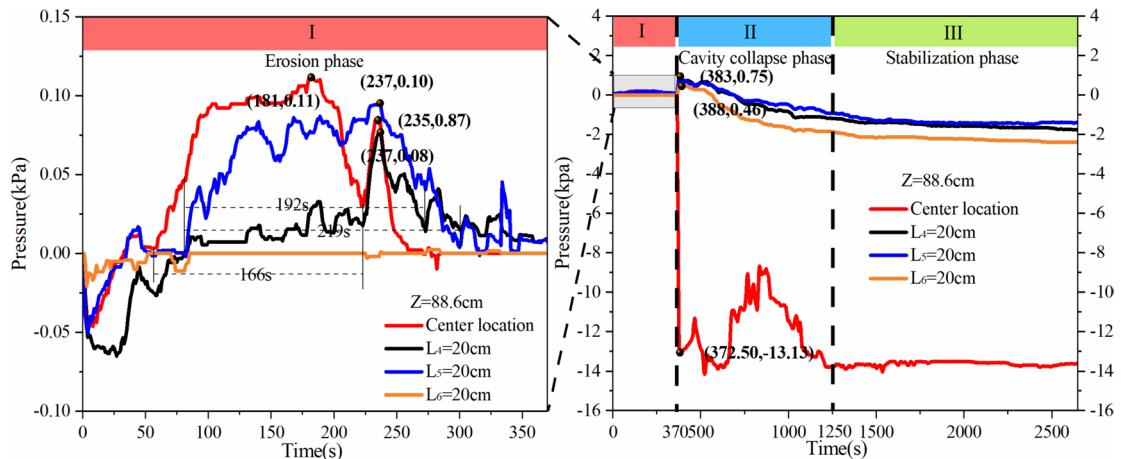
Figure 11. Stress evolution in the $Z=88.6$ cm stratum.

The horizontal soil stress evolution at $Z=88.6$ cm is depicted in Fig. 11. It can be observed that in the first stage, the evolution trends at L_4 , L_5 , and L_6 are largely consistent with those at L_1 , L_2 , and L_3 at $Z=79.3$ cm. Specifically, the curve at L_6 remains stable, while L_4 and L_5 exhibit convex-shaped curves in the first stage, reaching peak values of 0.08 kPa and 0.10 kPa at 237 s respectively. At the beginning of the second stage, L_4 , L_5 , and L_6 show rapid increases followed by gradual decreases. Notably, L_6 experiences the largest stress drop, reaching -2.39 kPa, which is 13.61% of the stress drop at the center points. Despite the presence of overlying sand at both $Z=79.3$ cm and $Z=88.6$ cm, the soil stress variations are more pronounced at $Z=88.6$ cm at the same positions. Considering the closer proximity of $Z=88.6$ cm to the collapse pit, it experiences greater influence from the loss of overlying soil particles and more severe erosion. In strata between the pipeline defect and the bottom of the conical collapse pit, closer proximity to the defect results in less pronounced effects. The strata continue to be covered by sand despite the pipeline leakage, primarily affected by the loss and seepage of overlying soil particles during the leakage process.

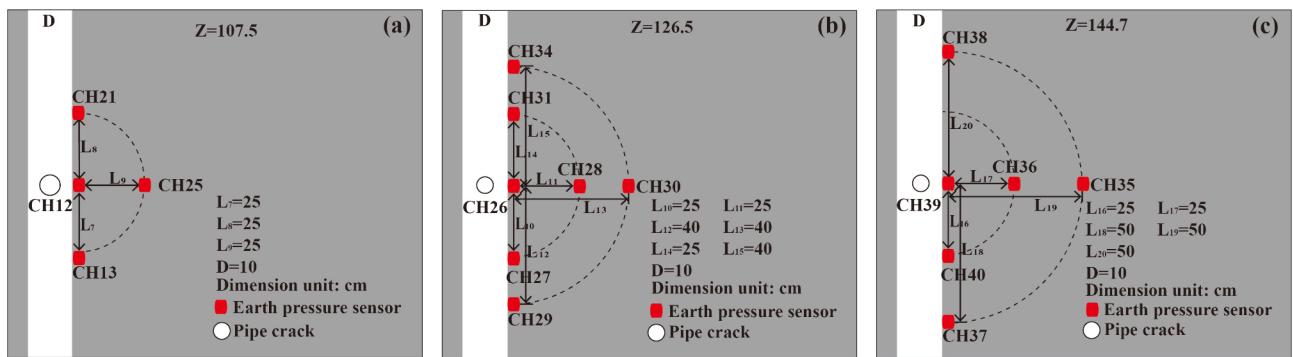
Figure 12. Distribution of horizontal sensors in the second group.

The sensors in the second group are positioned at heights of $Z=107.5$ cm, $Z=126.5$ cm, and $Z=144.7$ cm respectively, as shown in Fig. 12. These sensors are located above the bottom of the collapse pit and are arranged in a semi-circular pattern. At $Z=107.5$ cm, there are 4 sensors oriented around the center point CH12 of the collapse, with a radius of 25 cm. At $Z=126.5$ cm, there are 7 sensors arranged in a double semi-circular pattern around the center point CH26, with radii of 25 cm and 40 cm. At $Z=144.7$ cm, there are 6 sensors also arranged in a double semi-circular pattern around the center point CH39, with radii of 25 cm and 50 cm.

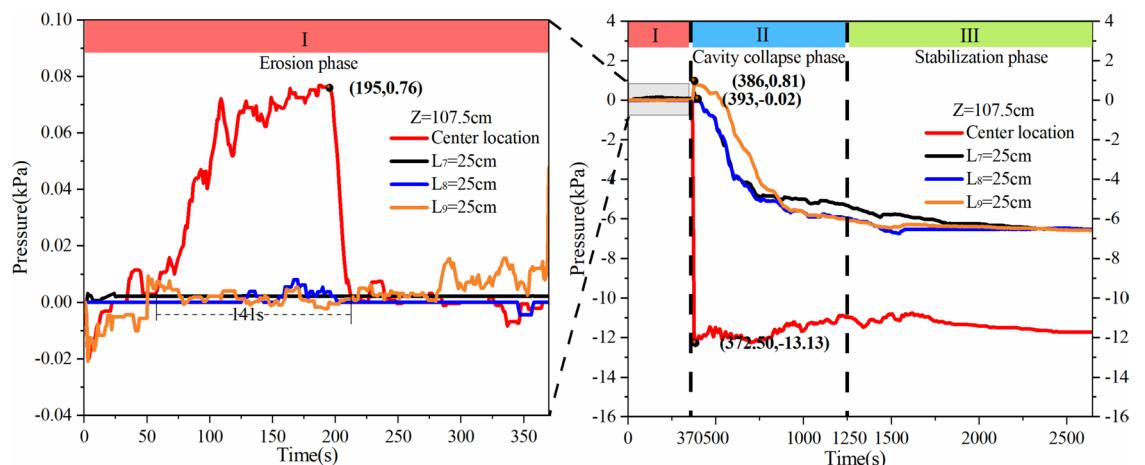
Figure 13. Stress evolution in the $Z = 107.5$ cm stratum.

The horizontal soil stress evolution at $Z = 107.5$ cm is shown in Fig. 13. It is evident that the stress evolution trends at L_7 , L_8 , and L_9 are nearly identical. In the initial stage, the stress curves show minor fluctuations. Around 390 s in the erosion stage, the stress curves rise sharply, reaching a maximum increase of 0.81 kPa, followed by a gradual decrease, which is markedly different from the rapid stress drop observed at the center point CH12. In the third stage, the three stress curves gradually stabilize at a mean value of 6.60 kPa, with an average stress drop of 56.31% compared to the center point. The soil pressure sensors at $Z = 107.5$ cm are positioned just above the bottom of the collapse pit, 6.19 cm away, where saturated sand migrates into the pipeline under erosion, leading to significant loss of the overlying sand. Compared to the evolution of stress curves at the bottom of the collapse pit in the first group, the upper strata above the collapse bottom experience greater disturbance.

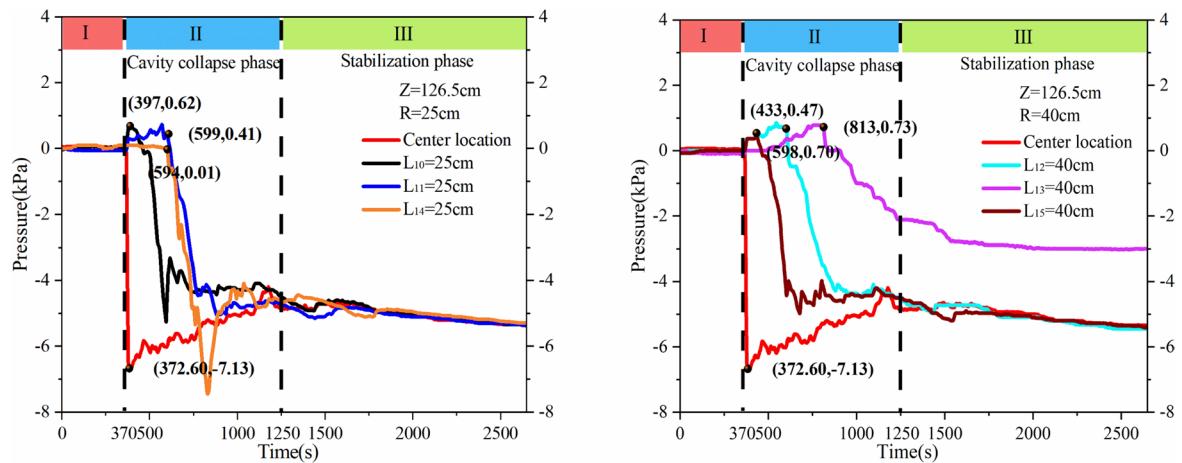
**Figure 14.** Stress evolution in the $Z = 126.5$ cm stratum.

The horizontal stress evolution at $Z = 126.5$ cm is analyzed with radii of 25 cm and 40 cm, as shown in Fig. 14. Compared to the horizontal stress evolution at $Z = 107.5$ cm with a radius of 25 cm, the stress evolution within this stratum closely resembles that at the central point. It can be observed that L_{10} , L_{11} , and L_{14} experience significant stress drops during the erosion phase at 415 s, 599 s, and 594 s respectively, stabilizing in the stable phase at -5.29 kPa. The average stress drop is 99.25% of the central stress drop. When $R = 40$ cm within this stratum, L_{12} , L_{13} , and L_{15} show stress drops occurring later in the erosion phase, at 433 s, 598 s, and 813 s respectively. In the stable phase, the three stress curves stabilize at -5.29 kPa, -3.00 kPa, and -5.29 kPa, with an average stress drop of 84.99% compared to the central stress drop. It is evident that within the same stratum, the collapse develops outward from the central point. Based on the horizontal stress evolution with radii of 25 cm at $Z = 107.5$ cm and $Z = 126.5$ cm, it is known that closer proximity to the surface results in a slower disturbance and less erosion within the collapse pit. Additionally, comparing the horizontal stress evolution between radii of 25 cm and 40 cm at $Z = 126.5$ cm indicates that erosion slows with increased distance from the collapse center within the same stratum. In summary, the collapse exhibits a conical distribution from the bottom to the surface, with the collapse progressing outward from the center to the periphery within the same stratum.

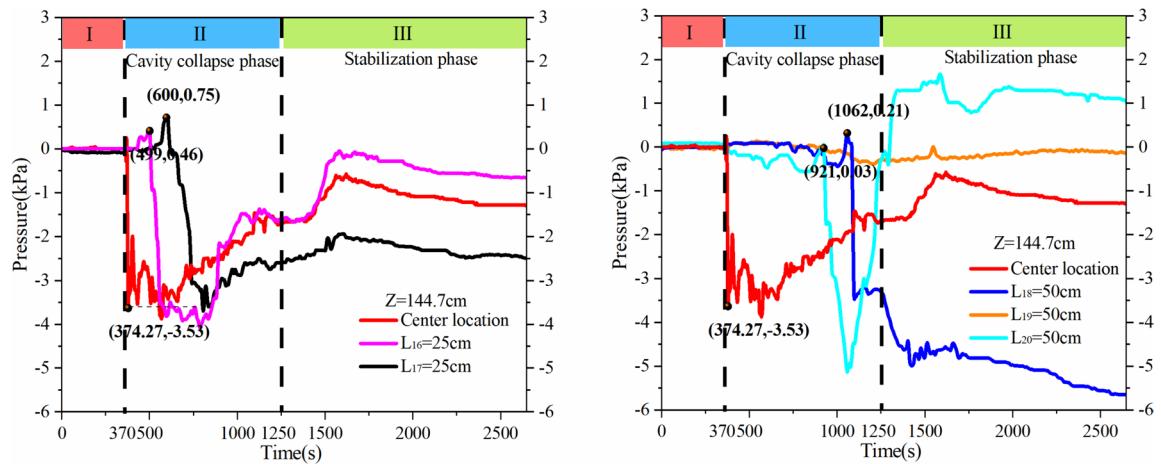
**Figure 15.** Stress evolution in the $Z = 144.7$ cm stratum.

The horizontal stress evolution at $Z = 144.7$ cm is analyzed with radii of 25 cm and 50 cm, as shown in Fig. 15. For $R = 25$ cm, the horizontal stress at L_{16} and L_{17} shows stress drops at 499 s and 600 s during the second stage, respectively, and stabilizes at -0.65 kPa and -2.47 kPa in the third stage, which is 84.81% of the central stress drop. Within this stratum, for $R = 50$ cm, the stress curves at L_{18} , L_{19} , and L_{20} show stress drops at 921 s, 1017 s, and 1062 s, respectively, and exhibit significant fluctuations after the drop, eventually reaching -5.56 kPa, -0.12 kPa, and 1.08 kPa, showing notable differences. The $Z = 144.7$ cm stratum is only covered by a 14.6 cm sand, indicating that erosion occurs relatively slowly compared to the lower stratum and is less intense. Considering the

proximity of this stratum to the surface, erosion during leakage leads to significant displacement of the stratum. After the test, it was observed that most sensors within the $R = 50$ cm radius in this stratum were displaced or tilted, resulting in severe fluctuations in the stress evolution curves.

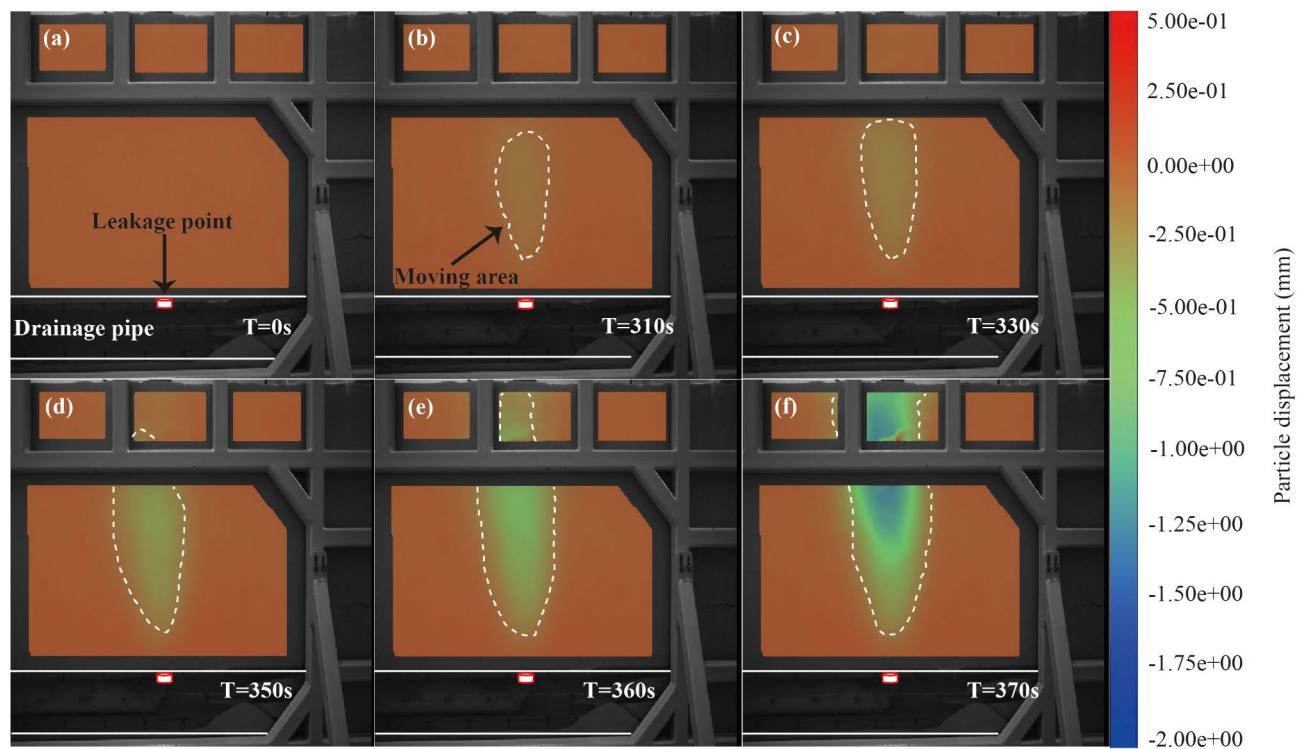
Figure 16. Transportation of soil particles during collapse.

The collapse caused by pipeline leakage typically occurs underground at considerable depths, making it difficult to observe soil particle displacement with the naked eye, especially in the initial stages of leakage. To address this, DIC technology were employed. By capturing grayscale digital images of the side surface of the sandy soil and comparing and analyzing the changes in these images over time, the deformation and displacement of soil particles were monitored, and the results are shown in Fig. 16. In Fig. 16, the orange background represents the calculation area, and the white lines represent the interface where particle movement occurs, with darker colors indicating greater displacement. It can be seen that before the initial stage of leakage (370 s), the seepage force is

insufficient to cause the soil particle skeleton to break, resulting in the loss of fine particles with little observable displacement. As the seepage force gradually exceeds the maximum restraint force of the soil skeleton, the coarse particle skeleton is lost, the soil structure is damaged, and cavities form inside the pipeline, quickly developing upwards until the top subsides (Fig. 16b-f).

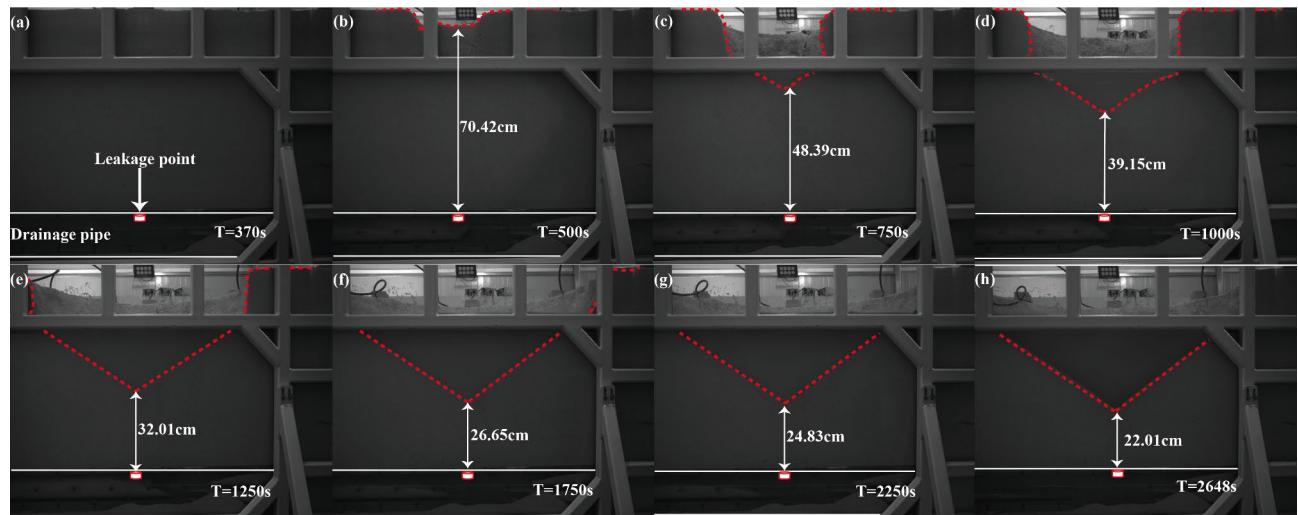
Figure 17. Collapse development.

As the loss of sandy soil at the top occurs, the pipeline leakage enters the collapse pit development stage, as shown in Fig. 17. In Fig. 17, the red lines represent the shape of the collapse pit development. During this stage, the soil coarse particle skeleton continues to be destroyed, the internal cavity of the formation gradually expands to the surface, and a cylindrical subsidence suddenly forms in the cylindrical area at the surface. In Fig. 17b, an irregular concave collapse initially appears at the top. As leakage worsens, the collapse pit's shoulder collapses (Fig. 17c-e). As the overlying stratum is eroded and damaged, sandy soil is lost from both sides, and the shape of the collapse pit gradually develops into a regular cone, exhibiting significant progressive characteristics (Fig. 17f-h). It is evident that the shape of the collapse pit changes rapidly in the early stages of development.

With the appearance of flow sand phenomena at the shoulders, the collapse pit development completes, and the expansion speed slows down.
